Arboricultural Assessment & Report: Avendon Estate, Glen Waverley Cypress Windrows Management Plan

Prepared for: Robert Mineo
Coordinator Arboricultural Services
City of Monash

Prepared by: Glenn Waters
Director/Consulting Arborist
Tree Logic Pty. Ltd.

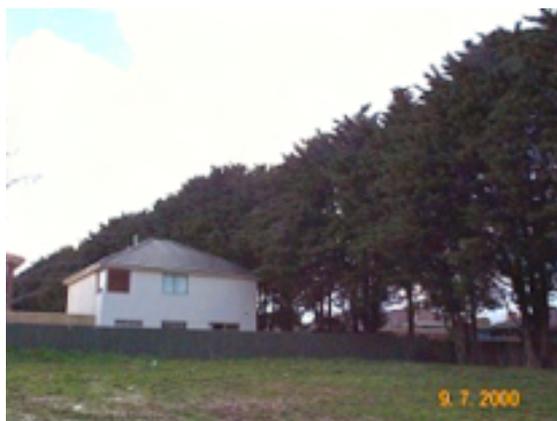
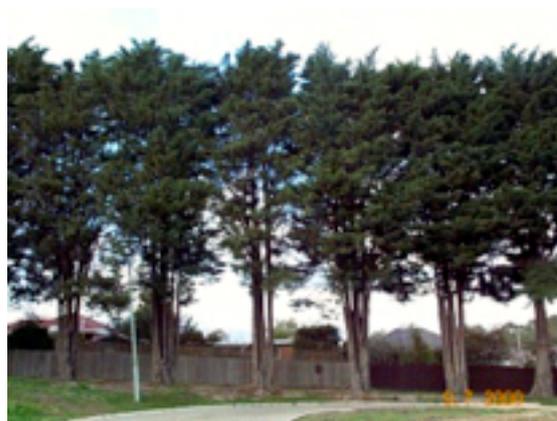
These 2 images from 2000 show the trees prior to completion of all construction within the Avendon Estate.
