Site Plan - 11 Chancellor Drive, Wheelers Hill

Site Sketch: 11 Chancellor Drive, Wheelers Hill

Re: 11 Chancellor Drive, Wheelers Hill – Arborist Report

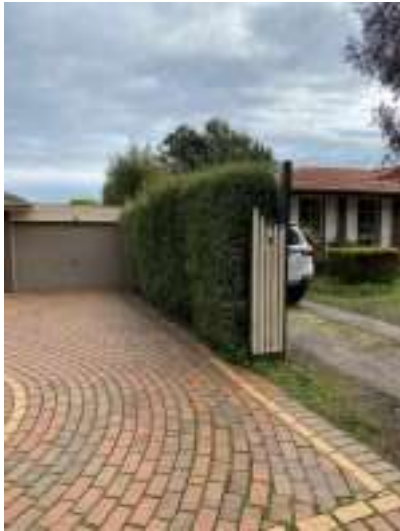
Tree 01 is a row of Pittosporum to the neighbouring side of the southern boundary. They have matured typically for the species forming an upright compacted hedge. As it is neighbouring it must be protected if a proposal proceeds. Tree Protection Fencing (TPF), would be required to the extent of the Tree Protection Zone (TPZ), as per AS-4970, forming an enclosed space within the existing site boundary. If site access is required within the TPZ, Ground Protection Measures, as per AS-4970 could be used to allow site access whilst protecting underlying roots.

As per AS-4970 there could be a maximum of 10% encroachment into the TPZ, unless it can be proven there are no roots greater than 40mm diameter or mass of fibrous roots with the proposed encroachment, via a Non-Destructive Root Investigation (NDRI). If roots greater than 40mm diameter or a mass of fibrous roots are present within proposed encroachment dependent on the size, depth, location, and number of roots present a proposal may require modification to the satisfaction of the relevant authority.

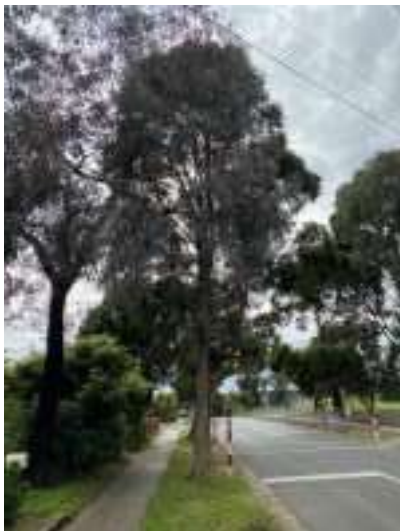
Tree 02 is a Prickly Tea Tree to the nature strip of Chancellor Drive, adjacent the site. It has matured typically for the species, forming a mid-sized canopy tree. As it is on council land it must be protected if a proposal proceeds. TPF will be required to the extent of its TPZ, forming an enclosed space within the lawn area of the nature strip. Protection measures must be as per AS-4970 and remain in place for the duration of the development. Refer to Tree 01 for notes on encroachment into a TPZ.

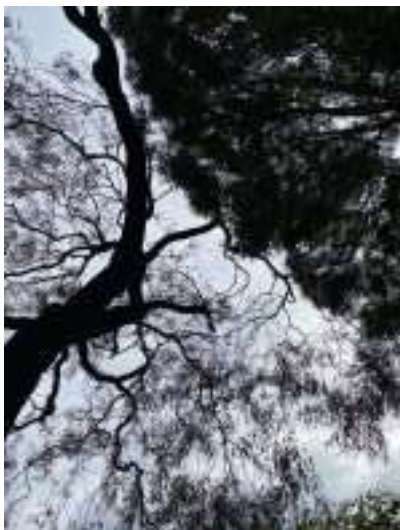
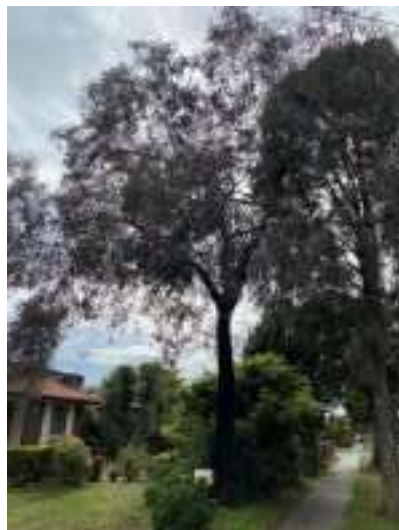
Tree 03 is a Red Iron Bark to the eastern boundary. It has matured in an average manner, however, is starting to decline with the canopy thinning and dieback present through stems to minor branches. Given its lack of vigour, it is of a low retention value and removal and replacement should be considered. Under the VPO1 it would require approval for removal.

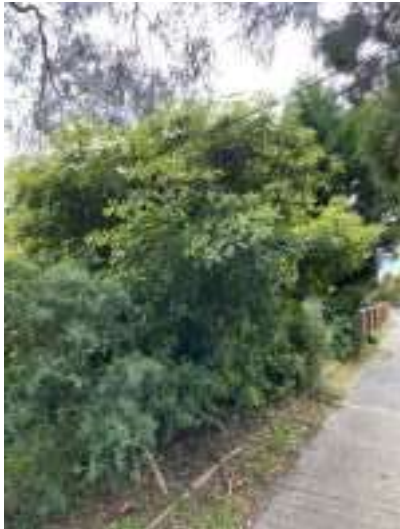
Tree 04 is a Sweet Pittosporum to the eastern boundary. As it is an environmental weed it is recommended for removal. AS noted, it is exempt from permit conditions under the VPO1.

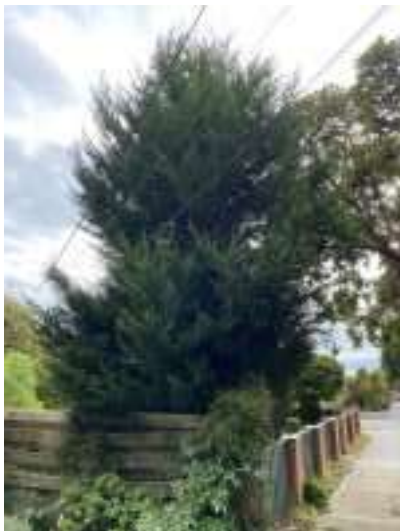
Tree 05 is a Monterey Cypress to the neighbouring side of the northern boundary. It is likely to mature into a substantial tree if not clipped regularly by the neighbour, with the potential to reach 20m high, with a similar width. It's removal in negotiation with the neighbouring is recommended as it is a poor species for cultivation in a suburban context. If the neighbour wish to retain it, it must be protected. Refer to Tree 01 for notes on protection, along with notes on encroachment, as per AS-4970.

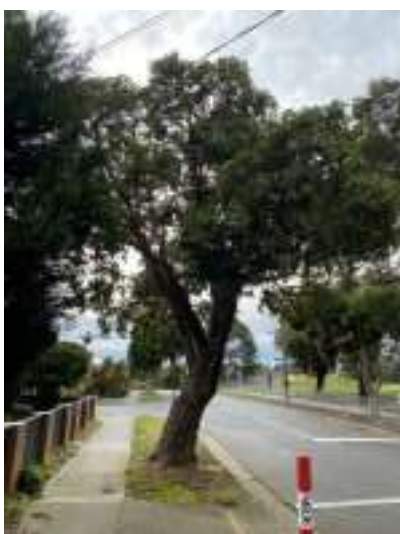
Tree 06 is a Red Flowering Gum to the nature strip of Chancellor Drive, to the north of the site. Given its distance from the site, it would not require any species tree protection works prior to a proposal proceeding.

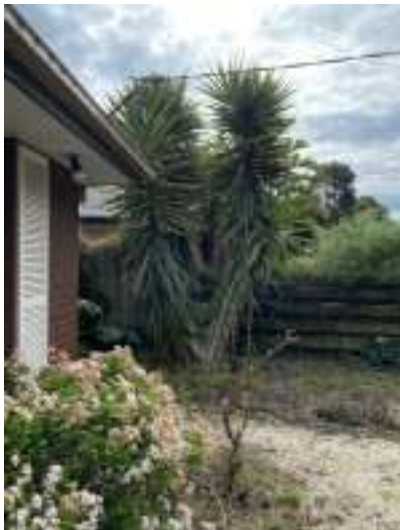
Tree 07 is a Variagated Yucca to the northern boundary. It is maturing poorly with two main branches radiating from base. Over time the failure of one or both branches is likely. As such it is of a low retention value and recommended for removal. It appears it wouldn't require approval for removal under the VPO1.

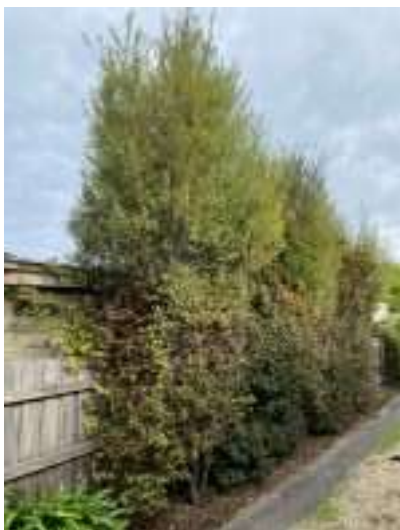
Tree 08 is a Mixed Hedge of Pittosporum and Lilly Pily to the southern boundary. It has been clipped to ensure clearance and is maturing poorly as a result with poor branch structure, supporting a high canopy. In addition to this the Lilly Pily are maturing poorly in competition with the Pittosporum.

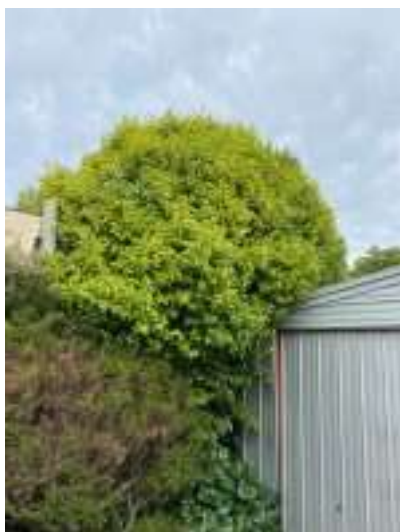
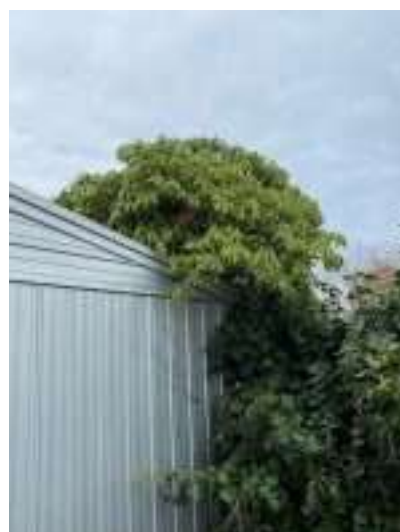
Tree 09 is a Michelia; Tree 10 is a Rhododendron. Both are located to the neighbouring side of the southern boundary. They are maturing well forming rounded upright small trees. As they are neighbouring, they must be protected if a proposal proceeds. TPF will be required to the extent of their TPZ, offset 1m from proposed works and or existing structures prior to demolition. Within the 1m offset Ground Protection Measures must be used. All protection measures are to be as per AS-4970. Prior to demolition canopy reduction works maybe required for access. If so, these must take place as per AS-4737 and undertaken by a suitably qualified arborist. Following pruning works a long-armed excavator or similar that can be positioned clear of its

TPZ, can then be used to demolish the existing garage. Refer to Tree 01 for notes on encroachment into a TPZ, as per AS-4970.

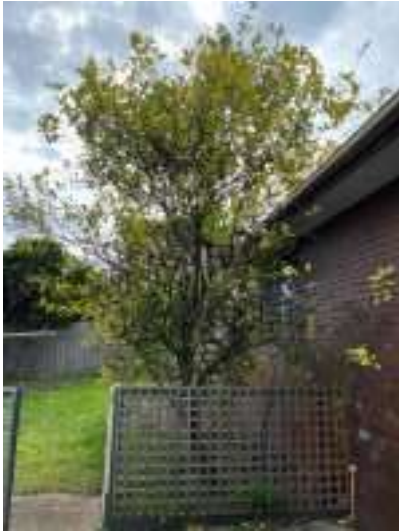
Tree 11 is a Lemon to the centre of the site. It has matured poorly and is heavily infected by Gall Wasps and other common citrus pests. It is of a low retention value and recommended for removal. It appears it wouldn't require approval for removal, under the VPO1.

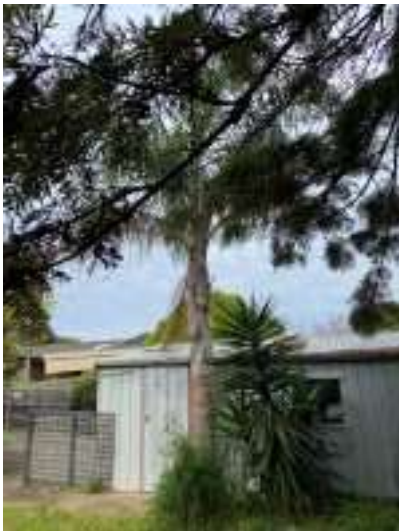
Tree 12 is a Queen Palm to the south of the site, adjacent the shed. Queen Palms produce fruit toxic to fruit bats, along with creating long term maintenance issues when shedding the fruit and old fronds. It is a poor species for cultivation because of these factors and impacts to wildlife and is therefore recommended for removal. It appears it wouldn't require a permit for removal under the VPO1.

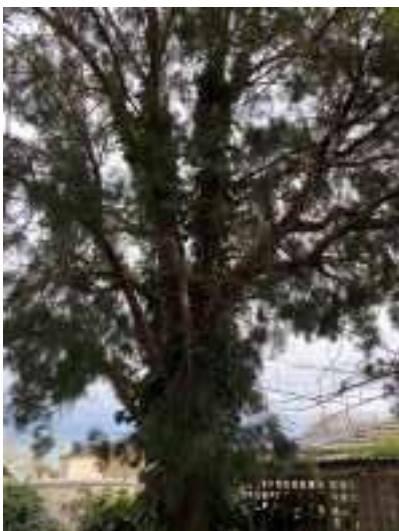
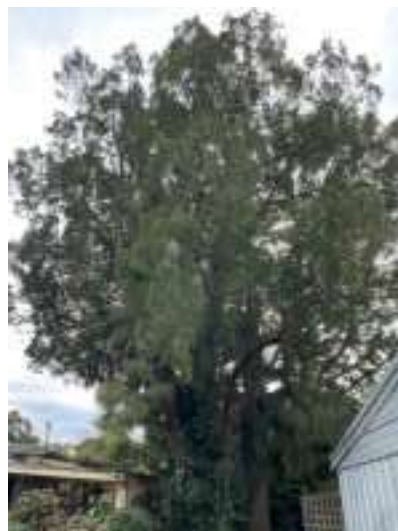
Tree 13 is a Rose Sheoak to the west of the site. It has matured typically for the species forming an upright mid-sized tree. Whilst its form is relatively uniform it is supported by poorly structured branches with minor and major branch tear outs likely overtime, particularly the main bifurcation. If this was to occur it presents a hazard risk to anyone present on the site. As such its removal should be considered, with a replacement tree of smaller stature considered. It would require a permit for removal, under the VPO1.

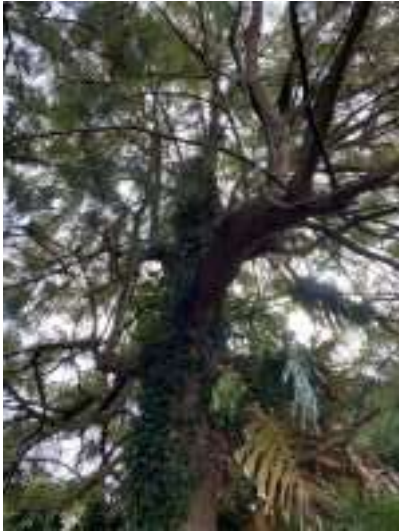
Tree 14 is a Silky oak to the north-west of the site. It has matured poorly having been lopped in its upper canopy resulting in poor branch structure and canopy form. The point of lopping was its central leader that was likely to have a substantial diameter to it, leaving behind a large surface area for decay. The ivy present across its minor and main branches has likely exacerbated to conditions for decay to occur, increasing the likelihood of decay present at the old lopping point. Given these factors it is of a low retention value and maybe hazardous if retained, with failure of secondary branches likely, posing a risk to anyone on the site, or neighbouring, particularly around the neighbouring pool which is within its fall zone. As it appears to be protected under the VPO1 it will require a permit for removal.

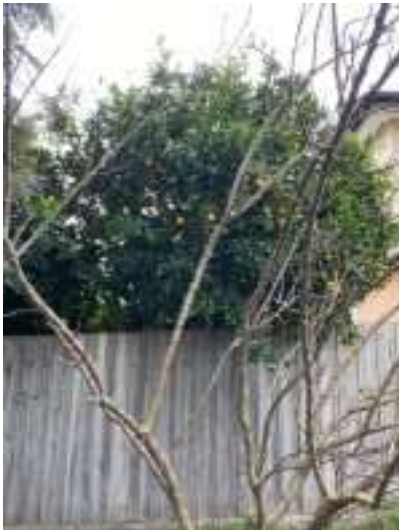
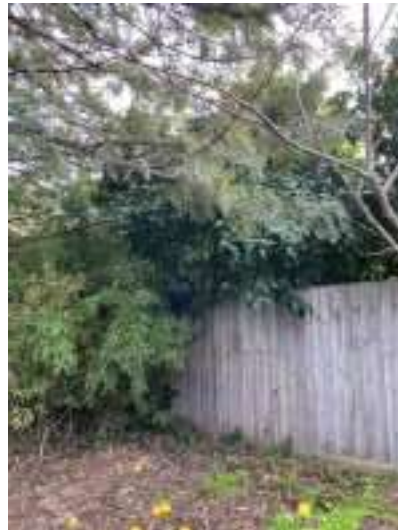
Tree 15 is a Grapefruit; Tree 16 is an Orange. Both are located to the neighbouring side of the northern boundary. As they are neighbouring, they must be protected if a proposal proceeds. Tree protection methods and notes on encroachment are as per Tree 01.

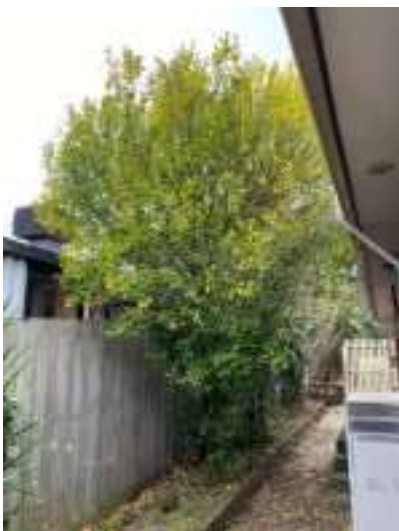
Tree 17 is a Kumquat to the northern boundary. It has matured with multiple over elongated thin branches supporting its thinning and slightly chlorotic canopy. It is of a low retention value and recommended for removal, and appears it wouldn't require approval for removal, under the VPO1.

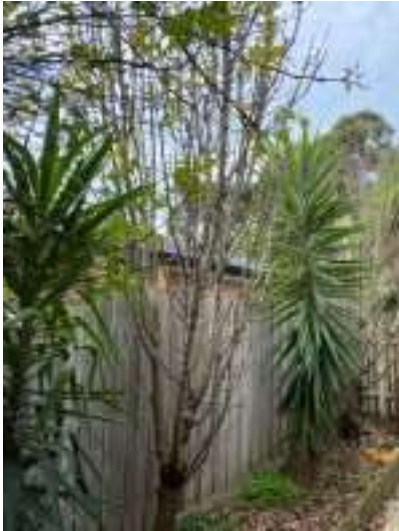
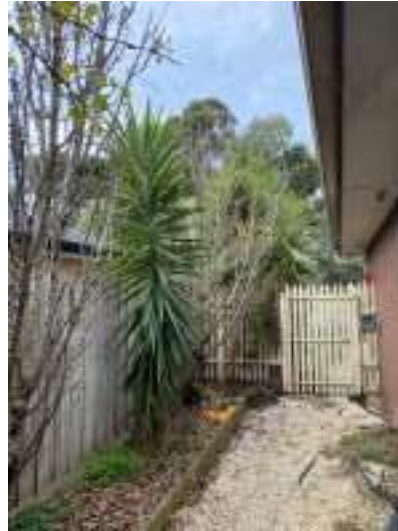
Trees 18 and 19 are Capital Pears to the northern boundary. They are maturing poorly having been lopped triggering suckering growth along their trunk that will adversely affect them over time. As such they are of a low retention value and recommended for removal. It appears it wouldn't require approval for removal, under the VPO1.

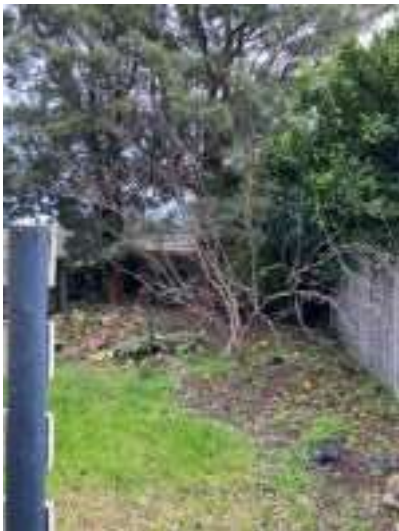
Tree 20 is a Plum to the northern boundary. It is maturing poorly with short trunk and a broad canopy of over extended branches. It will mature poorly into the future with failure of its main branches likely. As such it is of a low retention value and recommended for removal. It appears it wouldn't require approval for removal, under the VPO1.
