# Tree Impact Assessment

Client: ZC Wood Pty Ltd

Site: 31–33 High Street Rd, Ashwood 3147

Date of Inspection: 26 April 2022

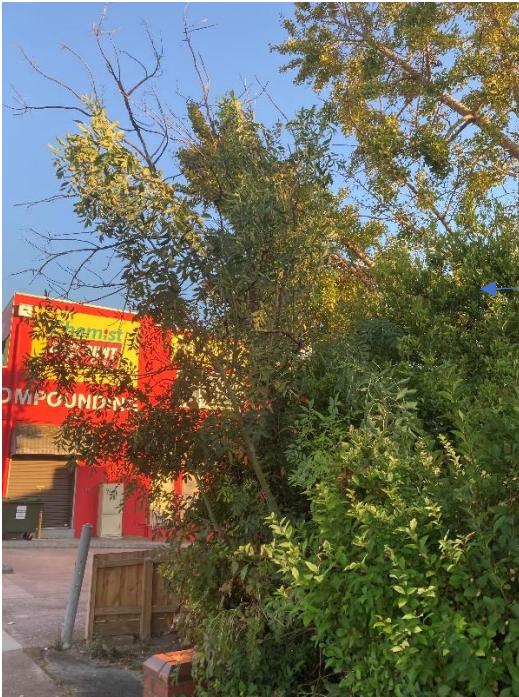
| Tree No. | Botanical Name | Age | Hei. x Wid. | DBH (cm) | TPZ (m) | SRZ (m) | ULE | Hea. | Stru. | Ret. Val. | Comments (Native or Exotic). 'BE': Building Envelope. 'b.': boundary. 'PL.': Previously Lopped |
|---|---|---|---|---|---|---|---|---|---|---|---|
| 1 | Fraxinus angustifolia subsp. angustifolia | S | 5.6x3.2 | 13 | 2 | 1.5 | Rem | Poor | Fair | Low | Exotic Weed Close to BE. Remove |

Tree 1 is a *Fraxinus angustifolia* subsp. *angustifolia* (Desert Ash), this exotic tree is a problematic weed tree in our urban landscape. It has been marked for removal to reduce its spread through the local area. It is growing in the front set back and is clear of the proposed building envelope and would not be directly affected by this proposal. Tree 2 is a *Citrus japonica* (Kumquat), this small exotic is growing on the southern boundary, clear of the proposed building envelope. It therefore would not be directly impacted by this proposal. It is suffering from scale infestation, lack of sunlight and long-term neglect; it will not reach its potential and has therefore been marked for removal. It would not be missed in the rejuvenation of this landscape.

Photo A shows Tree 1 a *Fraxinus angustifolia* subsp. *angustifolia* (Desert Ash) as seen from the south east. This exotic weed tree is dying back and has been marked for removal. The blue arrow indicates tree 2 a *Citrus japonica* (Kumquat) growing next to the driveway.

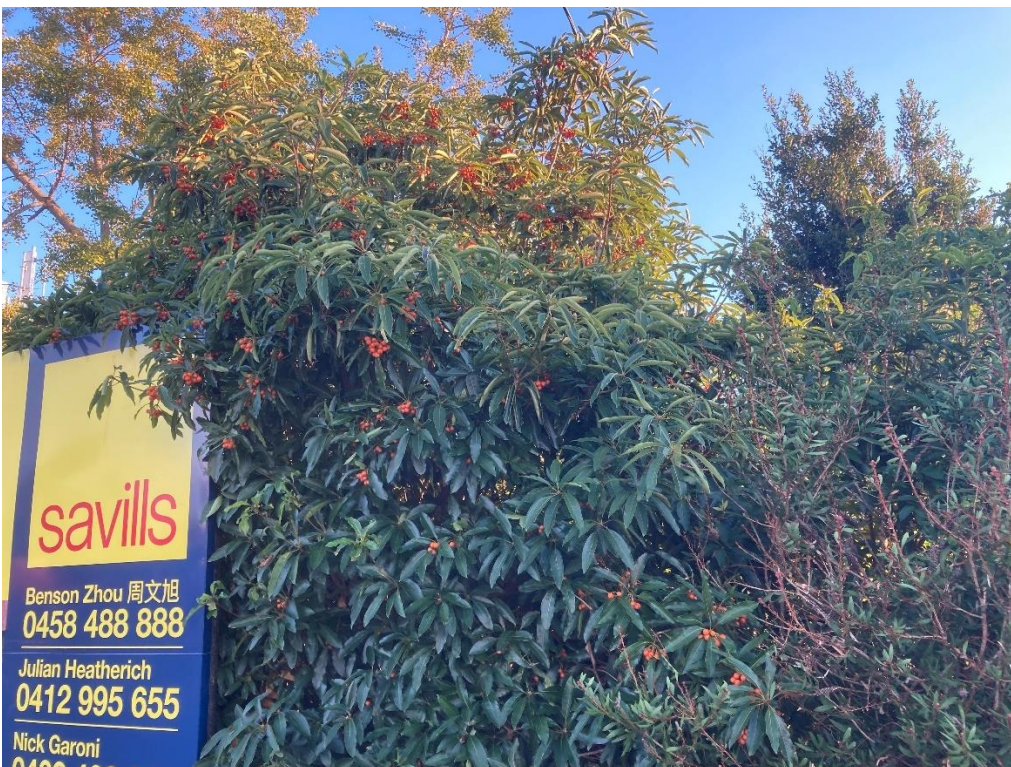
| Tree No. | Botanical Name | Age | Hei. x Wid. | DBH (cm) | TPZ (m) | SRZ (m) | ULE | Hea. | Stru. | Ret. Val. | Comments (Native or Exotic). 'BE': Building Envelope. 'b.': boundary. 'PL.': Previously Lopped |
|---|---|---|---|---|---|---|---|---|---|---|---|
| 3 | Pittosporum undulatum | S | 3.8x3 | 14 | 2 | 1.5 | Rem | Fair | Fair | Low | Native Weed Clear of BE. Remove |

Trees 3 and 4 are *Pittosporum undulatum* (Sweet pittosporum), this native is a problematic weed in our urban landscape. They have been marked for removal to reduce its spread through the local area, see Appendix 4. They are growing in the front set back and are clear of the proposed building envelope and would not be directly affected by this proposal. Trees 5 and 10 are *Michelia figo* (Port Wine Magnolia), this type of exotic is used as a screen in the landscape and has limited appeal in this garden. Tree 5 is clear of the proposed works and would not be affected by this proposal. Tree 10 would not survive the demolition of this derelict

Photo B shows Tree 3 a *Pittosporum undulatum* (Sweet Pittosporum) as seen from the south east. This native is a problematic weed tree and has been marked for removal.

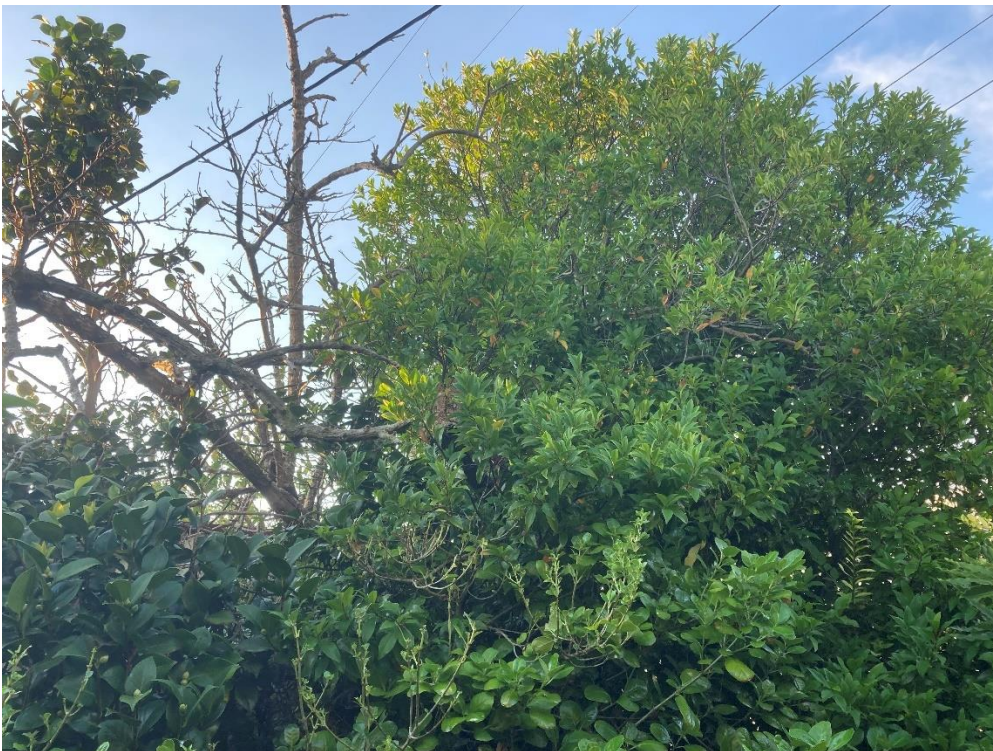
| Tree No. | Botanical Name | Age | Hei. x Wid. | DBH (cm) | TPZ (m) | SRZ (m) | ULE | Hea. | Stru. | Ret. Val. | Comments (Native or Exotic). 'BE': Building Envelope. 'b.': boundary. 'PL.': Previously Lopped |
|---|---|---|---|---|---|---|---|---|---|---|---|
| 5 | Michelia figo | M | 4x3.3 | 15 | 2 | 1.5 | Rem | Fair | Fair | Low | Exotic Possum damage Inside BE. Remove |
| 6 | Coprosma repens | Sen | 4.2x3 | 15 | 2 | 1.5 | Rem | Poor | Fair | Low | Exotic Weed Clear of BE. Remove |

Tree 6 is a *Coprosma repens* (Shiny Mirror Bush), this exotic is a problematic weed in our urban landscape and is dying off in areas of its canopy, see Appendix 4. It has been marked for removal to reduce its spread through the local area. It is growing in the front set back and is clear of the proposed building envelope and would not be directly affected by this proposal. Tree 7 is a *Cinnamomum camphora* (Camphor laurel), this exotic is a problematic weed in our urban landscape and can grow to a very large size and dominate unkempt areas. It has been marked for removal to reduce its spread through the local area. It is growing in the front set back and is clear of the proposed building envelope and would not be directly affected by this proposal.

Photo D shows Tree 5 a *Michelia figo* (Port Wine Magnolia) on the right of shot. On the left of shot is Tree 6 a *Coprosma repens* (Shiny Mirror Bush) dying back at its top, both exotics are marked for removal.

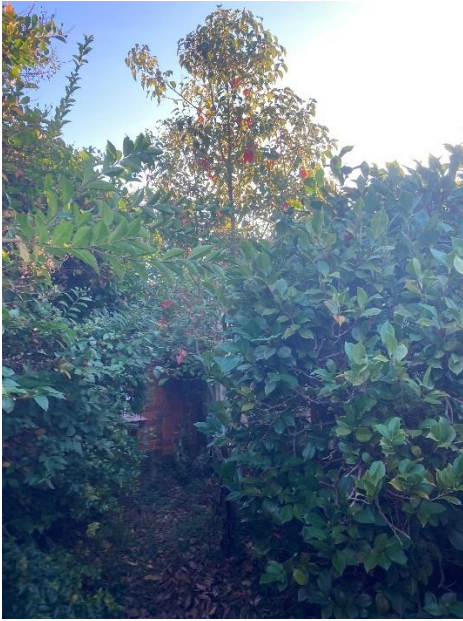
| Tree No. | Botanical Name | Age | Hei. x Wid. | DBH (cm) | TPZ (m) | SRZ (m) | ULE | Hea. | Stru. | Ret. Val. | Comments (Native or Exotic). 'BE': Building Envelope. 'b.': boundary. 'PL.': Previously Lopped |
|---|---|---|---|---|---|---|---|---|---|---|---|
| 7 | Cinnamomum camphora | Y | 4x1.4 | 6 | 2 | 1.5 | Rem | Fair | Fair | low | Exotic Weed Inside BE. Remove |
| 8 | Ligustrum ovalifolium | M | 5x5.3 | 14 | 2 | 1.5 | Rem | Fair | Fair | Low | 2 Exotics Inside BE. Remove |

Trees 8 and 18 are *Ligustrum ovalifolium* (Japanese Privet), this exotic is used as a short screen in our urban landscape. These shrubs have been allowed to grow uncontrolled and now are pushing up against the existing house. They will not survive the demolition of the house and have been marked for removal. They would not be missed from this neglected garden. Trees 9 and 11 are *Syzygium smithii* (Lilly Pilly), this type of native tree can reach more than 20 metres in height and is inappropriate in this position up against the house. They were previously lopped to manage their height and have now regrown uncontrolled. Their stems are poorly attached and are highly likely to fail in the near future. These inappropriate trees have been marked for removal and will not be missed from this neglected garden. They would not survive the demolition of the existing house.

Photo E shows Tree 7 a *Cinnamomum camphora* (Camphor Laurel) in the centre of shot, as self-sewn exotic weed tree. On the left of shot is Tree 8 a *Ligustrum ovalifolium* (Hedge Privet) an exotic that is usually hedged; it has been allowed to out grow this position and has been marked for removal.

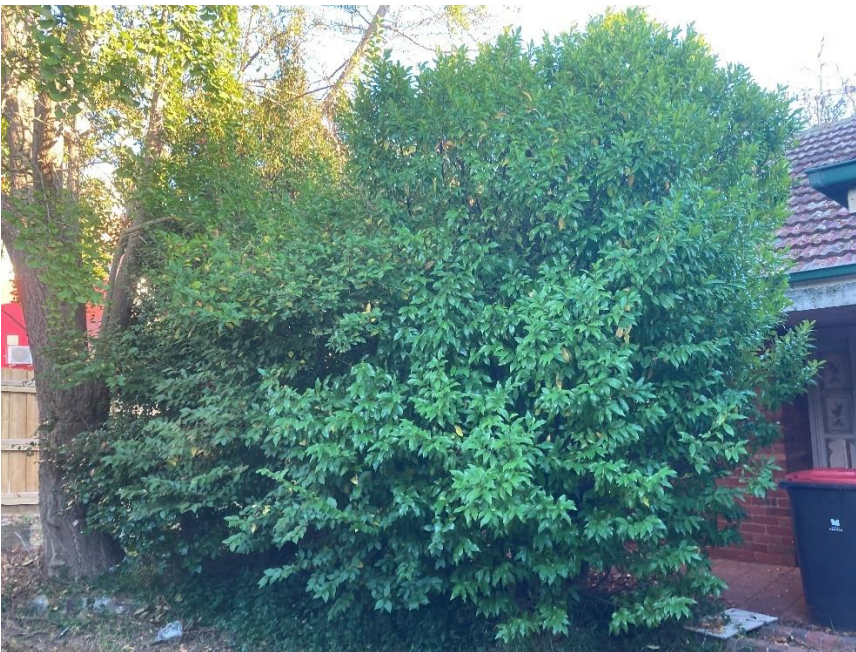
| Tree No. | Botanical Name | Age | Hei. x Wid. | DBH (cm) | TPZ (m) | SRZ (m) | ULE | Hea. | Stru. | Ret. Val. | Comments (Native or Exotic). 'BE': Building Envelope. 'b.': boundary. 'PL.': Previously Lopped |
|---|---|---|---|---|---|---|---|---|---|---|---|
| 10 | Michelia figo | M | 3.9x3 | 13 | 2 | 1.5 | Rem | Fair | Fair | Low | Exotic Inside BE. Remove |
| 11 | Syzygium smithii | S | 4.6x3 | 13 | 2 | 1.5 | Rem | Fair | Poor | Low | Native PL. Inside BE. Remove |

Photo F shows Tree 10 on the right of shot a *Michelia figo* (Port Wine Magnolia), to the left is Tree 11 a *Syzygium smithii* (Lilly Pilly) as indicated by the blue arrow; both are marked for removal. On the far left of shot is the lower trunk of Tree 12 a *Ginkgo biloba* (Ginkgo) an attractive tree marked for retention.

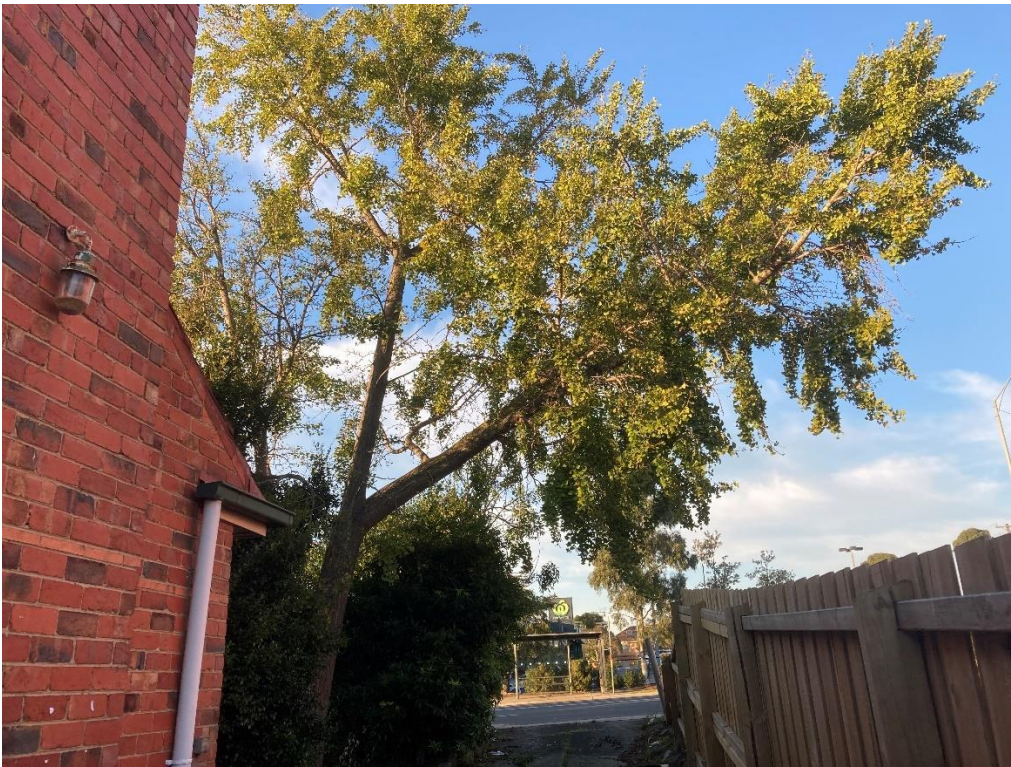
| Tree No. | Botanical Name | Age | Hei. x Wid. | DBH (cm) | TPZ (m) | SRZ (m) | ULE | Hea. | Stru. | Ret. Val. | Comments (Native or Exotic). 'BE': Building Envelope. 'b.': boundary. 'PL.': Previously Lopped |
|---|---|---|---|---|---|---|---|---|---|---|---|
| 12 | Ginkgo biloba | S | 14x11 | 55 | 6.6 | 2.5 | Med | Fair | Fair | Med | Exotic Inside BE. Remove |

Tree 12 is a *Ginkgo biloba* (Ginkgo), this exotic tree is rare in our landscape, in particular due to its reasonable size and potential. This tree is an attractive feature in this neglected landscape, see Appendix 4. There is already a concrete driveway running along the west side of its trunk and the existing house is less than 2 metres from its trunk. The footing for the existing brick house would be acting as an impervious barrier to the spread of the roots of this tree towards the north. This tree is inside the proposed building envelope of the underground car park; it is therefore not compatible with this proposal. It would have to be removed if this proposal was to be approved as it has been presented here.

Tree 12 is a *Ginkgo biloba* (Ginkgo), this exotic deciduous tree is still growing towards its mature size. This is the most significant tree detailed in this report. This type of tree is slow growing in our hot and dry climate, though prone to possums over grazing its canopy. This can cause the premature death of this type of tree if it is not managed appropriately. This tree is inside the proposed building envelope and would have to be removed to allow this proposal to proceed as it has been presented here. Tree 16 a *Waterhousia floribunda* (Weeping Lilly Pilly) is marked for removal and is one of two trees of any worth here. It dominates the northern boundary and would greatly restrict the landscaping or possible building envelope if it were to remain in position. It is still growing and is yet to reach its fully mature size. The replacement tree must be able to achieve at least 12 metres in height and greatly enhance this landscape. A deciduous tree would allow winter light to enter this property, while providing good summer shade.

Photo G shows Tree 12 a *Ginkgo biloba* (Ginkgo) as seen from the north, illustrating its close proximity to the existing house and the large scaffold branch growing towards the west.

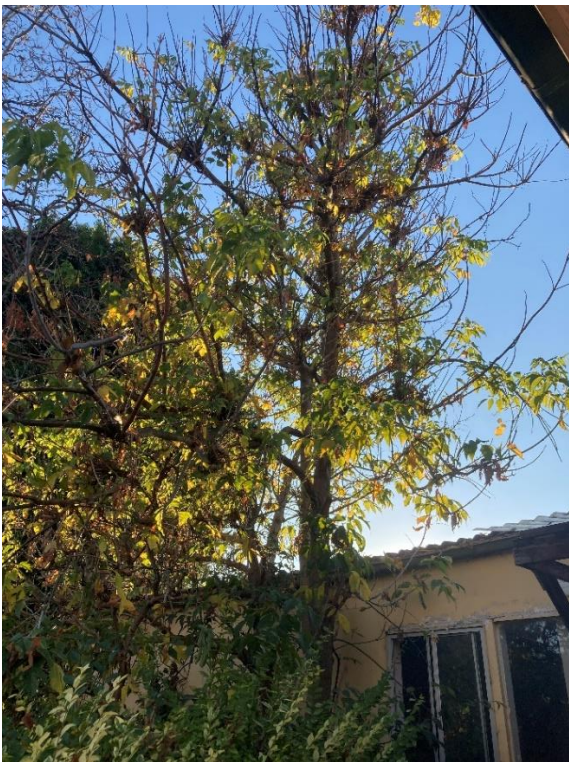
| Tree No. | Botanical Name | Age | Hei. x Wid. | DBH (cm) | TPZ (m) | SRZ (m) | ULE | Hea. | Stru. | Ret. Val. | Comments (Native or Exotic). 'BE': Building Envelope. 'b.': boundary. 'PL.': Previously Lopped |
|---|---|---|---|---|---|---|---|---|---|---|---|
| 13 | Acer negundo | Sen | 9.7x7 | 38 | 4.6 | 2.2 | Rem | Poor | Poor | Low | Exotic Weed PL. Inside BE. Remove |

Trees 13 and 15 are *Acer negundo* (Ash leaved Maple), this type of exotic tree is a problematic weed in our urban landscape. They have been marked for removal to reduce its spread through the local area. They are growing inside the proposed building envelope and would have to be removed to allow it to proceed as it has been presented here. Tree 14 is a *Liquidambar styraciflua* (Liquidambar), this exotic tree is dead, it has been grazed to death by possums and cannot be revived; see Appendix 4. It should be removed before it decays and suffers collapsing scaffold branches. It is inside the proposed building envelope and would have to be removed to allow it to proceed as it has been presented here.

Photo H shows Tree 13 an *Acer negundo* (Ash leaved Maple) as seen from the south west; the exotic is a problematic weed in our urban landscape and has been marked for removal. Its patchy canopy a symptom of its poor health.

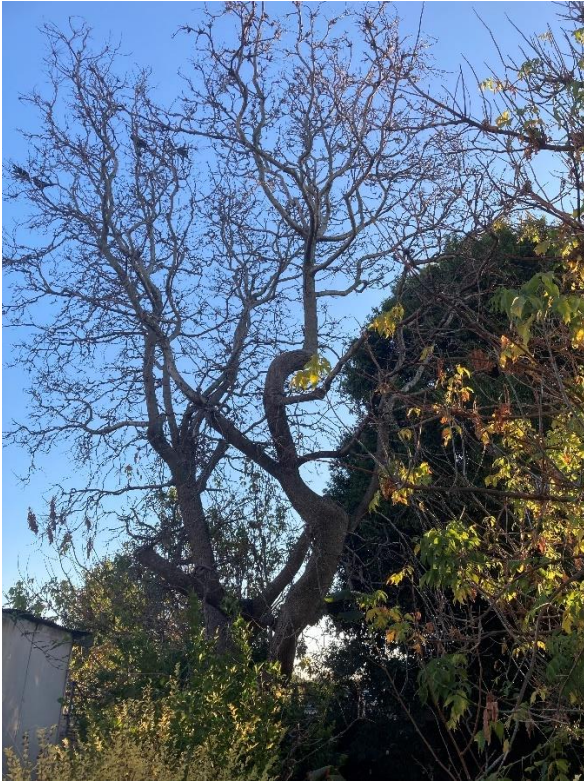
| Tree No. | Botanical Name | Age | Hei. x Wid. | DBH (cm) | TPZ (m) | SRZ (m) | ULE | Hea. | Stru. | Ret. Val. | Comments (Native or Exotic). 'BE': Building Envelope. 'b.': boundary. 'PL.': Previously Lopped |
|---|---|---|---|---|---|---|---|---|---|---|---|
| 14 | Liquidambar styraciflua | D | 18x10 | 59 | 7.1 | 2.7 | Rem | Dead | Poor | Low | Exotic Dead Inside BE. Remove |

Photo I shows Tree 14 a *Liquidambar styraciflua* (Liquidambar) as seen from the south; it is devoid of leaves as it is dead. It must be removed before it decays and begins to shed branches.

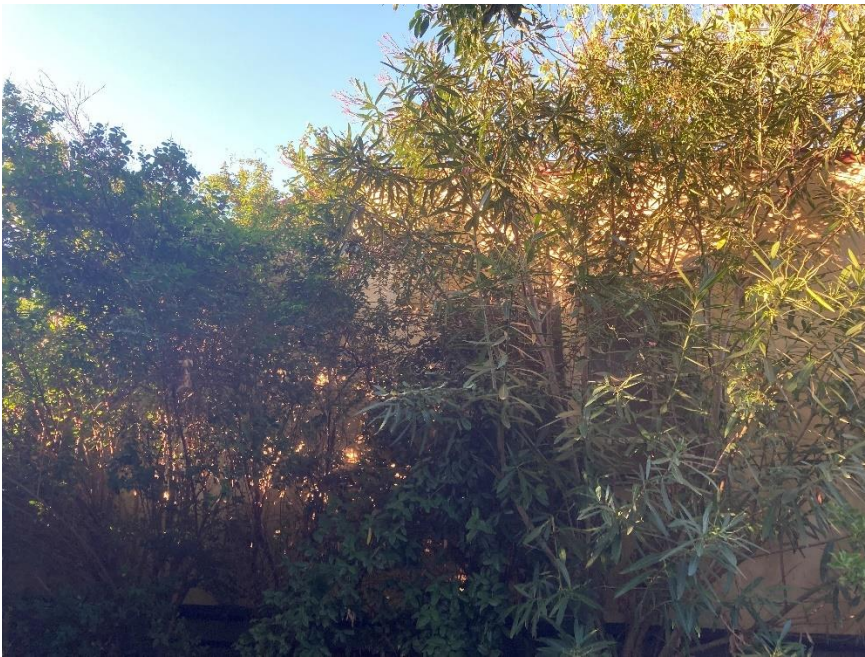
| Tree No. | Botanical Name | Age | Hei. x Wid. | DBH (cm) | TPZ (m) | SRZ (m) | ULE | Hea. | Stru. | Ret. Val. | Comments (Native or Exotic). 'BE': Building Envelope. 'b.': boundary. 'PL.': Previously Lopped |
|---|---|---|---|---|---|---|---|---|---|---|---|
| 19 | Nerium oleander | S | 5x3.3 | 14 | 2 | 1.5 | Rem | Fair | Fair | Low | Exotic Weed. Inside BE. Remove |

Tree 19 is a *Nerium oleander* (Oleander), this exotic is recognised as having a weedy habit and dominating unkempt areas, due to its tolerance to drought and poor soils; see Appendix 4. This unattractive shrub has been marked for removal to allow for the rejuvenation of this neglected landscape. It would not be missed as it cannot be seen from outside this property. Tree 20 is a *Ligustrum lucidum* (Glossy Privet). This exotic is a problematic weed in our urban landscape. It has been marked for removal to reduce its spread through the local area. It is growing inside the proposed building envelope and would have to be removed to allow this proposal to proceed as it has been presented here.

Photo K shows Tree 19 a *Nerium oleander* (Oleander) on the right of shot. On the left is Tree 18 a *Ligustrum lucidum* (Hedge Privet), these exotics have been marked for removal and replacement.

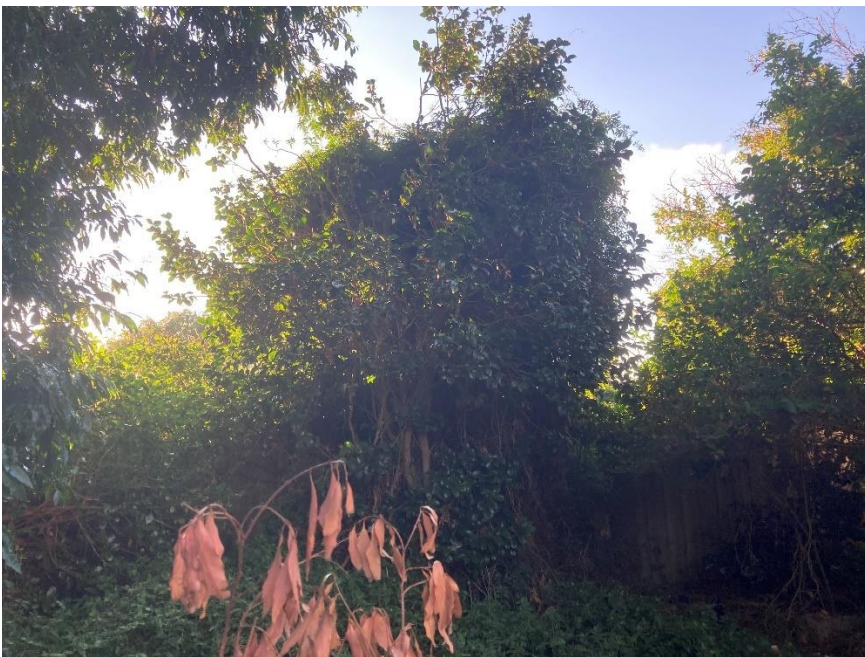
| Tree No. | Botanical Name | Age | Hei. x Wid. | DBH (cm) | TPZ (m) | SRZ (m) | ULE | Hea. | Stru. | Ret. Val. | Comments (Native or Exotic). 'BE': Building Envelope. 'b.': boundary. 'PL.': Previously Lopped |
|---|---|---|---|---|---|---|---|---|---|---|---|
| 17 | Camellia japonica | S | 4.8x3 | 13 | 2 | 1.5 | Rem | Poor | Fair | Low | Exotic Screen. Inside BE. Remove |

Photo L shows Tree 17 a *Camellia japonica* (Camellia) as seen from the west, growing in the shade of Tree 16 and partially covered in vines. It will never reach its potential and has been marked for removal.

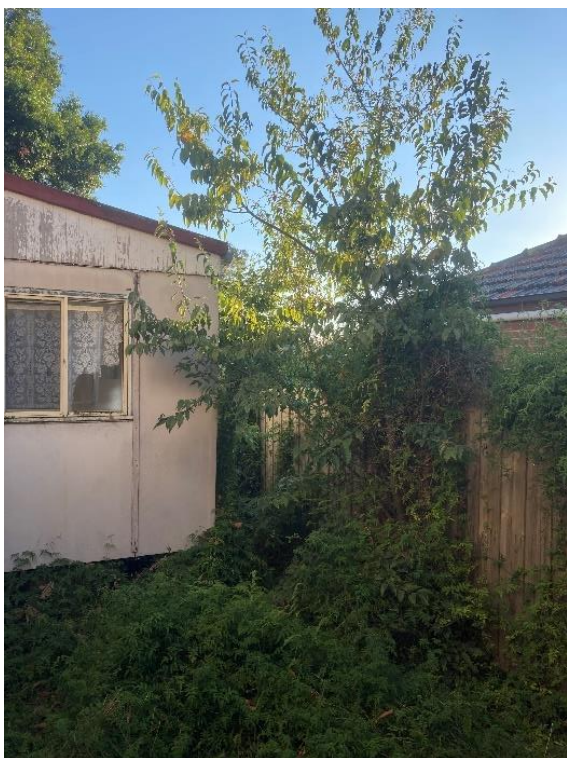
| Tree No. | Botanical Name | Age | Hei. x Wid. | DBH (cm) | TPZ (m) | SRZ (m) | ULE | Hea. | Stru. | Ret. Val. | Comments (Native or Exotic). 'BE': Building Envelope. 'b.': boundary. 'PL.': Previously Lopped |
|---|---|---|---|---|---|---|---|---|---|---|---|
| 21 | Celtis australis | S | 4.3x3 | 11 | 2 | 1.5 | Rem | Fair | Fair | Low | Exotic Weedy. Inside BE. Remove |

Tree 21 is a *Celtis australis* (European Nettle), this type of exotic tree is becoming a problematic weed in our urban landscape, self-seeding into unkempt gardens; see Appendix 4. This tree is self-sewn and there are some smaller seedlings emerging in these gardens. It has been marked for removal as it is inappropriate in this position. It would not be missed as it cannot be seen from outside these properties. It is inside the proposed building envelope and would have to be removed to allow this proposal to proceed as it has been presented here. Tree 23 is a *Magnolia x soulangiana* (Saucer Magnolia), this type of exotic small tree is drought sensitive and slow growing. This small tree is being over grazed by possums, see Appendix 4. It has entered a spiral of decline from which it cannot be revived. This poor specimen has been marked for removal. It would not be missed as it cannot be seen from outside this property. It is inside the proposed building envelope and would have to be removed to allow it to proceed as it has been presented here.

Photo M shows Tree 21 a *Celtis australis*

(European Nettle) as seen from the south west. This self-sewn exotic is recognised as being weedy in our urban landscape and has been marked for removal.

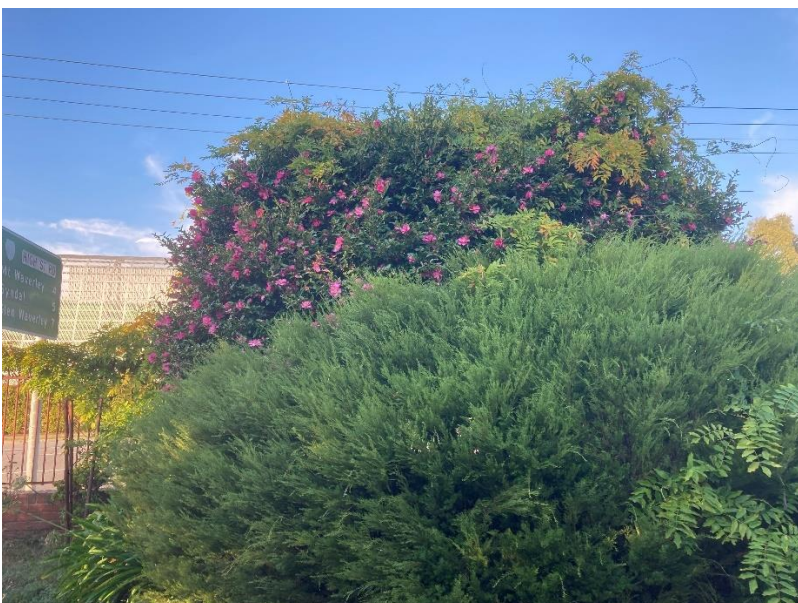
| Tree No. | Botanical Name | Age | Hei. x Wid. | DBH (cm) | TPZ (m) | SRZ (m) | ULE | Hea. | Stru. | Ret. Val. | Comments (Native or Exotic). 'BE': Building Envelope. 'b.': boundary. 'PL.': Previously Lopped |
|---|---|---|---|---|---|---|---|---|---|---|---|
| 22 | Camellia japonica | S | 4.7x4 | 26 | 3.1 | 1.9 | Rem | Poor | Fair | Low | Exotic Screen. Clear of BE. Remove |

Photo N shows Tree 22 a

*Camellia japonica* (Camellia) as seen from the north; this exotic screen tree is covered in vines and will not reach its potential. It has been marked for removal to allow for the rejuvenation of this neglected landscape.

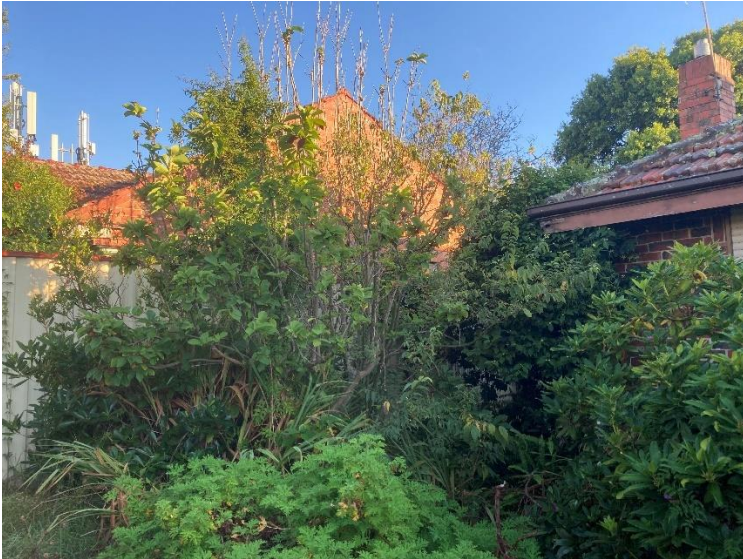
| Tree No. | Botanical Name | Age | Hei. x Wid. | DBH (cm) | TPZ (m) | SRZ (m) | ULE | Hea. | Stru. | Ret. Val. | Comments (Native or Exotic). 'BE': Building Envelope. 'b.': boundary. 'PL.': Previously Lopped |
|---|---|---|---|---|---|---|---|---|---|---|---|
| 23 | Magnolia x soulangiana | Sen | 5x4.2 | 19 | 2.3 | 1.8 | Rem | Poor | Fair | Low | Exotic Possum damage Inside BE. Remove |

Photo O shows Tree 23 a *Magnolia x soulangiana* (Saucer Magnolia) as seen from the south east. It is being stripped by possums over grazing its leaves; it cannot be recovered from this position and has been marked for removal.

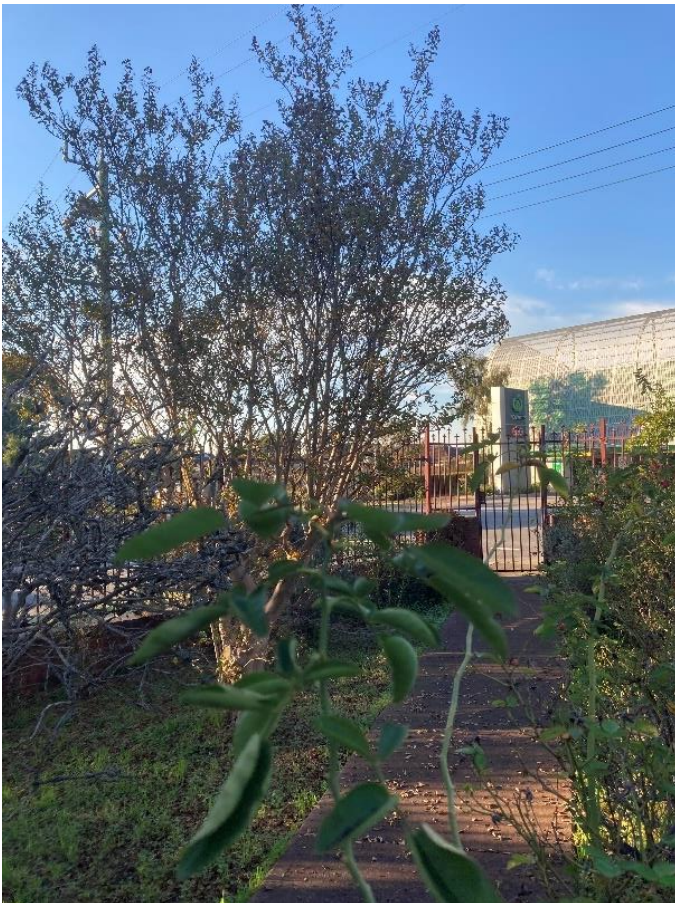
| Tree No. | Botanical Name | Age | Hei. x Wid. | DBH (cm) | TPZ (m) | SRZ (m) | ULE | Hea. | Stru. | Ret. Val. | Comments (Native or Exotic). 'BE': Building Envelope. 'b.': boundary. 'PL.': Previously Lopped |
|---|---|---|---|---|---|---|---|---|---|---|---|
| 24 | Lagerstroemia indica | S | 4.5x4 | 21 | 2.5 | 1.8 | Rem | Fair | Fair | Low | Exotic PL. Inside BE. Remove |

Tree 24 is a *Lagerstroemia indica* (Crepe Myrtle), this small tree has been lopped in the past and allowed to regrow unrestricted. This was typical past practice for this type of small tree. This tree is drought stressed, with all of its leaves with burnt margins, this is consistent with a garden that has been neglected for some years. This small tree has been marked for removal as it could be easily replaced with a more suitable and better positioned tree. It is inside the proposed building envelope and would have to be removed to allow this proposed to proceed as it has been presented here. Trees 27–29 are *Castanea sativa* (Chestnut), these 3 exotic trees have been previously lopped to manage their height. As this type of tree can exceed 20 metres at full maturity. This has reduced the flower and fruit production and allowed these trees to decline in health as well. These are inappropriate trees in this position and have been marked for removal and replacement. They are inside the proposed building envelope and would have to be removed to allow it to proceed as it has been presented here. They would not be missed as they cannot be seen from outside this property.

Photo P shows Tree 24 a *Lagerstroemia indica* (Crepe Myrtle), this exotic has been previously lopped and is inside the proposed building envelope. It has therefore been marked for removal and replacement.

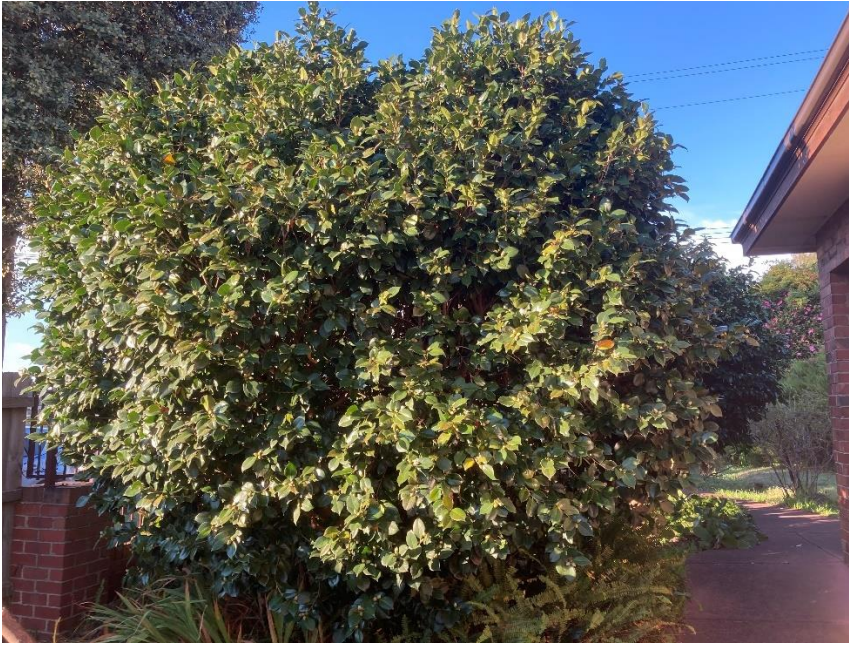
| Tree No. | Botanical Name | Age | Hei. x Wid. | DBH (cm) | TPZ (m) | SRZ (m) | ULE | Hea. | Stru. | Ret. Val. | Comments (Native or Exotic). 'BE': Building Envelope. 'b.': boundary. 'PL.': Previously Lopped |
|---|---|---|---|---|---|---|---|---|---|---|---|
| 26 | Camellia japonica | S | 4.5x4 | 18 | 2.1 | 1.6 | Rem | Fair | Fair | Low | Exotic Screen. PL. Inside BE. Remove |

Photo Q shows Tree 26 a *Camellia japonica* (Camellia) as seen from the north; this exotic screen tree has been marked for removal and replacement.

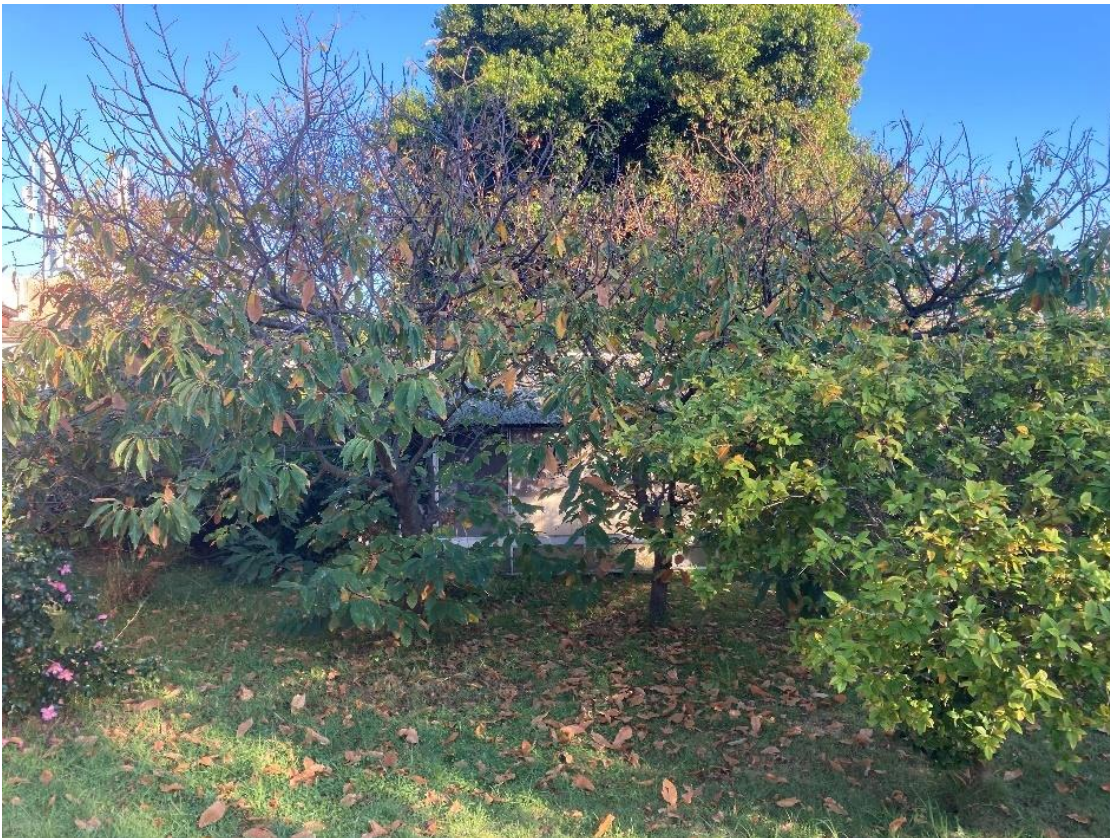
| Tree No. | Botanical Name | Age | Hei. x Wid. | DBH (cm) | TPZ (m) | SRZ (m) | ULE | Hea. | Stru. | Ret. Val. | Comments (Native or Exotic). 'BE': Building Envelope. 'b.': boundary. 'PL.': Previously Lopped |
|---|---|---|---|---|---|---|---|---|---|---|---|
| 27 | Castanea sativa | S | 4.4x6 | 17 | 2 | 1.6 | Rem | Poor | Fair | Low | Exotic PL. Inside BE. Remove |
| 28 | Castanea sativa | S | 4x3.6 | 14 | 2 | 1.6 | Rem | Poor | Fair | Low | Exotic PL. Inside BE. Remove |

Photo R shows Trees 27 and 28 a pair of *Castanea sativa* (Chestnut) as seen from the south east; illustrating the small size of these exotic nut trees.

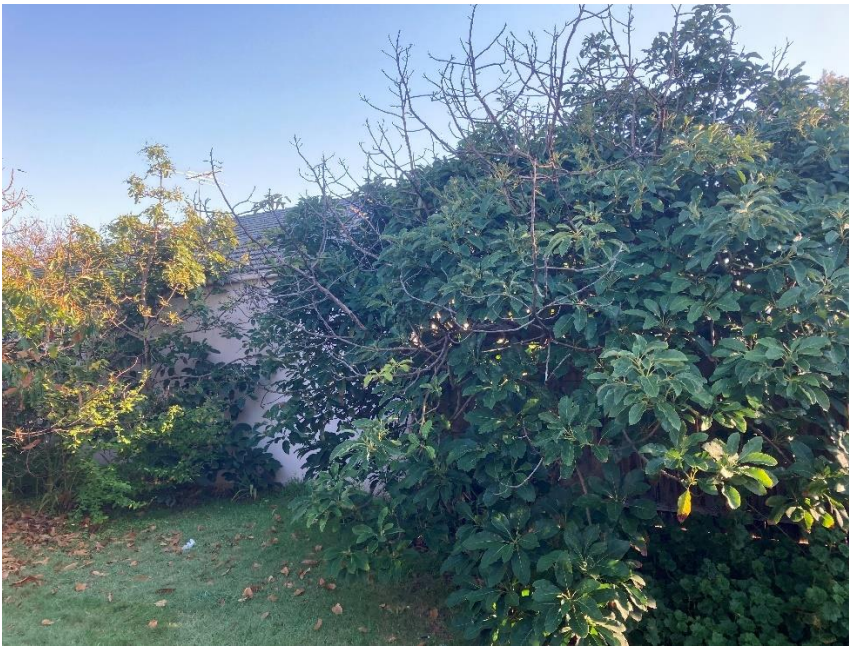
| Tree No. | Botanical Name | Age | Hei. x Wid. | DBH (cm) | TPZ (m) | SRZ (m) | ULE | Hea. | Stru. | Ret. Val. | Comments (Native or Exotic). 'BE': Building Envelope. 'b.': boundary. 'PL.': Previously Lopped |
|---|---|---|---|---|---|---|---|---|---|---|---|
| 30 | Persea americana | Sen | 4.4x3 | 9 | 2 | 1.5 | Rem | Poor | Fair | Low | Exotic Possum damage. Close to BE. Remove |
| 31 | Persea americana | M | 4.2x6 | 26 | 3.1 | 1.9 | Rem | Poor | Fair | Low | Exotic PL. Close to BE. Remove |

Trees 30 and 31 are *Persea americana* (Avocado), these exotic trees are being over grazed by possums, see Appendix 4. This is a common problem for this type of tree in our urban landscape. If they cannot be isolated from their activity, they will go the same way as Tree 14 the Liquidambar and die prematurely. They are growing up against the northern boundary, there is therefore no way to isolate

them from possums. These trees are inside the proposed building envelope and have been marked for removal to allow it to proceed as it has been presented here.

Photo S shows Trees 30 and 31 a pair of *Persea americana* (Avocado) as seen from the south east. Illustrating the stripped top leaves of Tree 31 on the right of shot; these poor exotics are marked for removal.

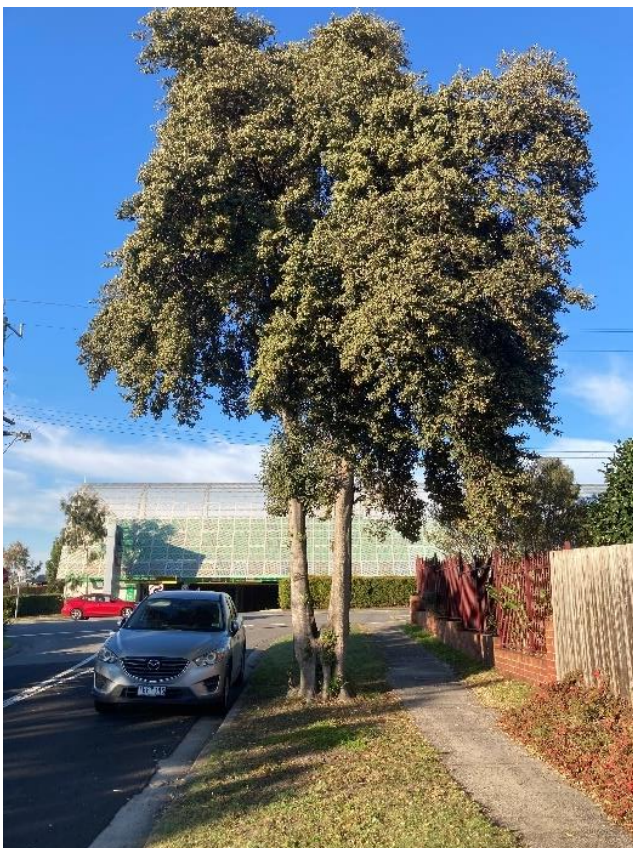
| Tree No. | Botanical Name | Age | Hei. x Wid. | DBH (cm) | TPZ (m) | SRZ (m) | ULE | Hea. | Stru. | Ret. Val. | Comments (Native or Exotic). 'BE': Building Envelope. 'b.': boundary. 'PL.': Previously Lopped |
|---|---|---|---|---|---|---|---|---|---|---|---|
| 32 | Lagunaria patersonia | M | 16x8 | 50 | 6 | 2.5 | Short | Fair | Fair | Low | Exotic Clear of BE. Causes irritation. Retain |

Tree 32 is a *Lagunaria patersonia* (Norfolk Island Hibiscus) is growing on the nature strip in Kennett Street, outside the eastern boundary of this property. It is clear of the proposed building envelope and would not be impacted by this proposal. This type of tree is problematic when people move around near its canopy, as they produce fine fibres in their seed capsules that can cause severe irritation in peoples' skin. Many councils are removing this drought tolerant type of tree to prevent this problem form occurring. It is growing opposite a double brick boundary wall on the boundary of this property. This will have prevented the roots of this tree from entering this property and restricting the proposed building envelope. It will require temporary fencing around it to isolate it from any possible impact. It must be isolate the exposed areas of the TPZ of this tree, to protect it from soil compaction or direct impact.

Photo T shows Tree 32 a *Lagunaria patersonia* (Norfolk Island Hibiscus) as seen from the north; illustrating its position in the nature strip clear of the property boundary.

- Tree Protection Zones for Trees 32–34 must be fenced off with a 1.8 metres high temporary cyclone wire fence prior to the commencement of any works; clearly marked with signs indicating it as an exclusion zone.

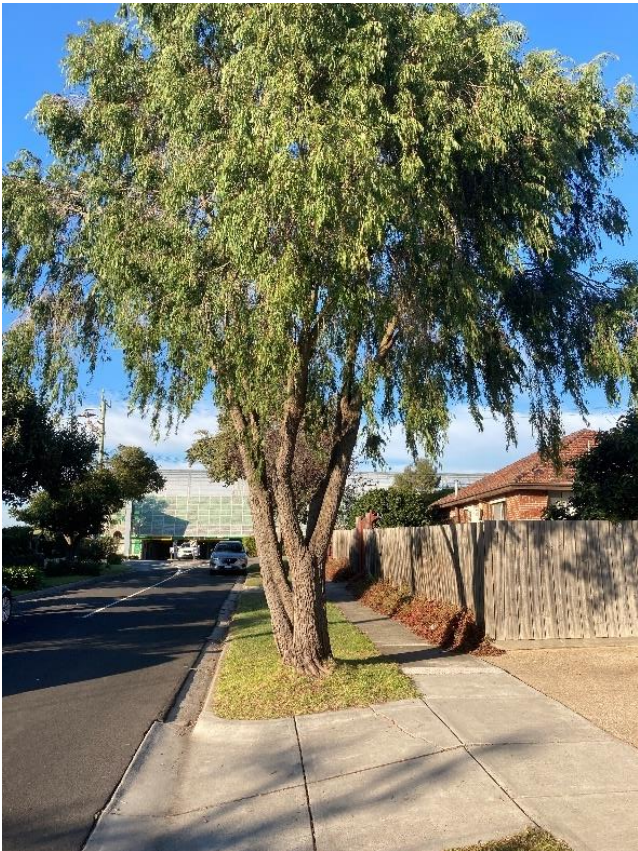
| Tree No. | Botanical Name | Age | Hei. x Wid. | DBH (cm) | TPZ (m) | SRZ (m) | ULE | Hea. | Stru. | Ret. Val. | Comments (Native or Exotic). 'BE': Building Envelope. 'b.': boundary. 'PL.': Previously Lopped |
|---|---|---|---|---|---|---|---|---|---|---|---|
| 34 | Agonis flexuosa | S | 11x9 | 48 | 5.8 | 2.5 | Med | Fair | Fair | Med | Native 1.5m to b. Clear of BE. Retain |

Tree 34 is an *Agonis flexuosa* (Willow Myrtle), this native tree growing 1.5 metre to the north of the northern boundary of this property, on the natures trip to the east of it. It is clear of the proposed building envelope and therefore would not be directly impacted by it, see Appendix 4. It will require temporary fencing around it to isolate it from any possible impact. It must be isolate the exposed areas of the TPZ of this tree, to protect it from soil compaction or direct impact.

Photo V shows Tree 34 an *Agonis flexuosa*

(Willow Myrtle) as seen from the north, 1.5 metres to the north of site; this native is clear of the property; it will require temporary protective to isolate it from the proposed works.
