Talbot Village, Oakleigh South

Domain 4 Batter Stability Assessment Report

Reference: 754-GEOTABTF09257AA-EG

21 September 2021

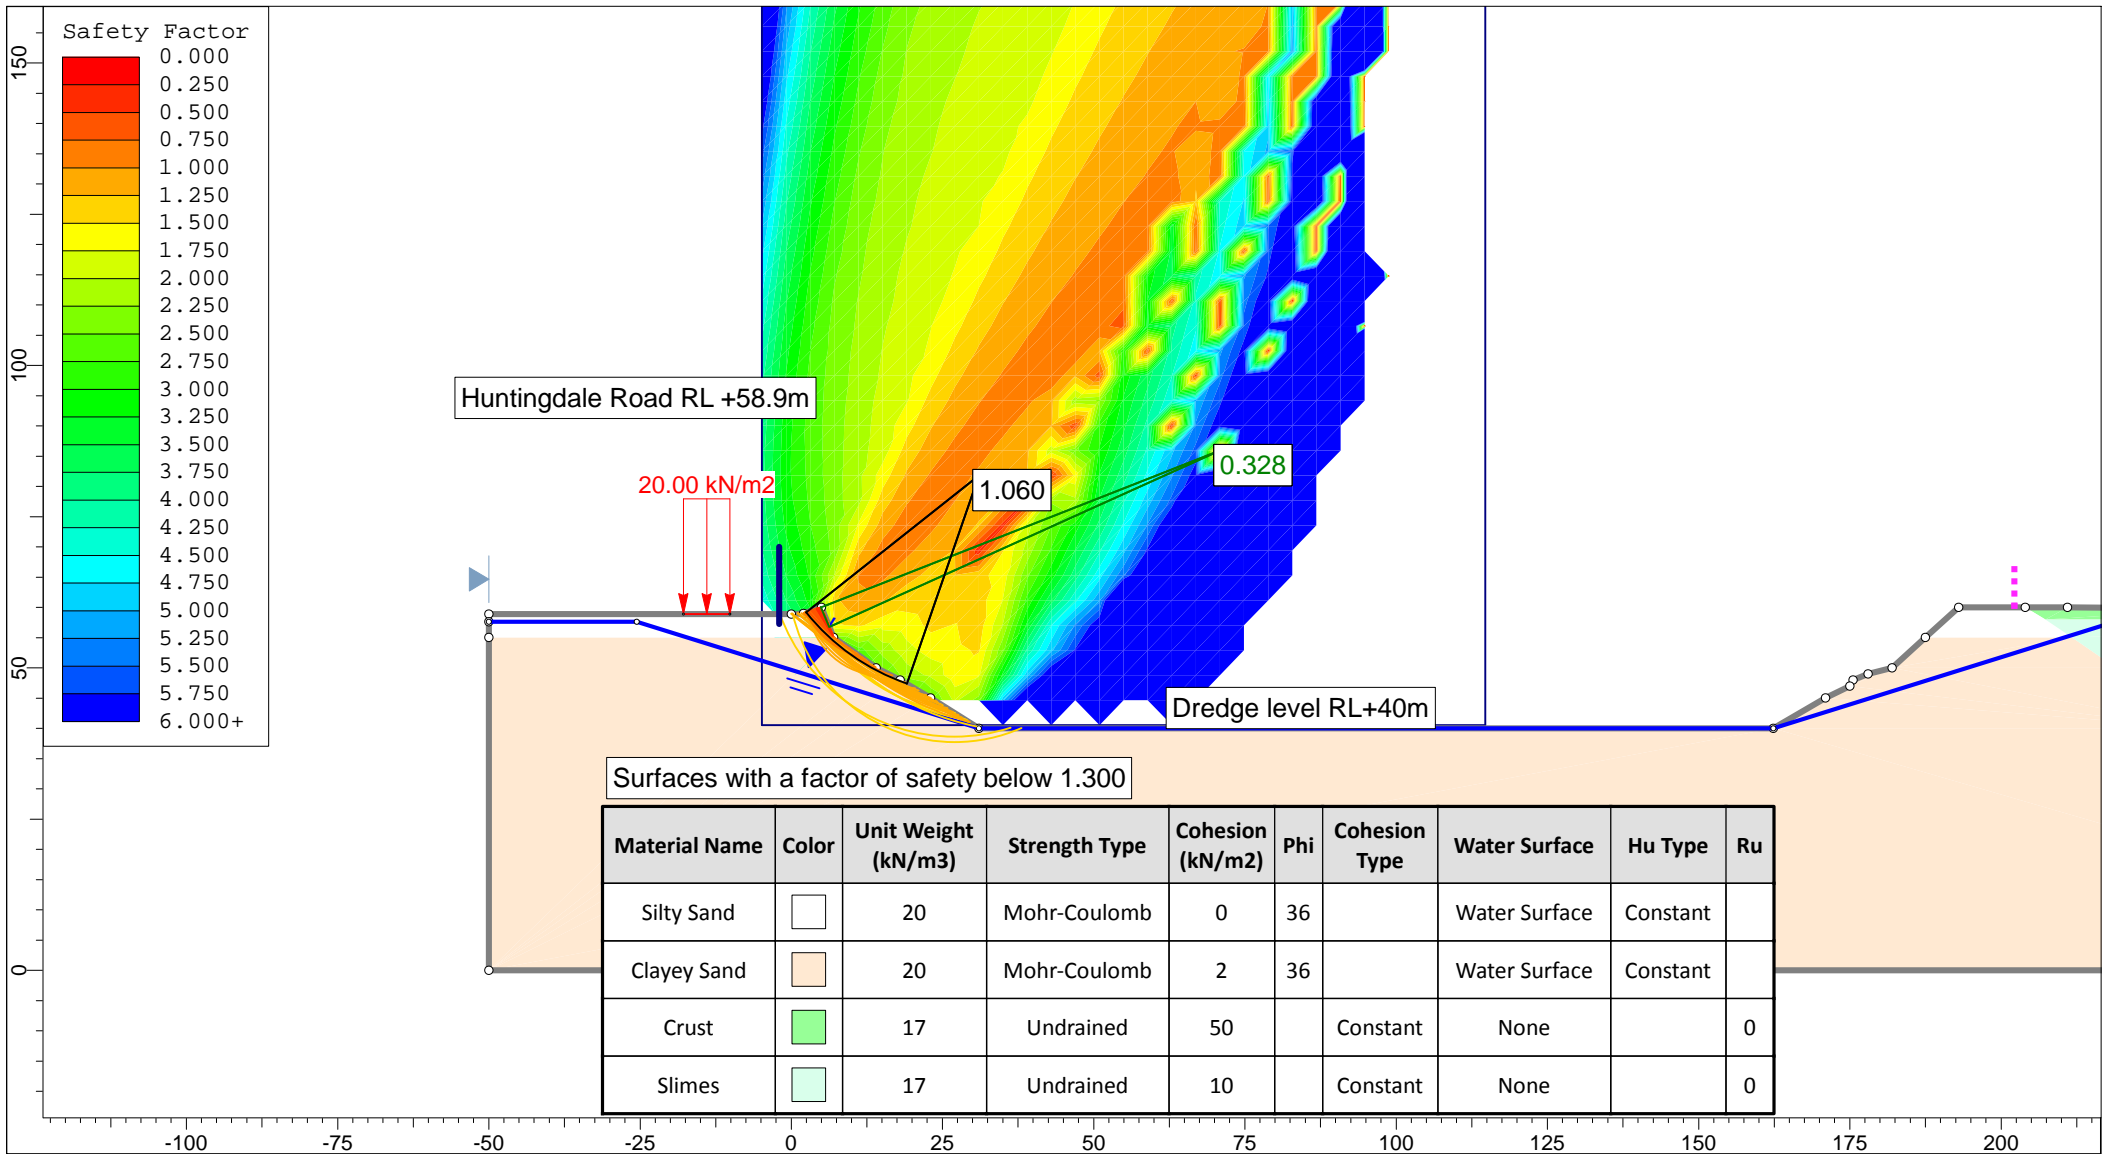
Project				Huntingdale Estate, Oakleigh, Victoria			
	Analysis Description				West batter - Back analysis - Shallow			
	Drawn By		Scale		Company			
	Date		File Name					
		CB		1:1250		Talbot Road Finance Pty Ltd		
		14/01/2015, 2:17:49 PM		WEST Figure A1.slim

The results of the back analysis of the western batters are presented in Figure A1 which are based on an assumed conservative groundwater profile extending rising from the base of the quarry to close to Huntingdale Road level about 25m back from the site boundary. A FOS of 1.06 was obtained for a shallow failure in the upper 10m of the slope using the friction angle of 36° for the sands and a cohesion of 2 kPa for the clayey sands. The result of this analysis gave geotechnical strength parameters which we consider represent conservative values for the materials. These strength parameters are presented in Table 1 together with the results of assessment.

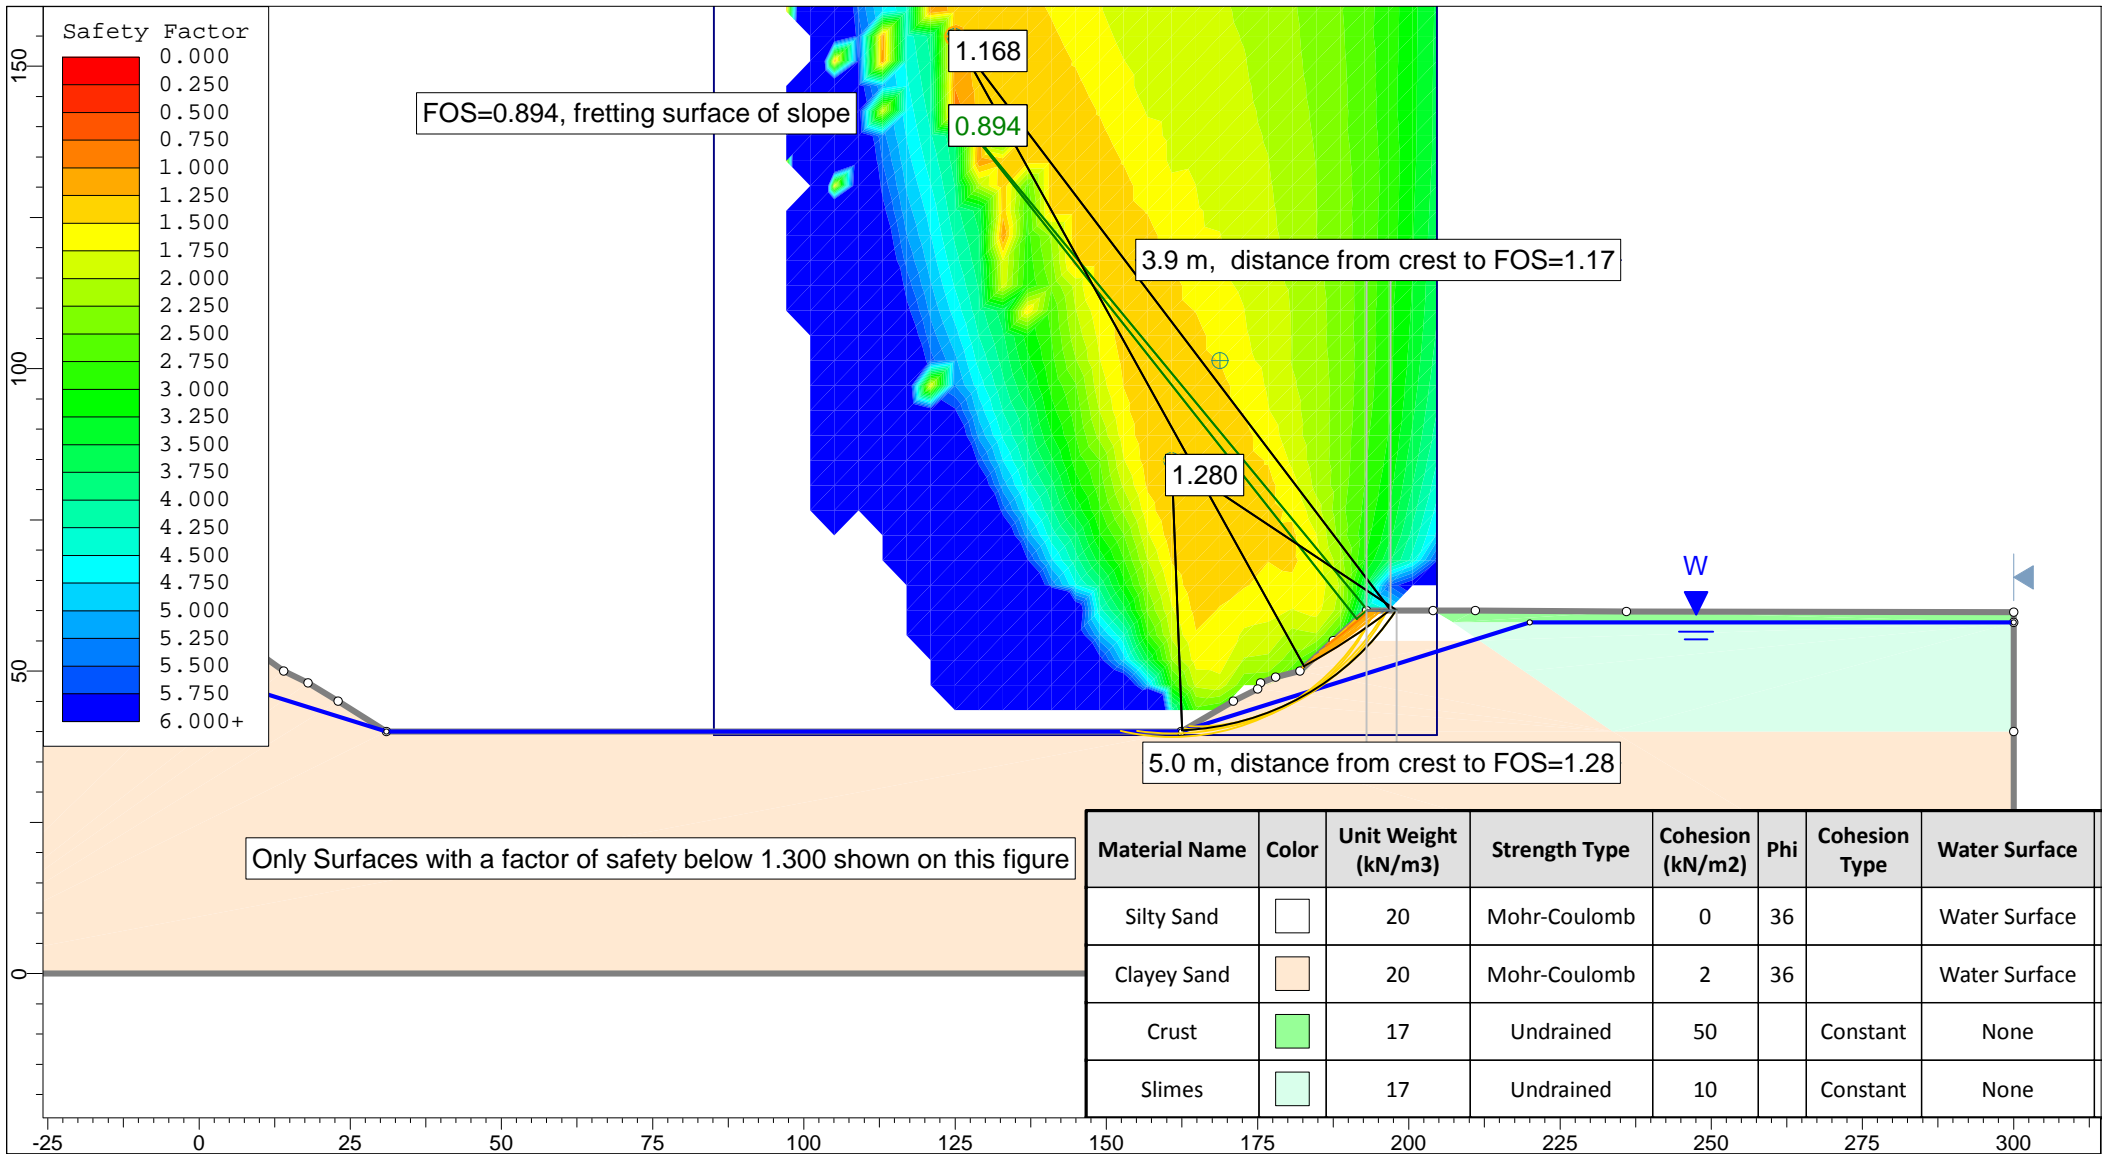
Project			Huntingdale Estate, Oakleigh South, Victoria		
	Analysis Description			East batter - Back analysis - Shallow		
	Drawn By	CB	Scale	1:1250	Company	Talbot Road Finance Pty Ltd
	Date	14/01/2015, 2:17:49 PM		File Name	EAST Figure 6%slim

Figure B1 shows the minimum FOS for a shallow failure is 1.17 ignoring the very small and shallow failure surface. The deeper seated failure surface extending back 3.9m from the crest gave a FOS of 1.28, which is marginally below 1.3.

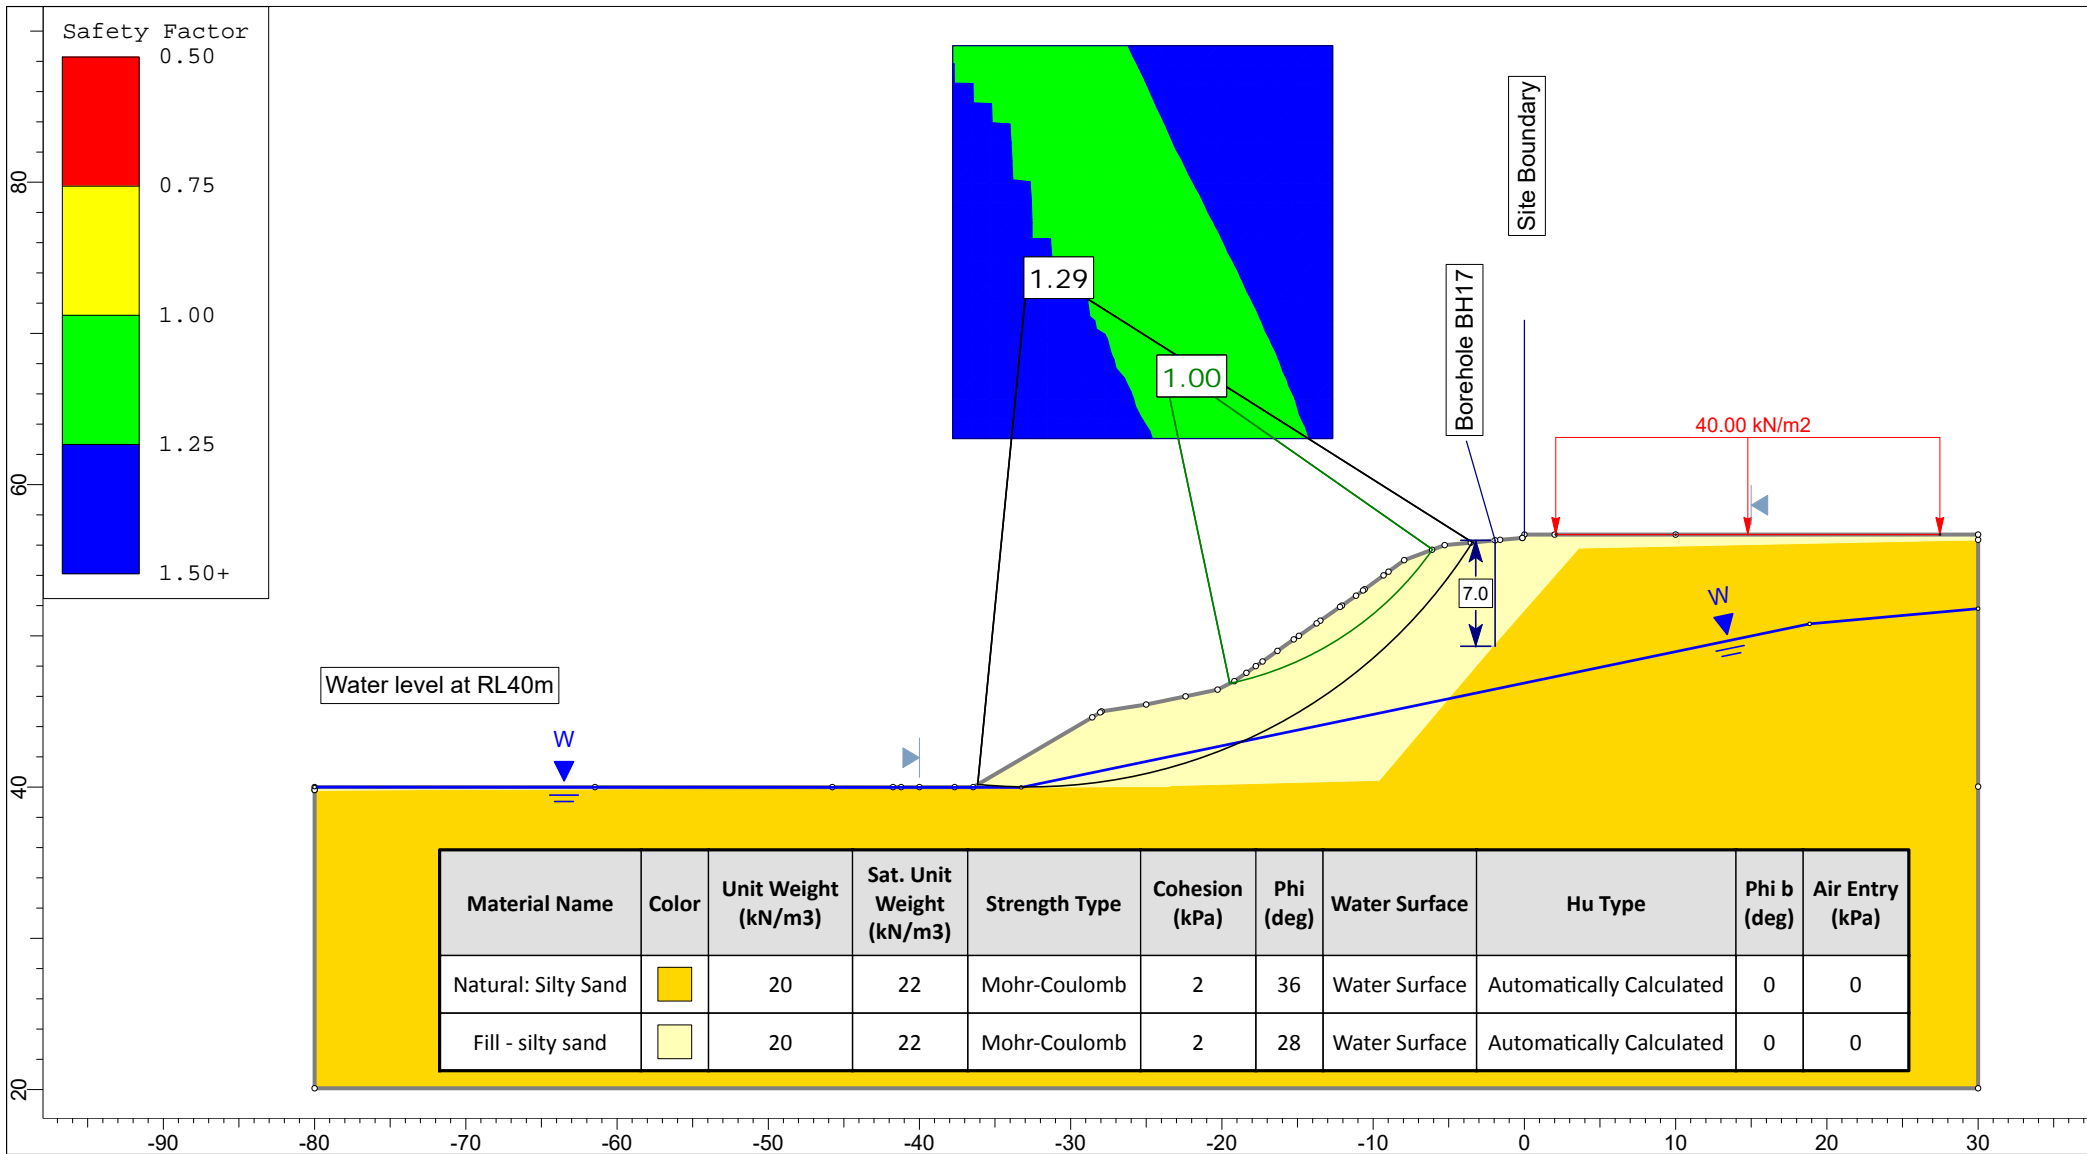
<i>Project</i>				Huntingdale Estate, Oakleigh							
<i>Analysis Description</i>				Domain 4 - Stability of south batter - back analysis							
<i>Drawn By</i>		MF		<i>Scale</i>		1:500		<i>Company</i>		Talbot Road Finance Pty Ltd	
<i>Date</i>		11/09/2017				<i>File Name</i>		SOUTH Figure C1.slim

and a FOS of 1.29 for global stability with the water table at RL40m which was assumed to be the condition when the fill was placed as shown in Figure C1 in Appendix C.

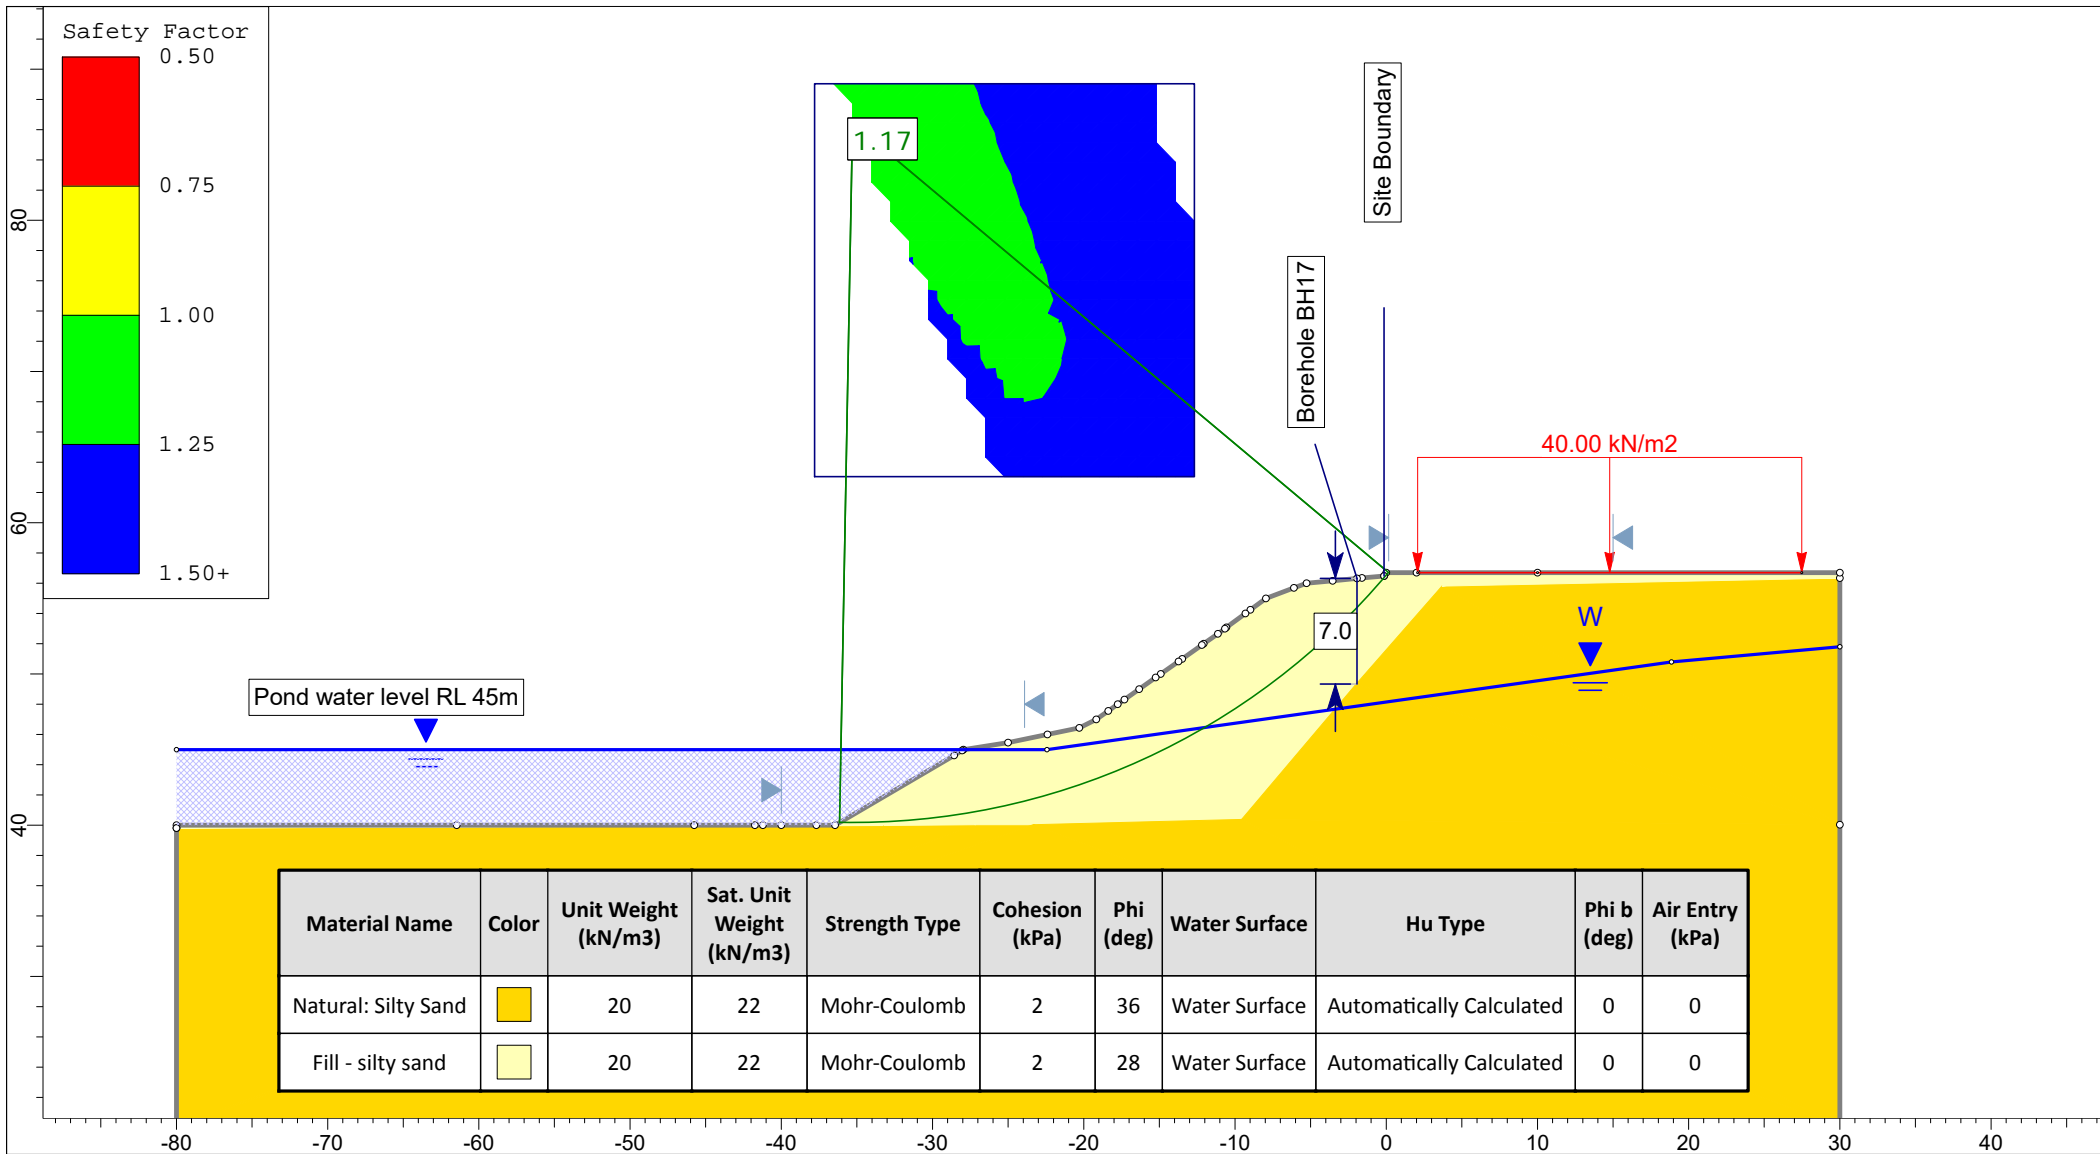
<i>Project</i>		Huntingdale Estate, Oakleigh	
<i>Analysis Description</i>		Domain 4! - Stability of south batter - estimated existing pond water level	
<i>Drawn By</i>	MF	<i>Scale</i>	1:500
<i>Date</i>	11/09/2017	<i>Company</i>	Talbot Road Finance Pty Ltd
		<i>File Name</i>	SOUTH Figure C2.slim

Figure C2 considers a complete slope failure at the site boundary with the fill placed along the southern boundary and the water level at RL45m. The results show a FOS of 1.17 where the failure slip extends near to the southern boundary.

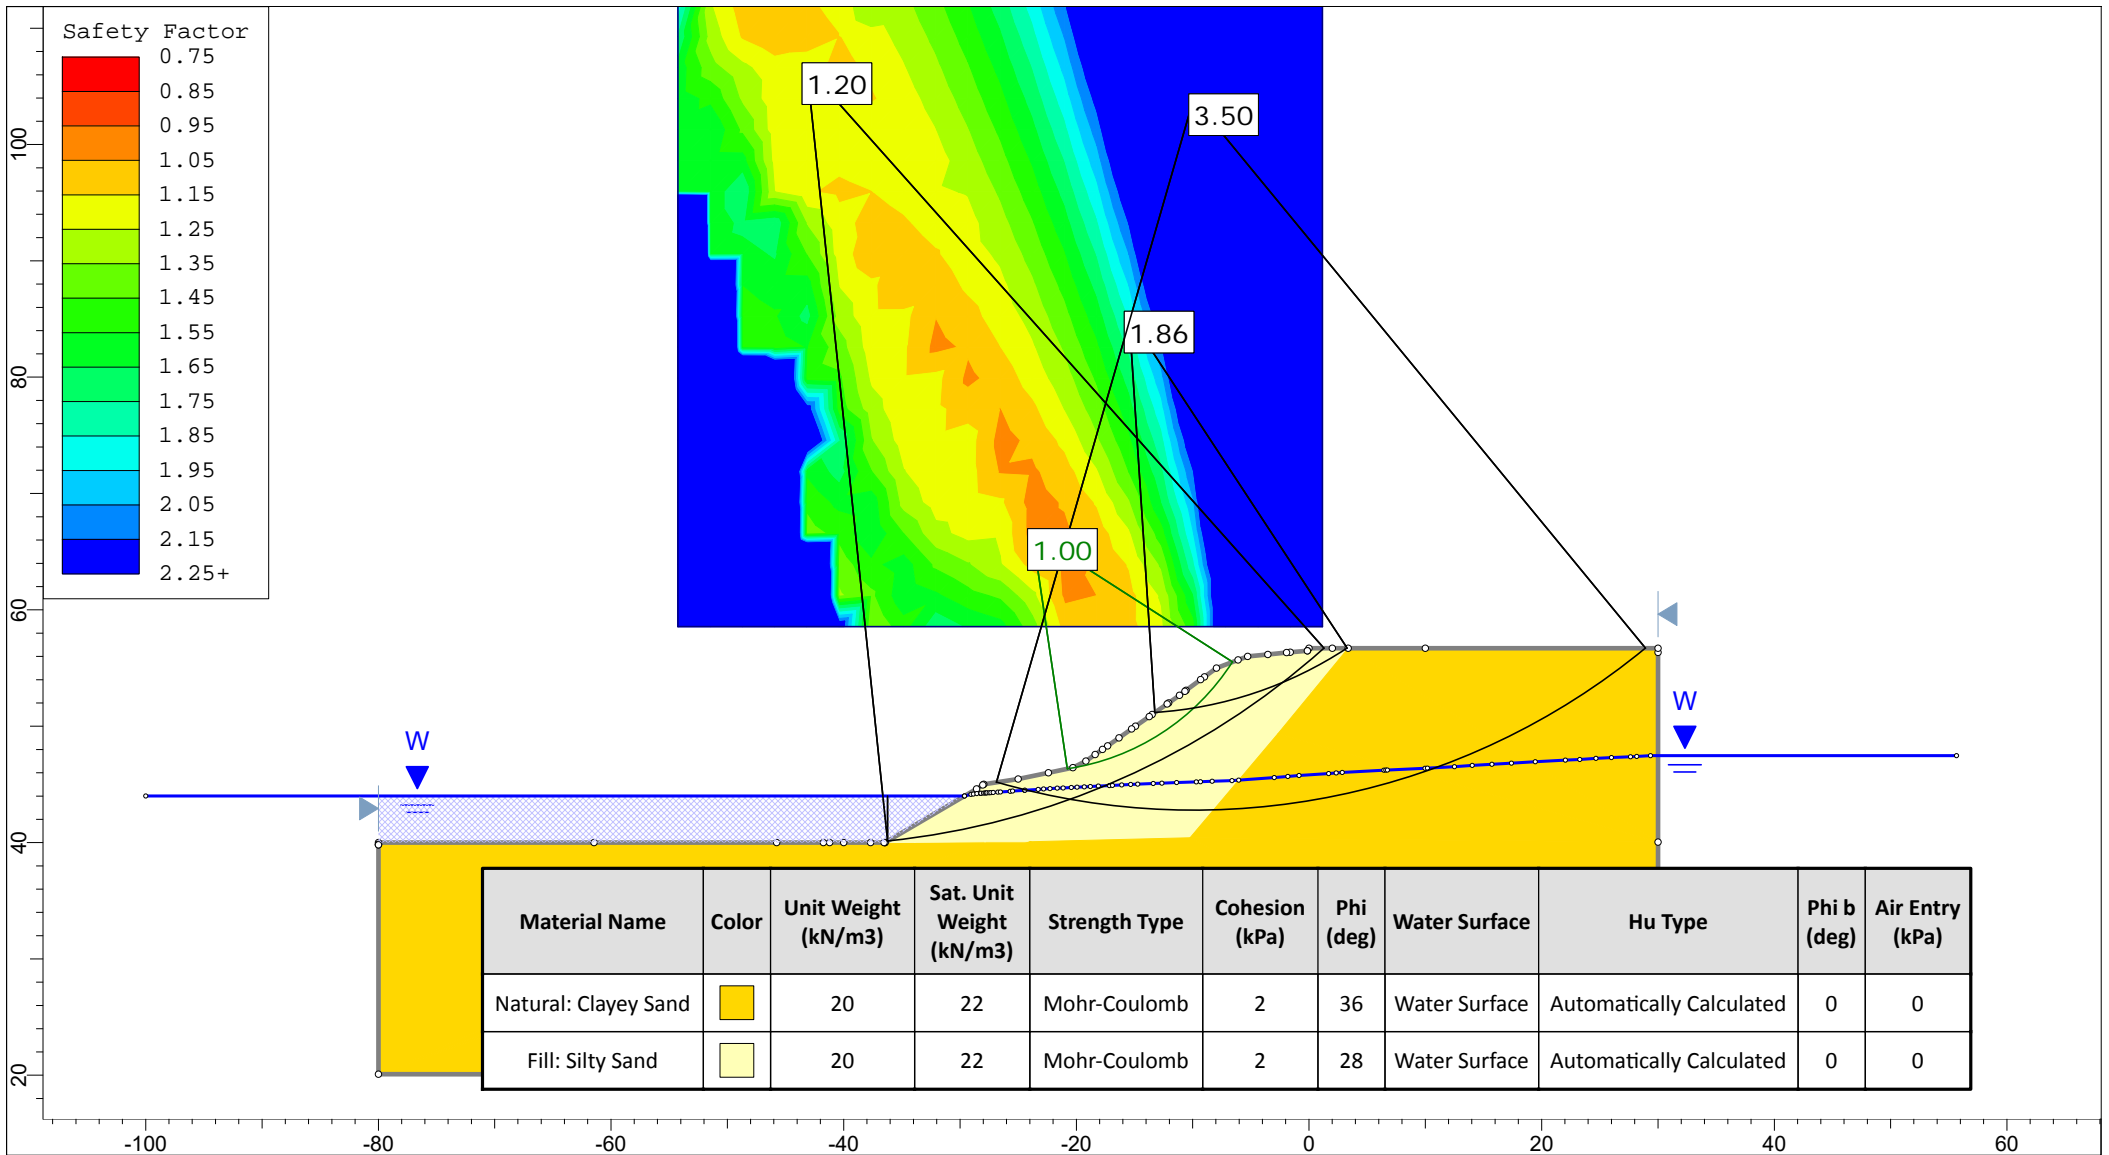
Figure C5 in Appendix C presents the factors of safety for various parts of the southern batter prior to the inclusion of the new building. The FOS are similar to the values obtained in the 2017 initial assessment (Figure C2). The minimum FOS is 1.00 for shallow failure of the batter.

The FOS for a failure surface starting at the Domain 4 boundary and extending to near the base of the pit is 1.20.

The FOS for failure through the buildings is also presented with a FOS of 1.86 at the northern edge while the FOS for the entire building is 3.50. These FOS significantly exceed the FOS of 1.5 that is normally adopted value for assessing the stability of slopes.

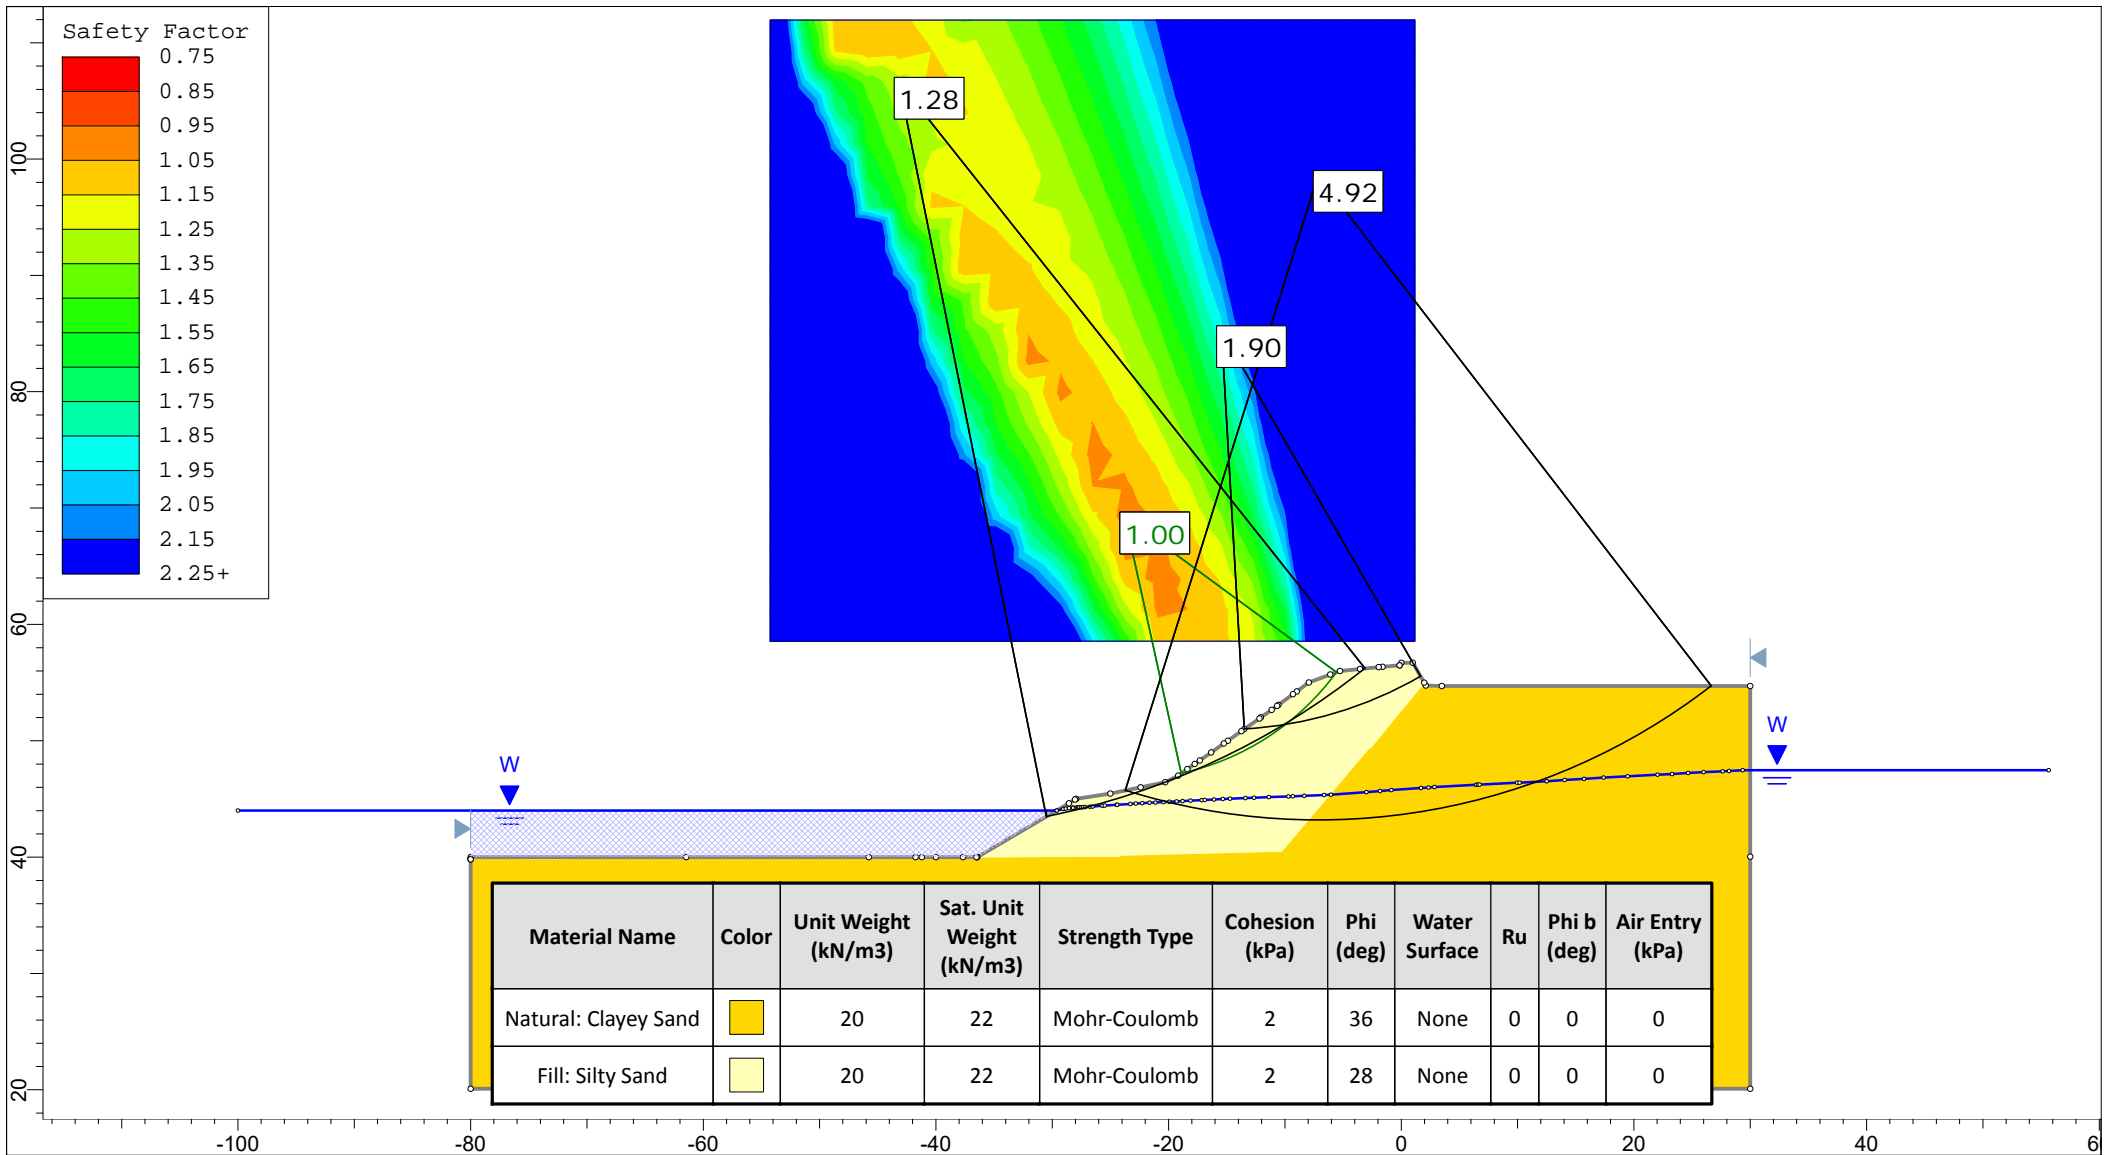
<i>Project</i>		Talbot Quarry Domain 4 south batter stability assessment			
<i>Analysis Description</i>		Current water level - after basement excavation			
<i>Drawn By</i>	MF	<i>Scale</i>	1:650	<i>Job Number</i>	754-GEOTABTF09257AA-BD
<i>Date</i>	26 February 2019			<i>File Name</i>	Figure C5a.slim

Figure C5a considers the site after the 2m deep excavation for the adjacent building. The FOS for the batters is similar to that in Figure C5 while the FOS for the failure surface extending back 25m increases as the driving forces are reduced. The FOS for the batters inside Domain 4 are unchanged from the pre-excavation case.

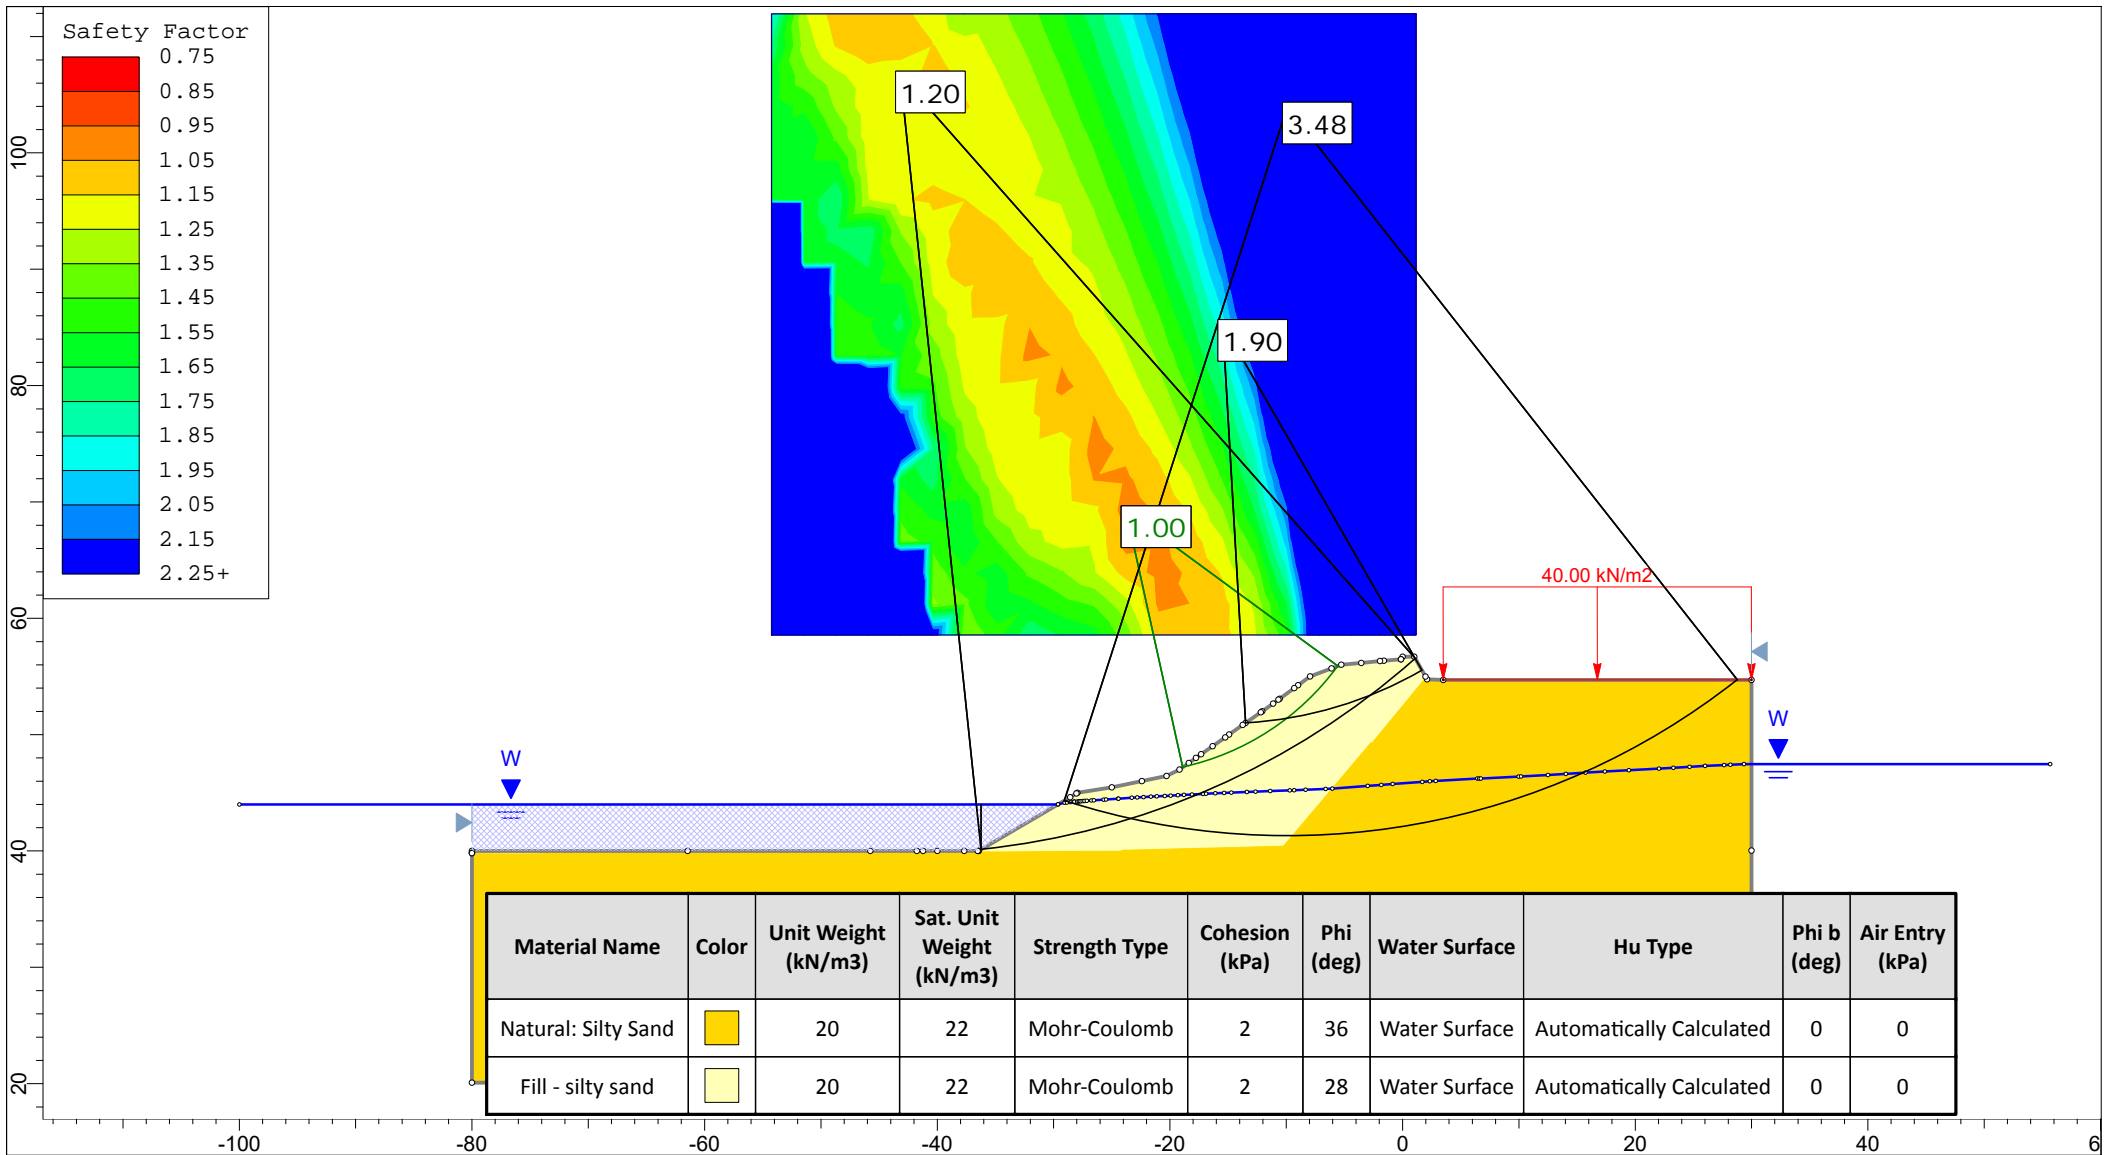
<i>Project</i>				Talbot Quarry Domain 4 south batter stability assessment			
<i>Analysis Description</i>				After construction of apartments			
<i>Drawn By</i>	MF	<i>Scale</i>	1:650	<i>Job Number</i>	754-GEOTABTF09257AA-BD		
<i>Date</i>	26 February 2019			<i>File Name</i>	Figure C6.slm

Figure C6 presents the results for the application of the building load. The FOS for the building with the failure surface across the building is 3.48 and similar to the previous analyses. The FOS for a failure surface on the north side of the building is 1.90 which is marginally higher than the FOS of 1.86 for the same failure surface in the pre-excavation model.

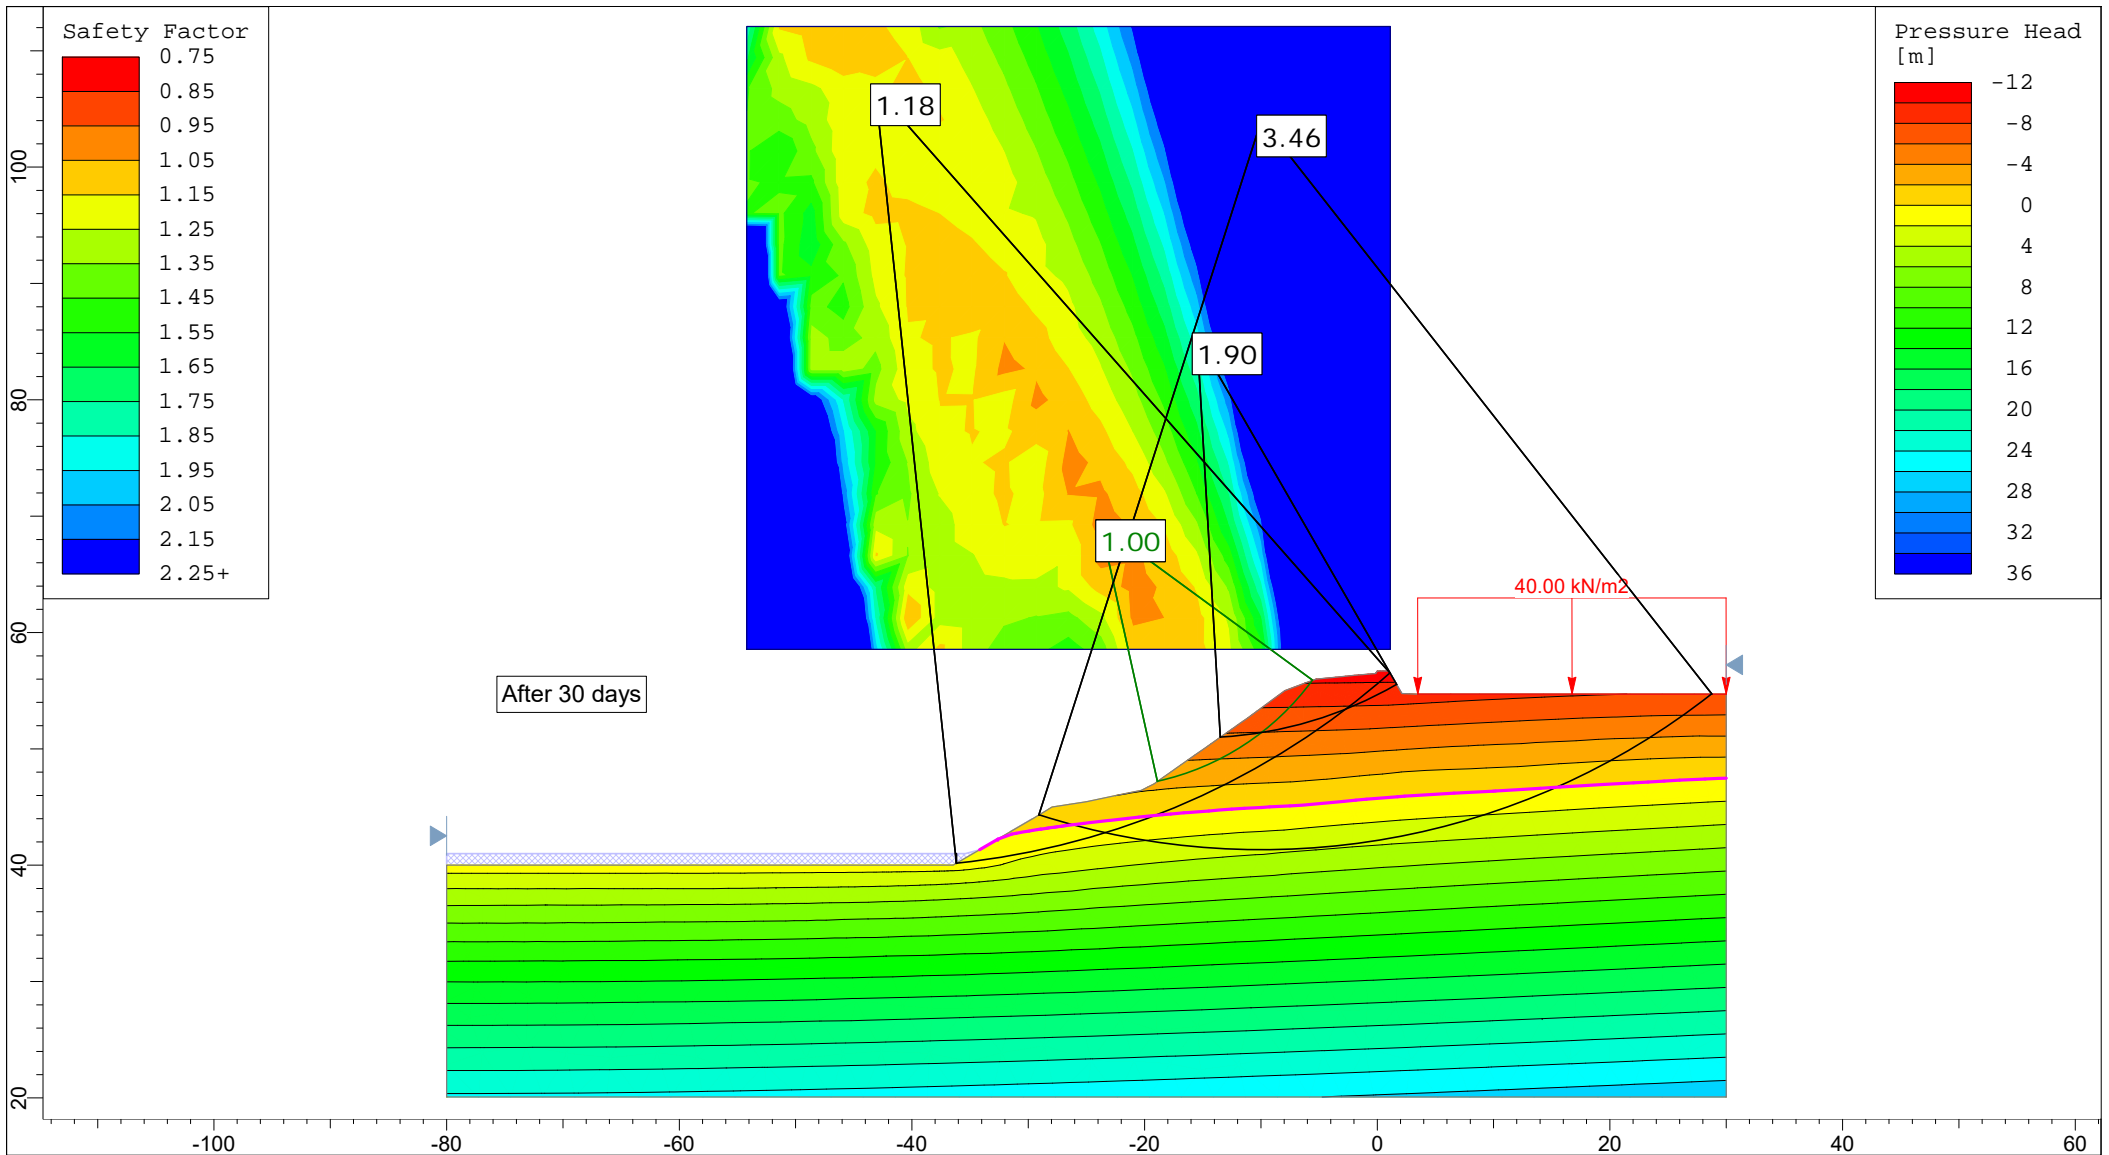
Project		Talbot Quarry Domain 4 south batter stability assessment	
Analysis Description		Transient groundwater 0.1m/day drawdown - After 30 days	
Drawn By	MF	Scale	1:650
Date		27 February 2019	
		Document Reference	754-GEOTABTF09257AA-BD
		Figure C8c

Figure C8b presents the results after 5 days for a drawdown of 0.1m per day. This results in a FOS of 1.16. The FOS after 30 days and 60 days are 1.18 and 1.21 respectively (Figures C8c and C8d). The results indicate that the FOS changes by a few percent (generally less than 2%) during the drawdown process. In all cases the FOS is more than the back-analysed shallow slope failure.
