Talbot Village, Oakleigh South

Domain 4 Batter Stability Assessment Report

Reference: 754-GEOTABTF09257AA-EG

21 September 2021

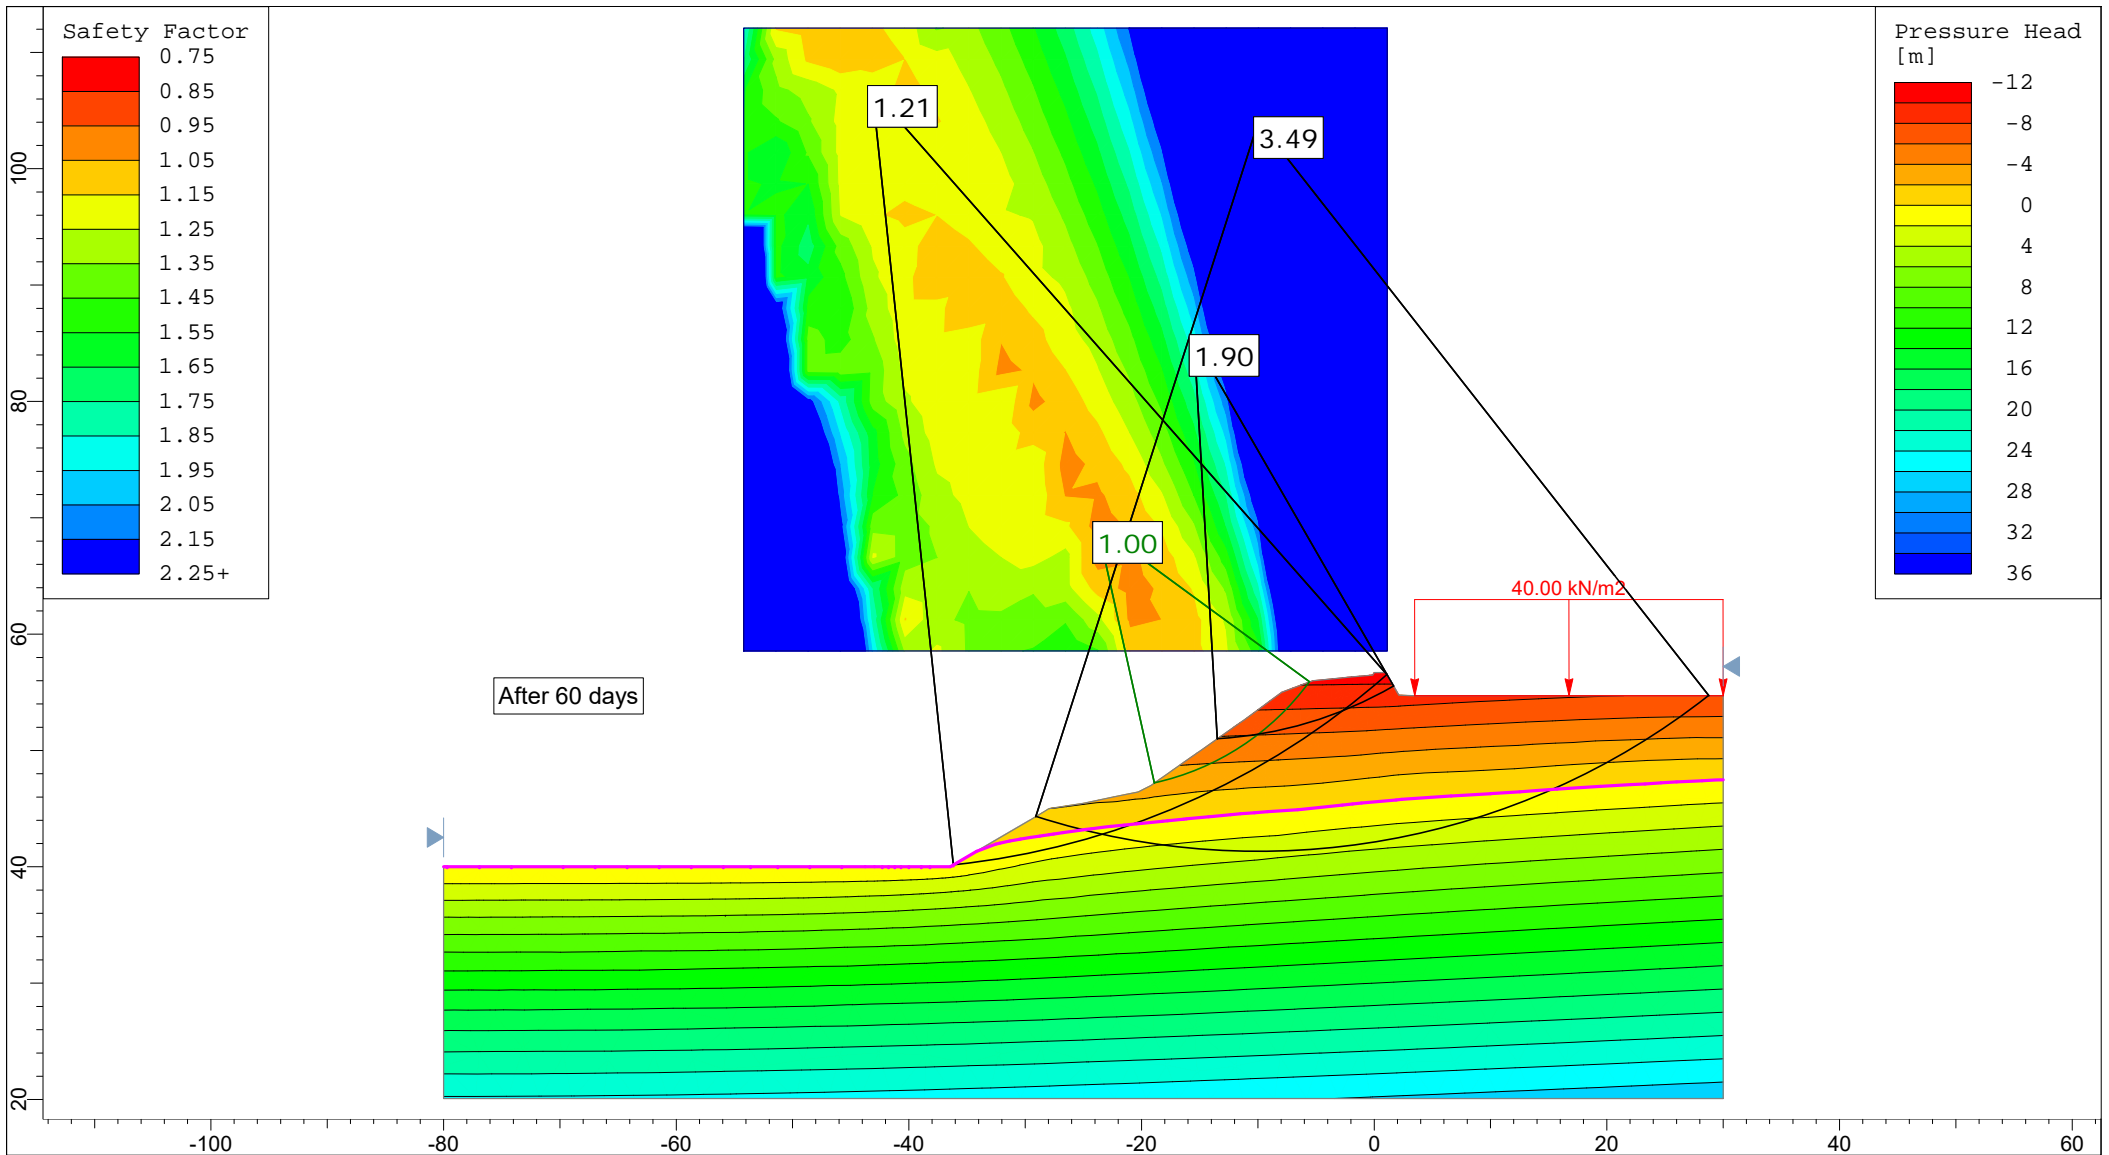
Project		Talbot Quarry Domain 4 south batter stability assessment	
Analysis Description		Transient groundwater 0.1m/day drawdown - After 60 days	
Drawn By	MF	Scale	1:650
Date	27 February 2019	Document Reference	754-GEOTABTF09257AA-BD
		Figure C8d

Figure C8b presents the results after 5 days for a drawdown of 0.1m per day. This results in a FOS of 1.16. The FOS after 30 days and 60 days are 1.18 and 1.21 respectively (Figures C8c and C8d). The results indicate that the FOS changes by a few percent (generally less than 2%) during the drawdown process. In all cases the FOS is more than the back-analysed shallow slope failure.
