12 April, 2021

Arborist Report

Health & Condition Report

First Church Of Christ, Scientist
256 Stephensons Rd, Mount Waverley

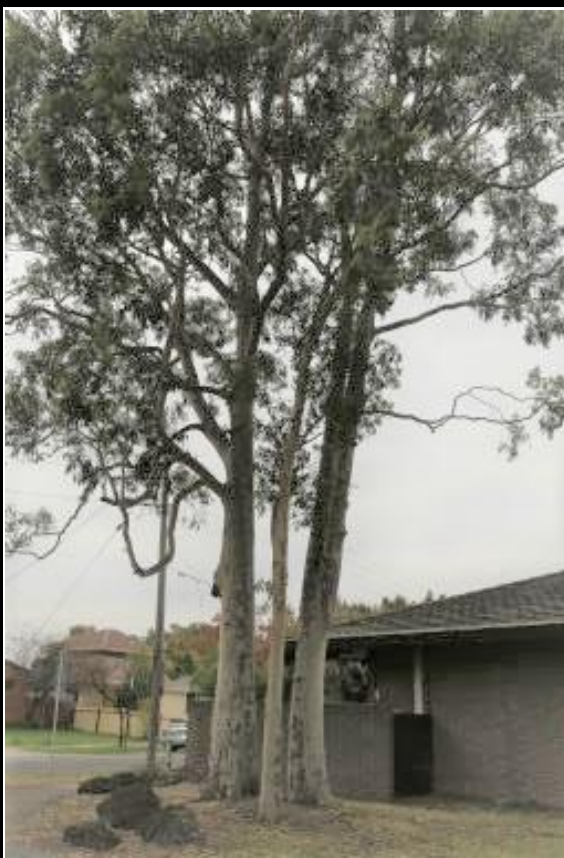
Figure 5.0. Overall photo of tree 1

Tree Number 1 is a small *Corymbia maculata*. The tree is shorter than the adjacent trees, tree 2 & 3, as it has been suppressed. There is evidence of past dieback in the upper canopy, due to suppression. See figure 5.1. The deadwood has been pruned out which is quite evident and can be seen clearly in multiple locations in the canopy.

The tree is in good health but does have some minor pest problems including lerps and sooty mould. Both are not affecting the health of the tree to a large degree.

The tree has almost no trunk flare and has a small lean of growth away from the other 2 adjacent trees. Although the tree has been suppressed, it is a vital part of the stability of the 3 trees. The tree has grown up in unison with tree 2 and 3. This means canopy protection and root entanglement that can help stabilise the larger trees.

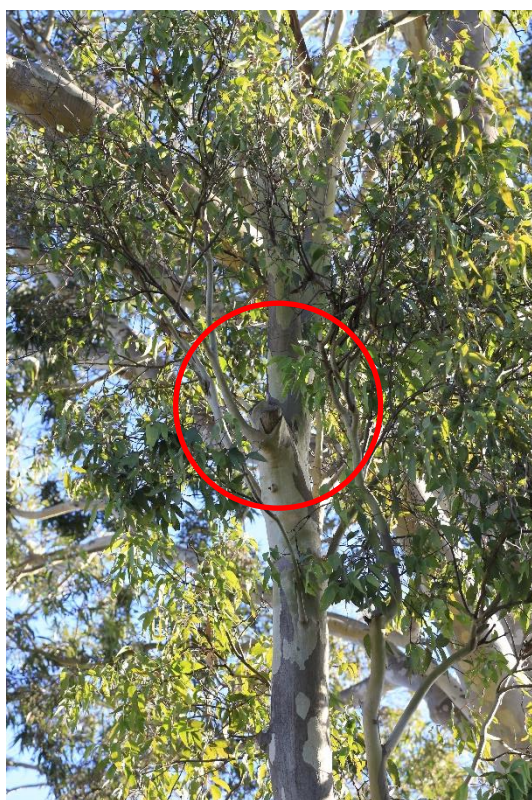
Figure 5.1. Past dieback in the upper canopy of tree 1.

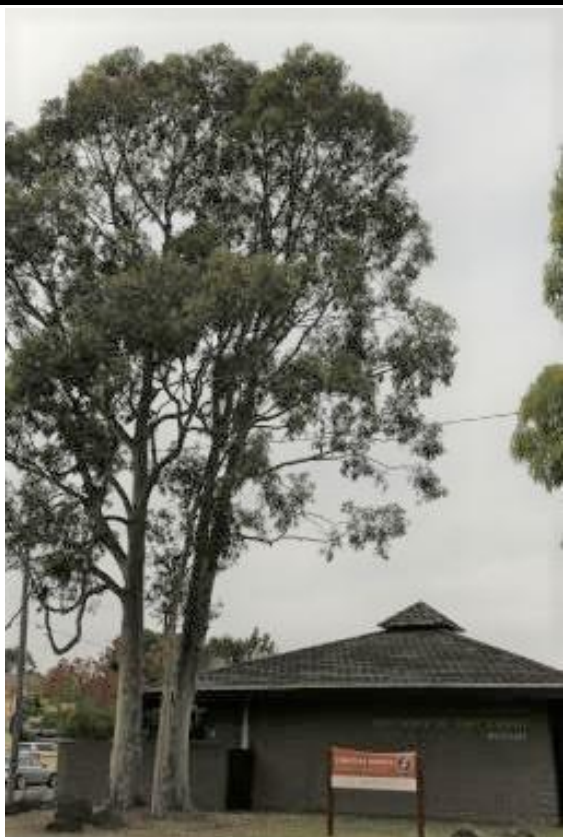
Figure 5.2. Overall photo of tree 2

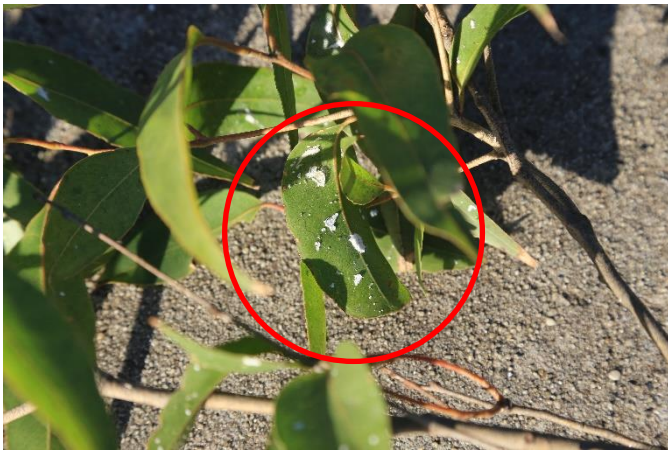
Tree Number 2 is a large *Corymbia maculatta*. Once again, this tree also has some minor pest issues including sooty mould and lerps. Both of these are only minor and have not drastically affected the health of the tree. This can be seen in figure 5.3.

Figure 5.3. Evidence of lerps on the leaves of all 3 trees. Sample taken from Tree 3.

The specimen shows some signs of pest and disease, with sooty mould and lerps both present in the canopy. Seen in figure 5.3.

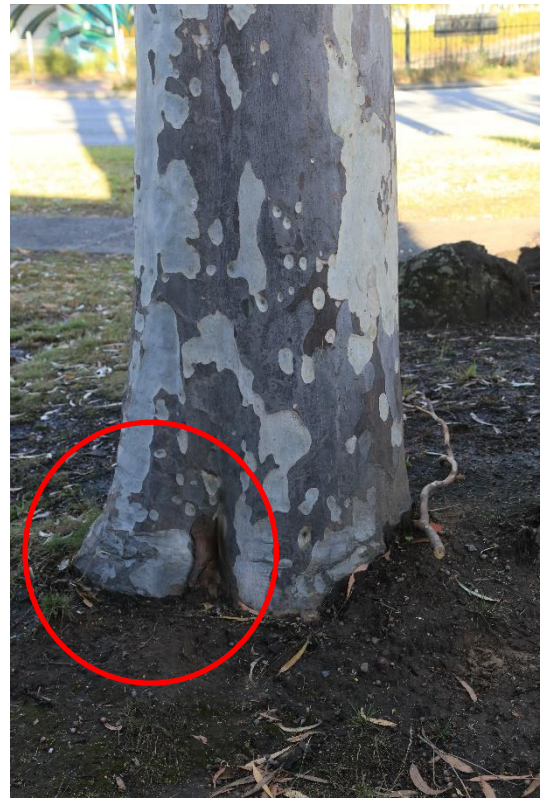
The subject tree has good trunk flare but is also slightly one sided once again due to competition. See figure 5.4.

Figure 5.4. Trunk flare more evident on the one side of the tree in tree2.

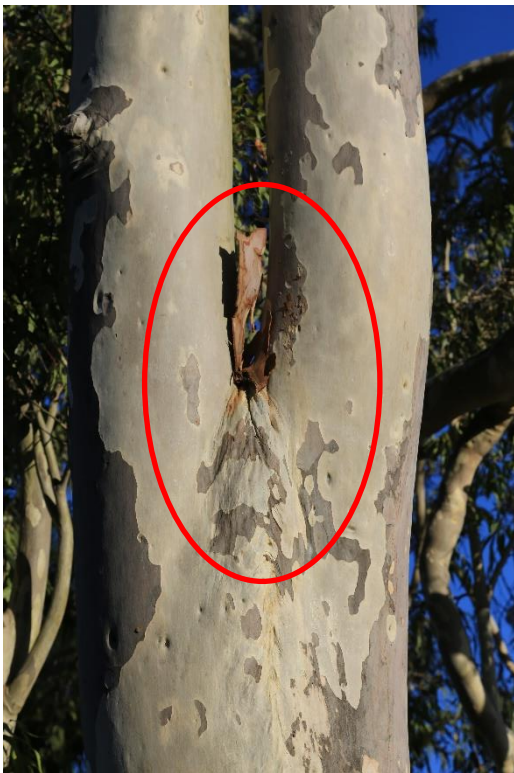
Figure 5.5. Bifurcated stem in tree 2. No included bark present and a nice open union.

Tree Designs recommends minor canopy clearance back from the building. This pruning is not a high priority. Weight reduction is not needed throughout the canopy and there is no need for asset clearance. The bifurcation in tree 2 is not a concern as there is no evidence of included bark. However, the union should be monitored over time to ensure included bark does not develop.

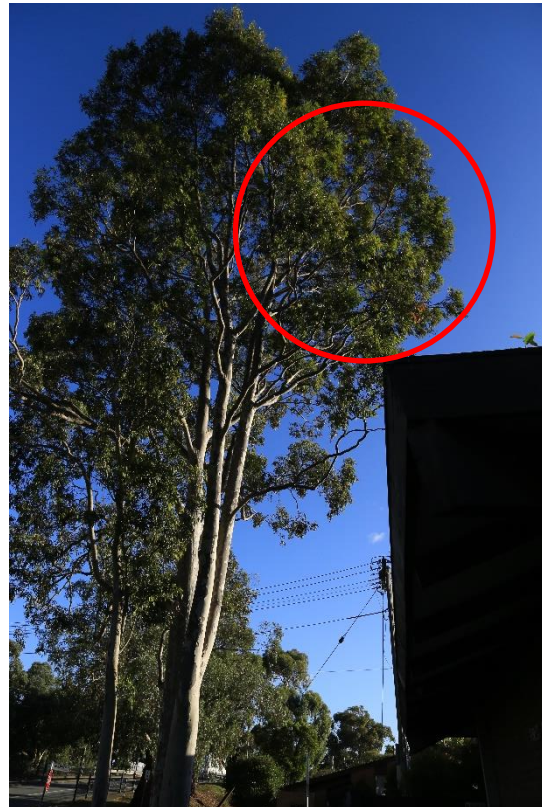
There are extended branches over the roof line of the building. The branches are not over extended and do not require pruning for safety. However, they could be reduced for the purpose of reducing leaf litter in the roof gutters. See figure 5.6.

The trunk and canopy of the tree has a slight lean towards the building; however, the tree has grown this way due to the adjacent trees competing for light. This is also shown in figure 5.6.

Figure 5.6. Canopy branches extending over roof of church building in tree 2.

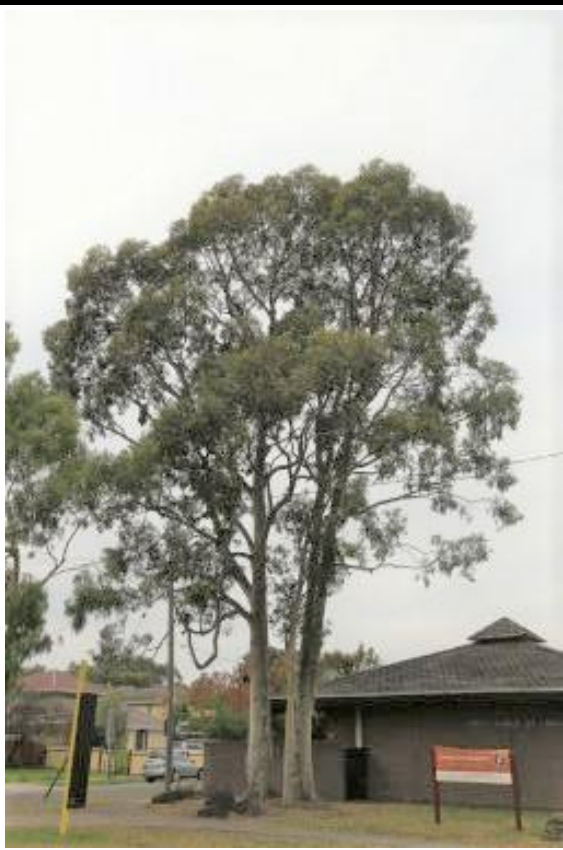
Figure 5.7. Overall photo of tree 3.

Tree 3 is another large *Corymbia maculatta*. A valuable tree to the surrounding area in terms of landscape contribution.

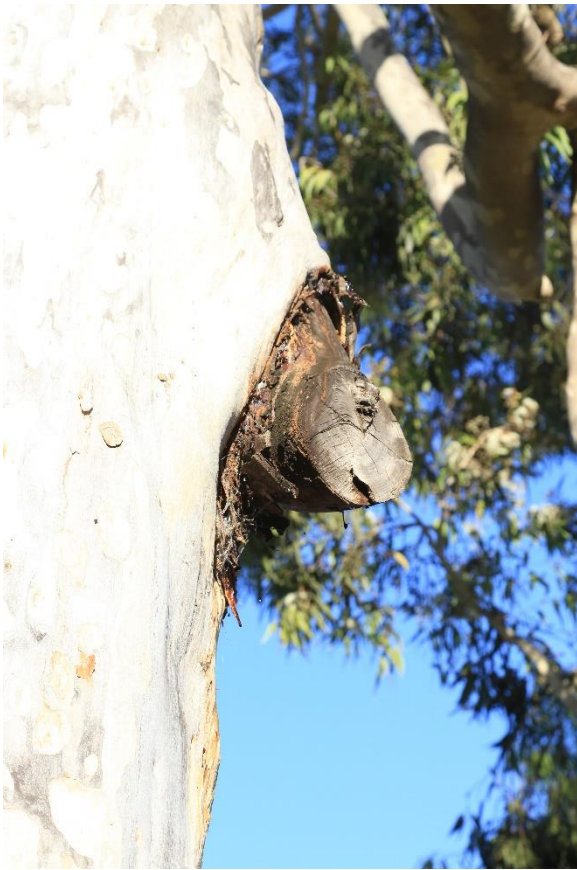
Figure 5.8. shows an old wound from previous branch removal. Although this a poor pruning cut, the wound has not caused any problems to the health or structural safety of the tree and is beginning to show good signs of compartmentalisation.

Figure 5.8. Old branch removal in tree 3.

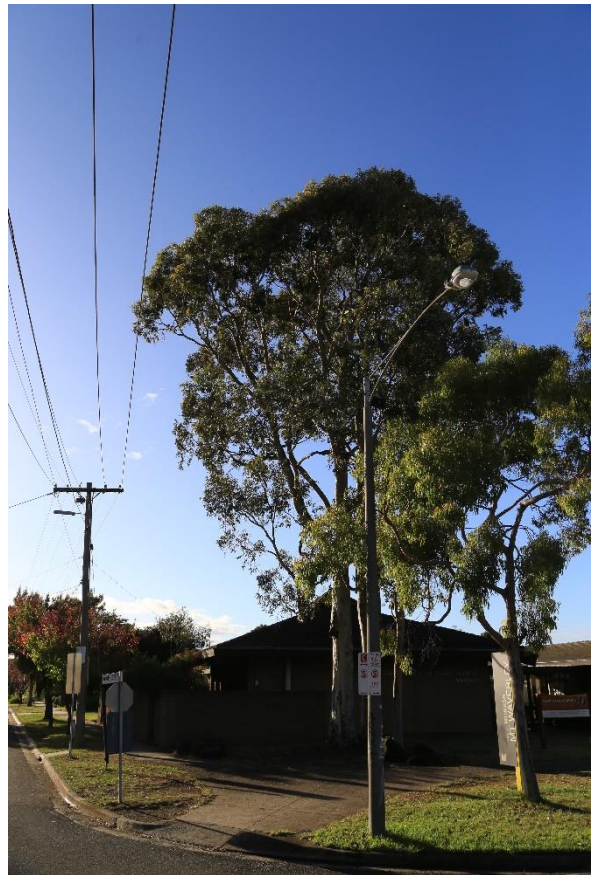
The tree leans out towards the street and towards the powerlines but has grown in this direction and therefore is not a huge concern. This can be seen in figure 5.9. and figure 5.10.

Figure 5.9. Canopy of tree 3 over powerlines

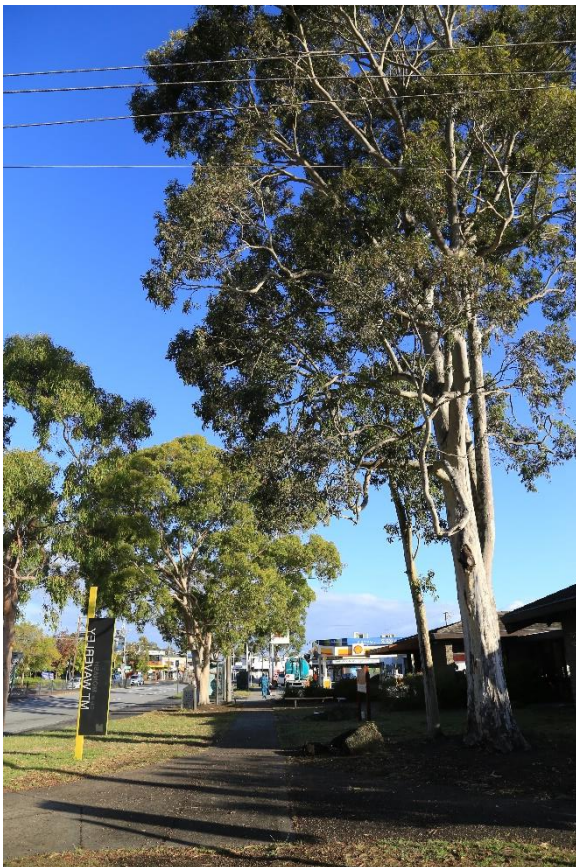
Figure 5.10. Tree 3 has grown with a lean over the street

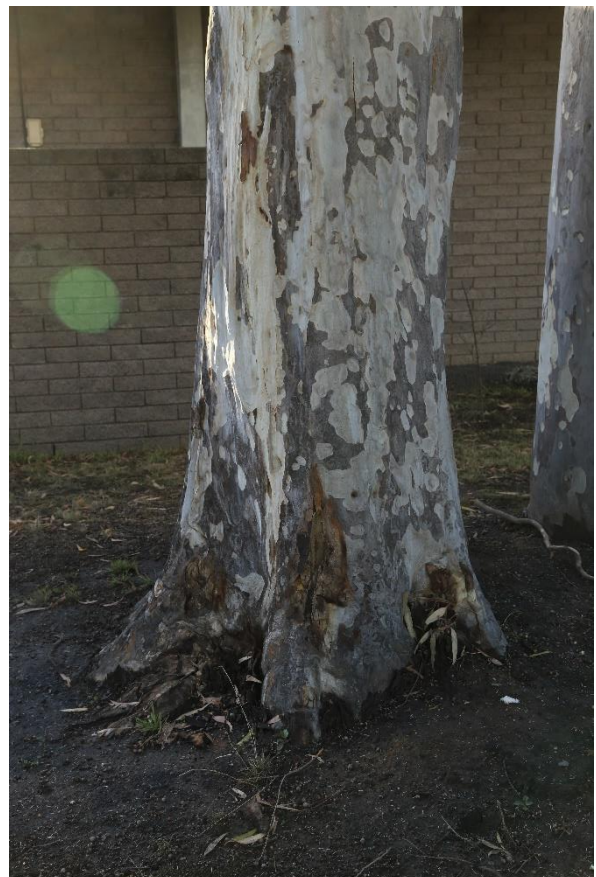
The tree has good trunk flare showing a very stable root base as seen in figure 5.11. More then likely the roots of all 3 trees are intertangled giving great stability.

Figure 5.11. Good trunk flare on tree 3.
