Arboricultural Impact Assessment

299 High St Rd,
Mount Waverley VIC 3149

Friday, February 05, 2021

VERSION 2

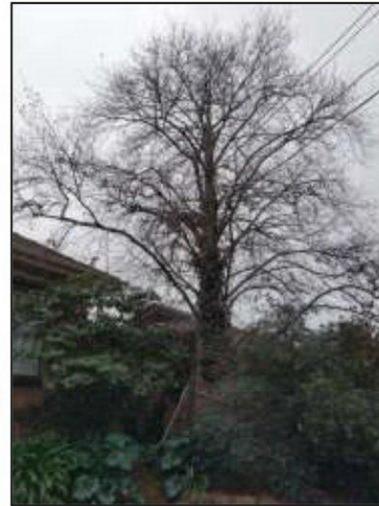
Tree 5

Site cut

- The site cut is proposed to be a major encroachment (6.3.2) of 26% of the TPZ and 9.7% of the SRZ.
- Individually, the excavation of the proposed site cut has the potential to compromise the tree's long-term viability.

Dwelling

- The dwelling is proposed to be a major encroachment (6.3.2) of 10.6% of the TPZ and 0% of the SRZ.
- Individually, the construction of the proposed dwelling has the potential to compromise the tree's long-term viability.

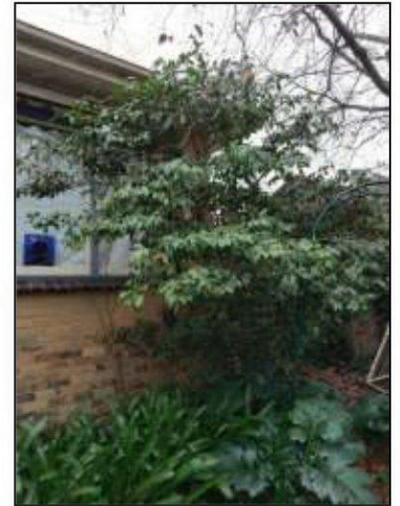
Tree 6

1.57 m													
	Grey alder				E-W 8 m	0.56 m								
6	<i>Cemellia japonica</i>	Semi mature	Exotic	4 m	N-S 3 m	0.13 m	Fair	Fair	20 + years	Low	Low	2.0 m	1.5 m	Multi-stemmed at ground level. DBH & CA1 measured at ground level. Existing dwelling located within TPZ.

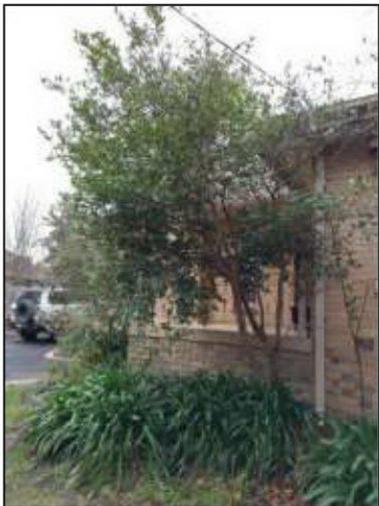
Tree 7

0.41 m													
	Japanese camellia				E-W 3 m	0.13 m								
7	<i>Cemellia japonica</i>	Semi mature	Exotic	5 m	N-S 3 m	0.14 m	Fair	Fair/ poor	10-20 years	Low	Low	2.0 m	1.5 m	Multi-stemmed at ground level. DBH & CA1 measured at ground level. Decay present within trunk. Existing dwelling located within TPZ.
