Arboricultural Report

Development Impact Assessment

Site address: Mulgrave Private Hospital
Blanton Dr, Mulgrave VIC 3170

Date of issue: 30 Nov 2023

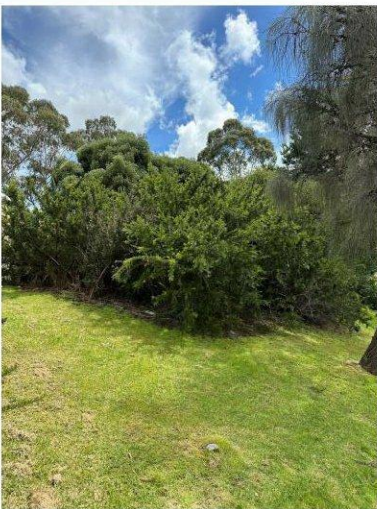
Figure 33 Example of minor insignificant vegetation
