# Talbot Village, Oakleigh South

## Domain 1 Preload Design Report

Huntingdale Estate Nominees Pty Ltd  
c/- Sterling Global

12 November 2021

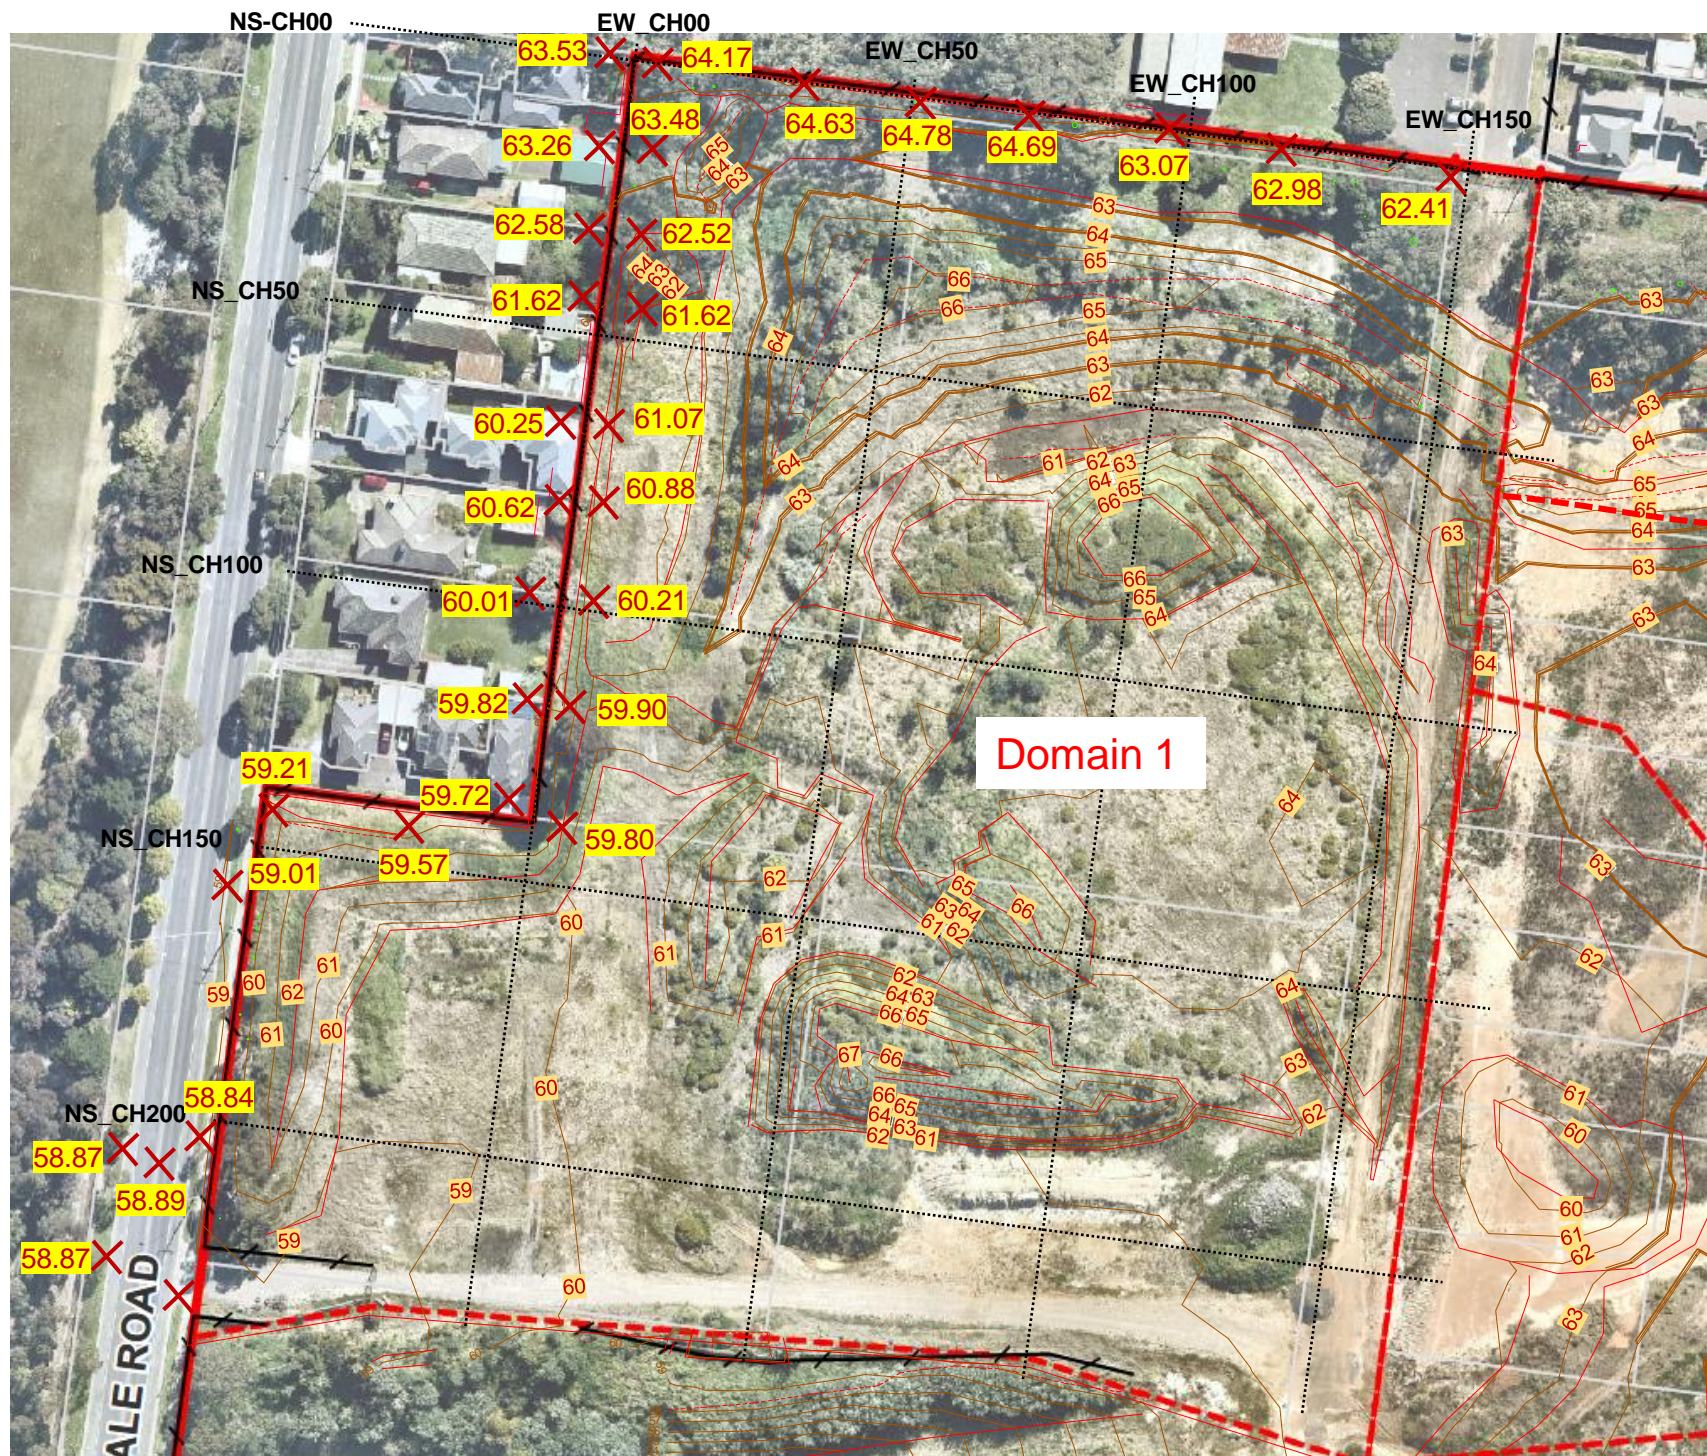
EXISTING GROUND LEVELS – DOMAIN 1

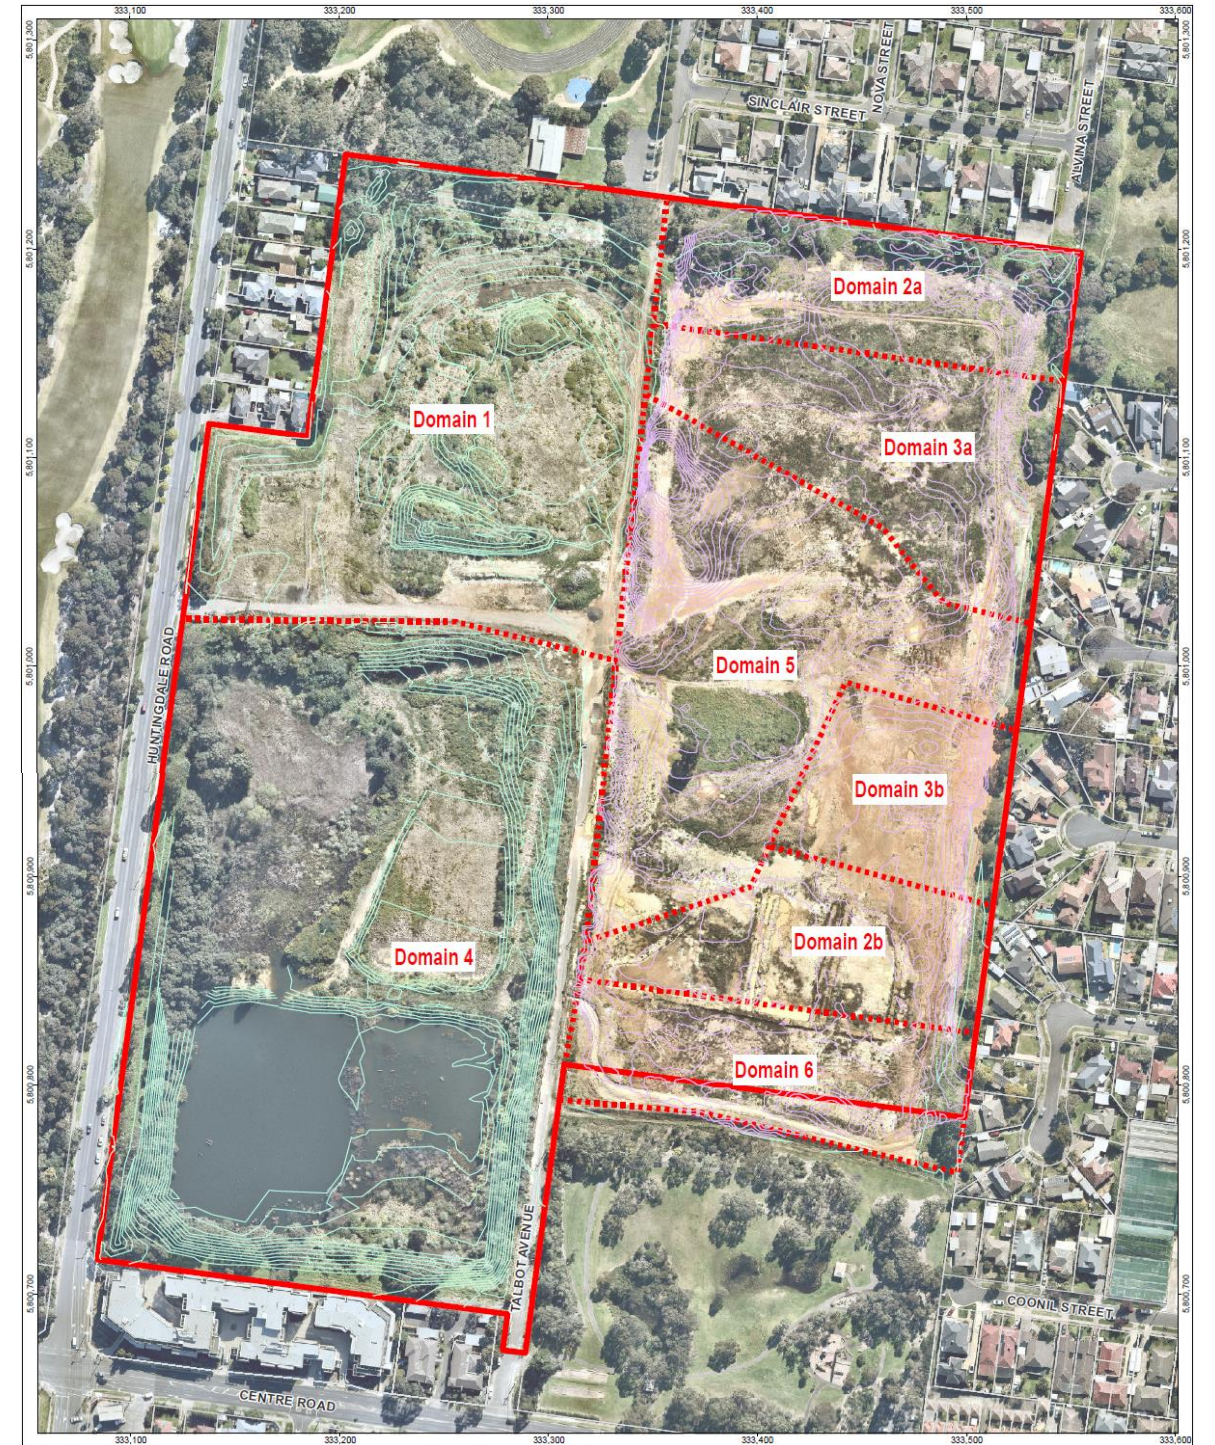
SITE GEOTECHNICAL DOMAINS

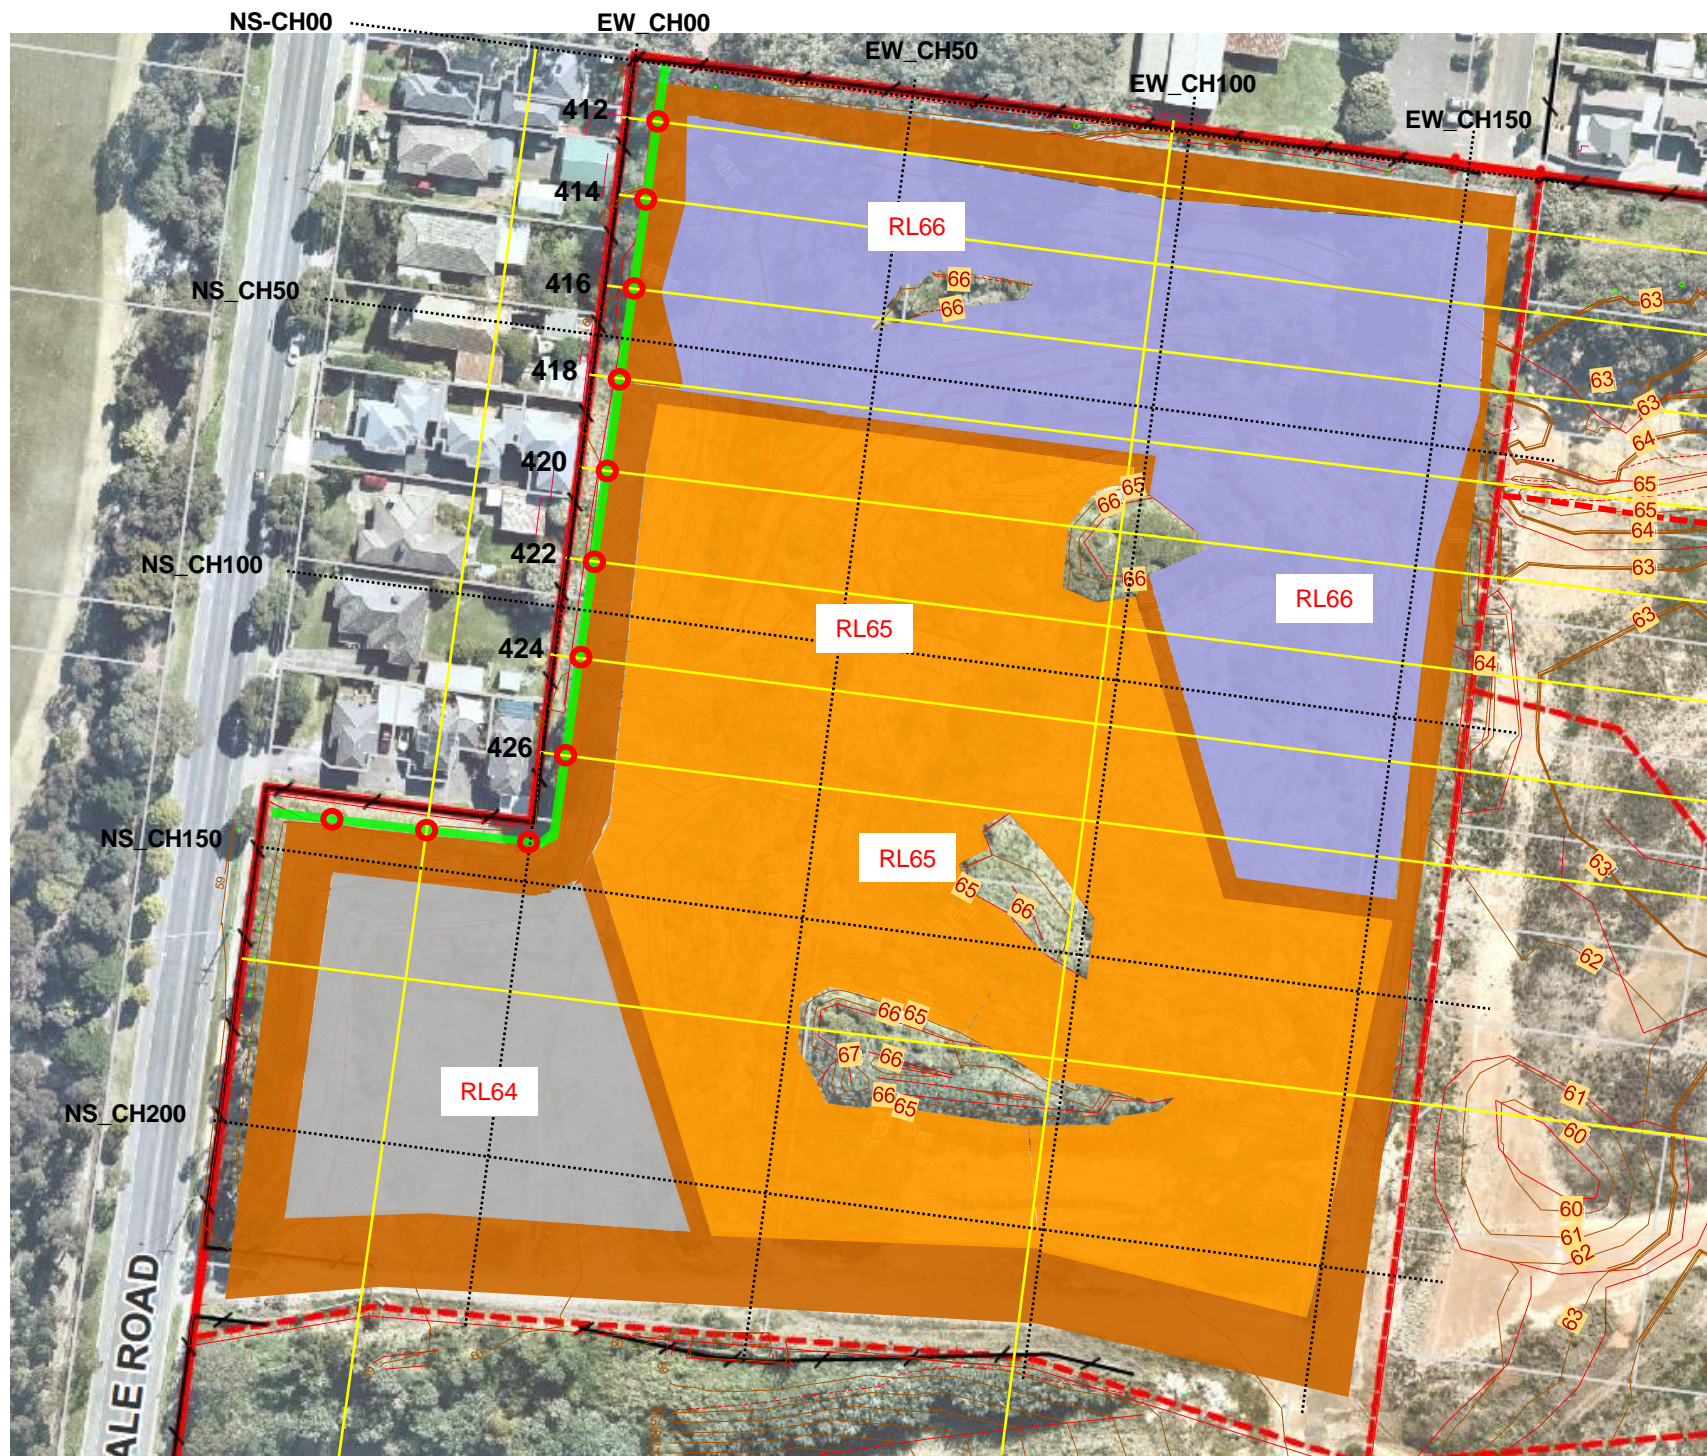
revision	description	drawn	approved	date	NOTES:	drawn	FK		client:	HUNTINGDALE ESTATE NOMINEES PTY LTD		
	DRAFT	FK	IP	23.07.21		approved	IP		project:	TALBOT AVENUE, OAKLEIGH SOUTH		
	DRAFT	FK	IP	07.09.21		date	21.09.21		title:	EXISTING CONDITIONS PLAN		
	V0	FK	IP	21.09.21		scale	AS SHOWN		project no:	GEOTABTF092574AA	figure no:	1
	V1	FK	IP	11.10.21		original size	A3

Preloading has been carried out across the eastern side of the site in Domains 2a, 2b, 3a, 3b, 5 and 6 (see Figure 1) with the settlement of the preload measured by a series of settlement plates and pins. The results of the settlement monitoring have been used to derive “calibrated” ground deformation parameters for use in numerical analysis to predict future ground movements across the development. It is proposed that the same approach be used in Domain 1 to allow the collection of settlement data to inform the development design.

Domain 1 is a closed landfill site covered with inert uncontrolled fill. The current surface of Domain 1 comprises soil mounds and stockpiles with surface elevations ranging from RL59m to over RL66m (see Figure 1).

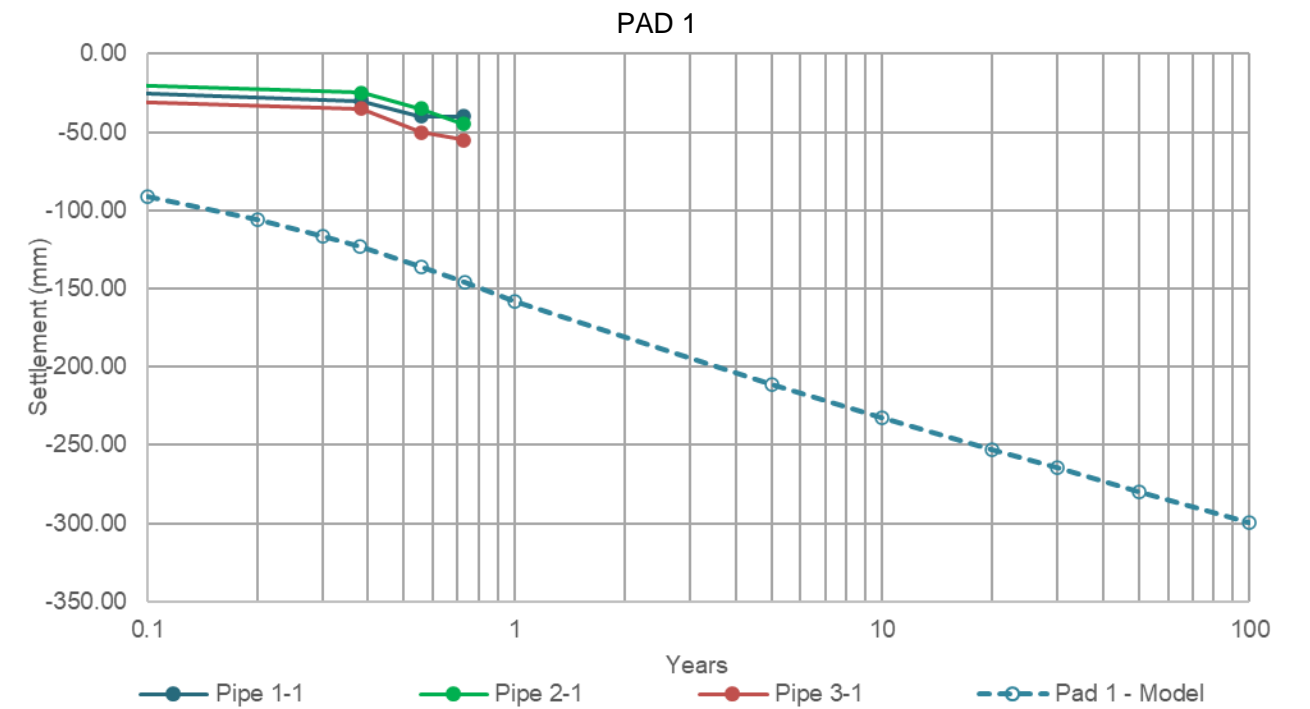
Calibration of model parameters using the results of 2004 trial pads

client:	HUNTINGDALE ESTATE NOMINEES
project:	TALBOT QUARRY 22 TALBOT AVE, OAKLEIGH SOUTH
title:	Model Calibration - Domain 1
project no:	GEOTABTF09257AA
figure no:	B1

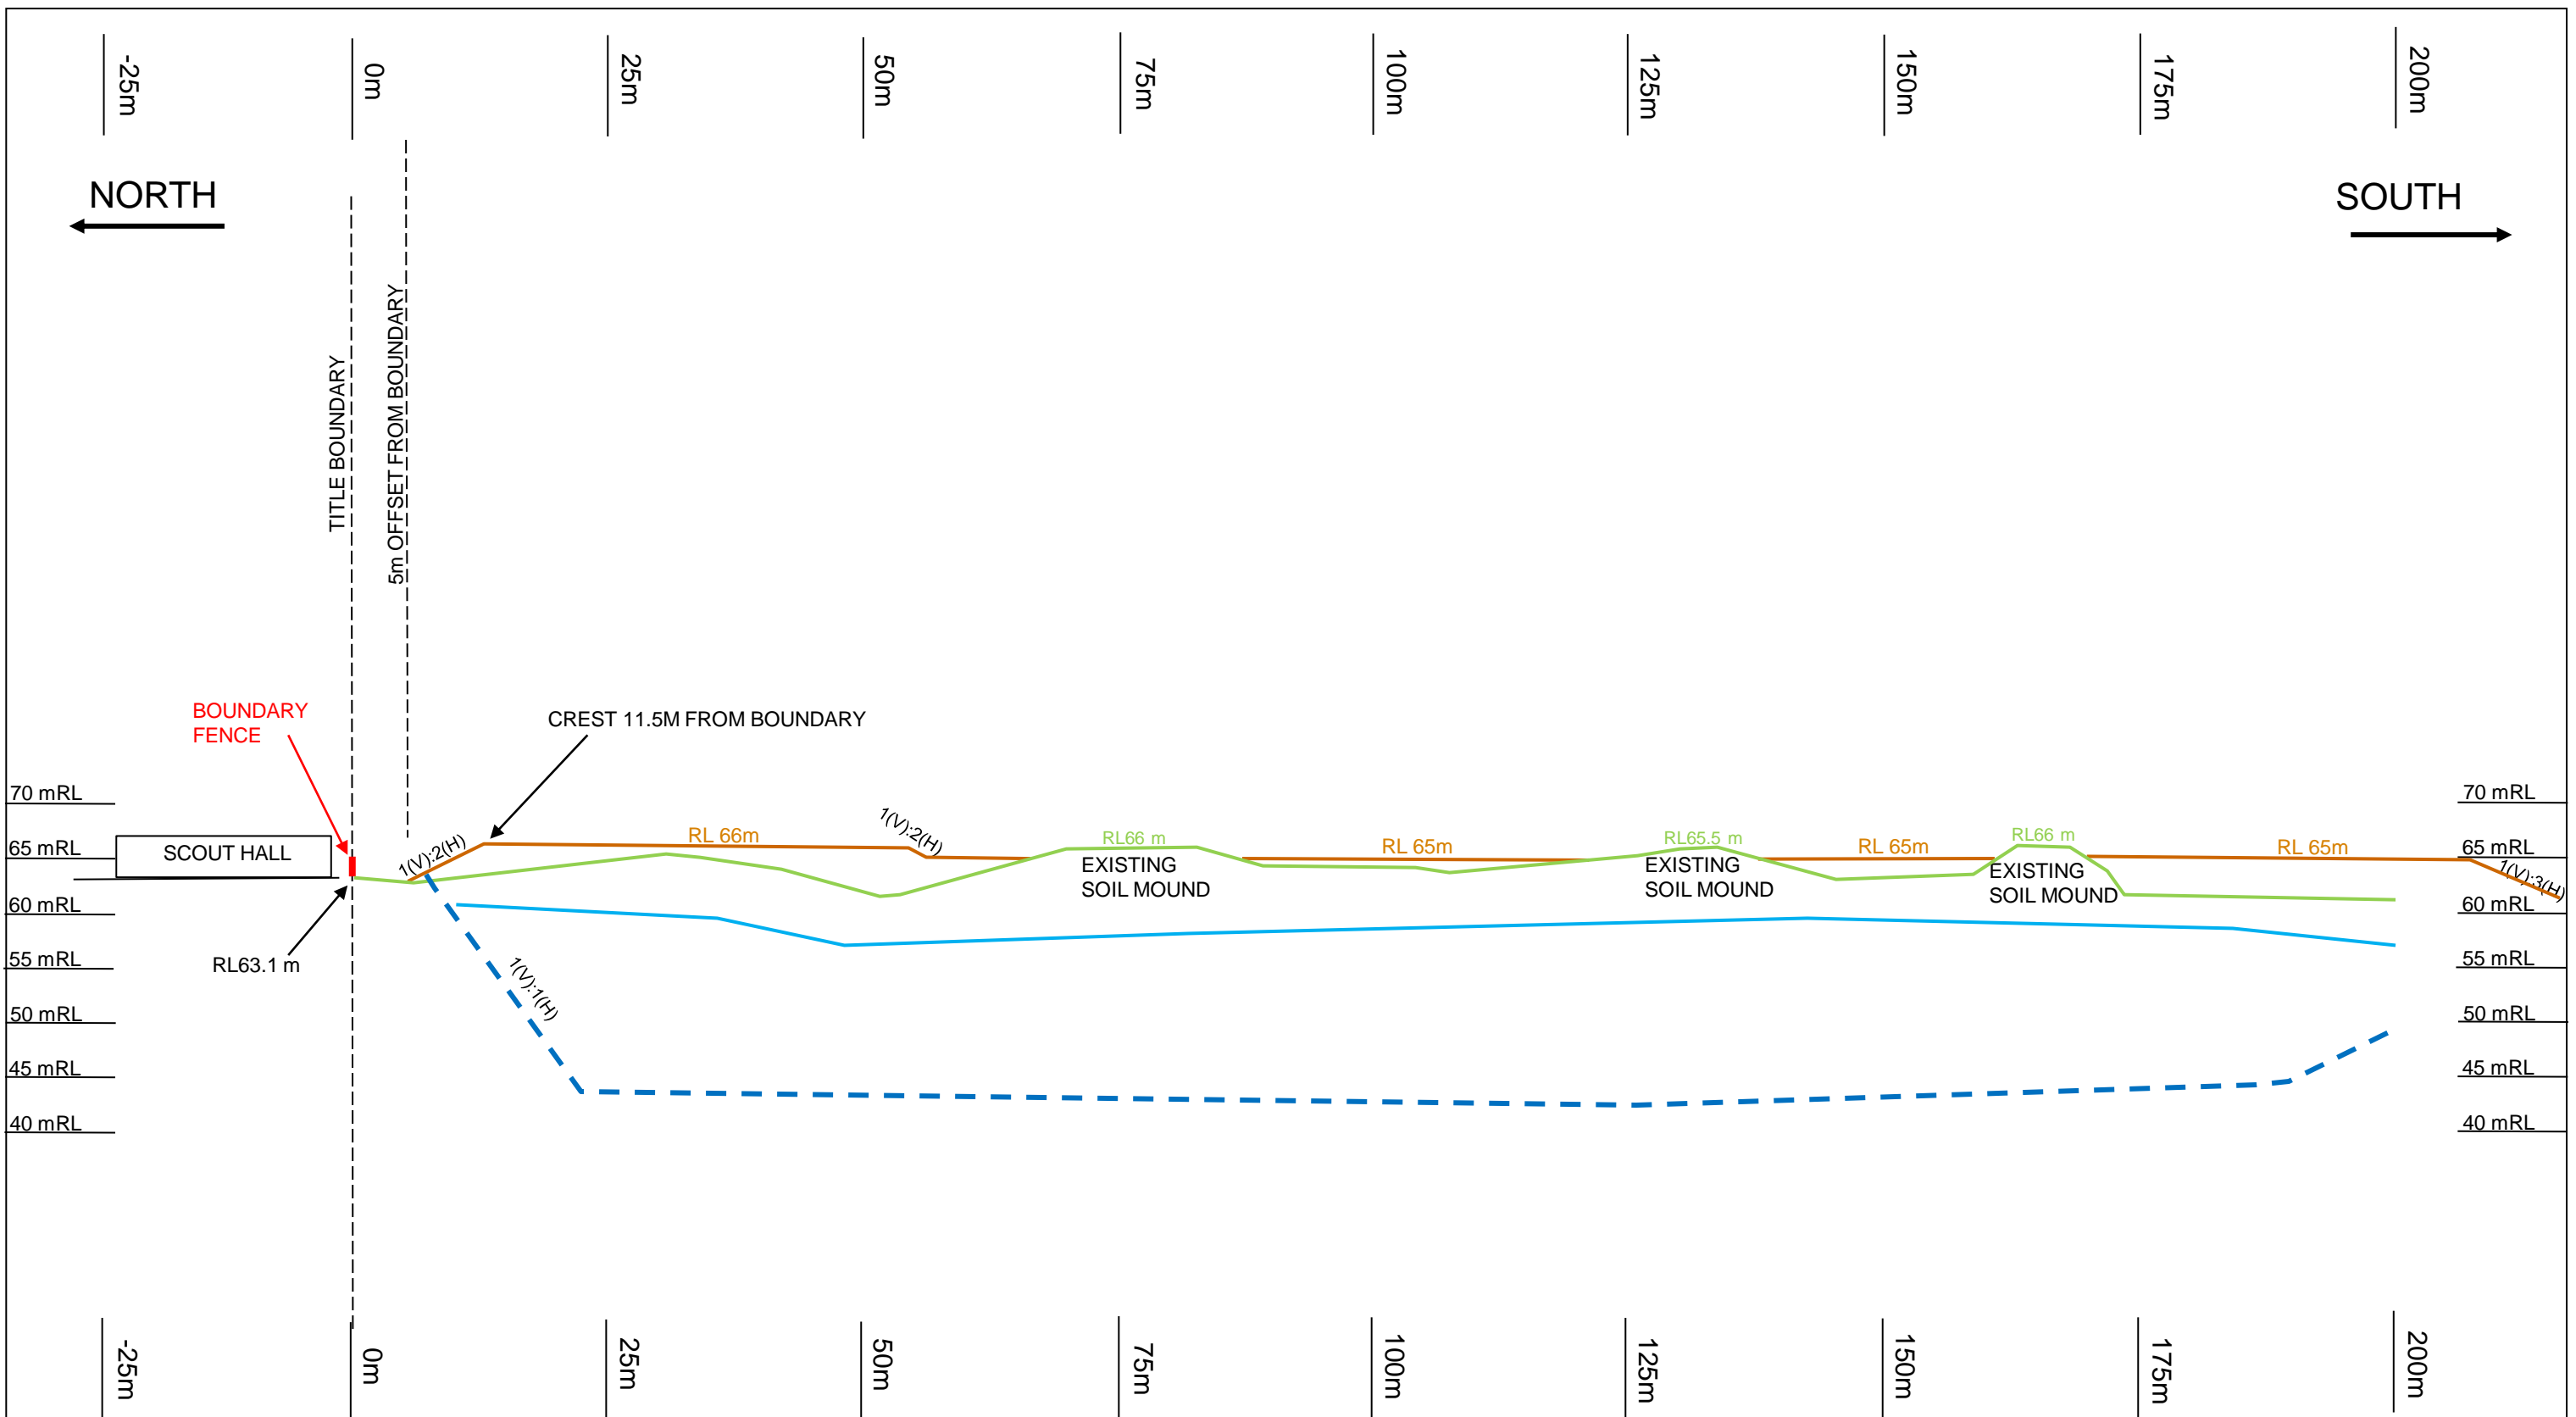
client:	HUNTINGDALE ESTATE NOMINEES PTY LTD	
project:	TALBOT AVENUE, OAKLEIGH SOUTH	
title:	SECTION 8	
project no:	GEOTABTF092574AA	figure no: C9

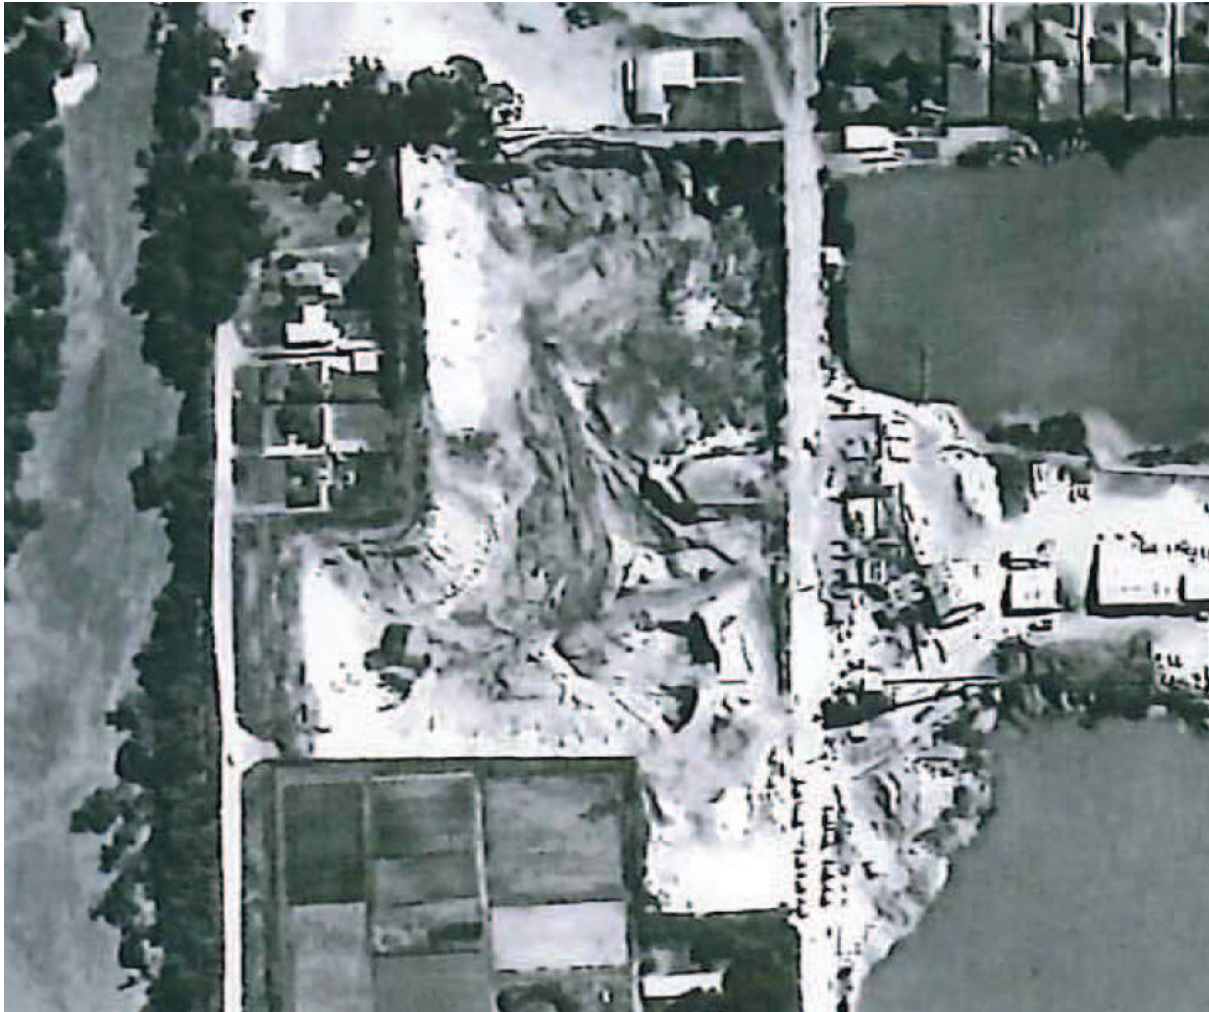
Figure 1 - Aerial photograph of Zone 1 from October 1970

The quarry void in Zone 1 was backfilled with land fill in the mid-1970s. The aerial photograph shown in Figure 1 was taken in 1970 during quarrying, it shows that the eastern side of the Zone 1 pit had extended into Zone 4. By 1975 an overlapping pit had been excavated in the northern part of Zone 4, which is shown inundated with water in Figure 2 and the Zone 1 pit had been partially backfilled with municipal landfill waste.

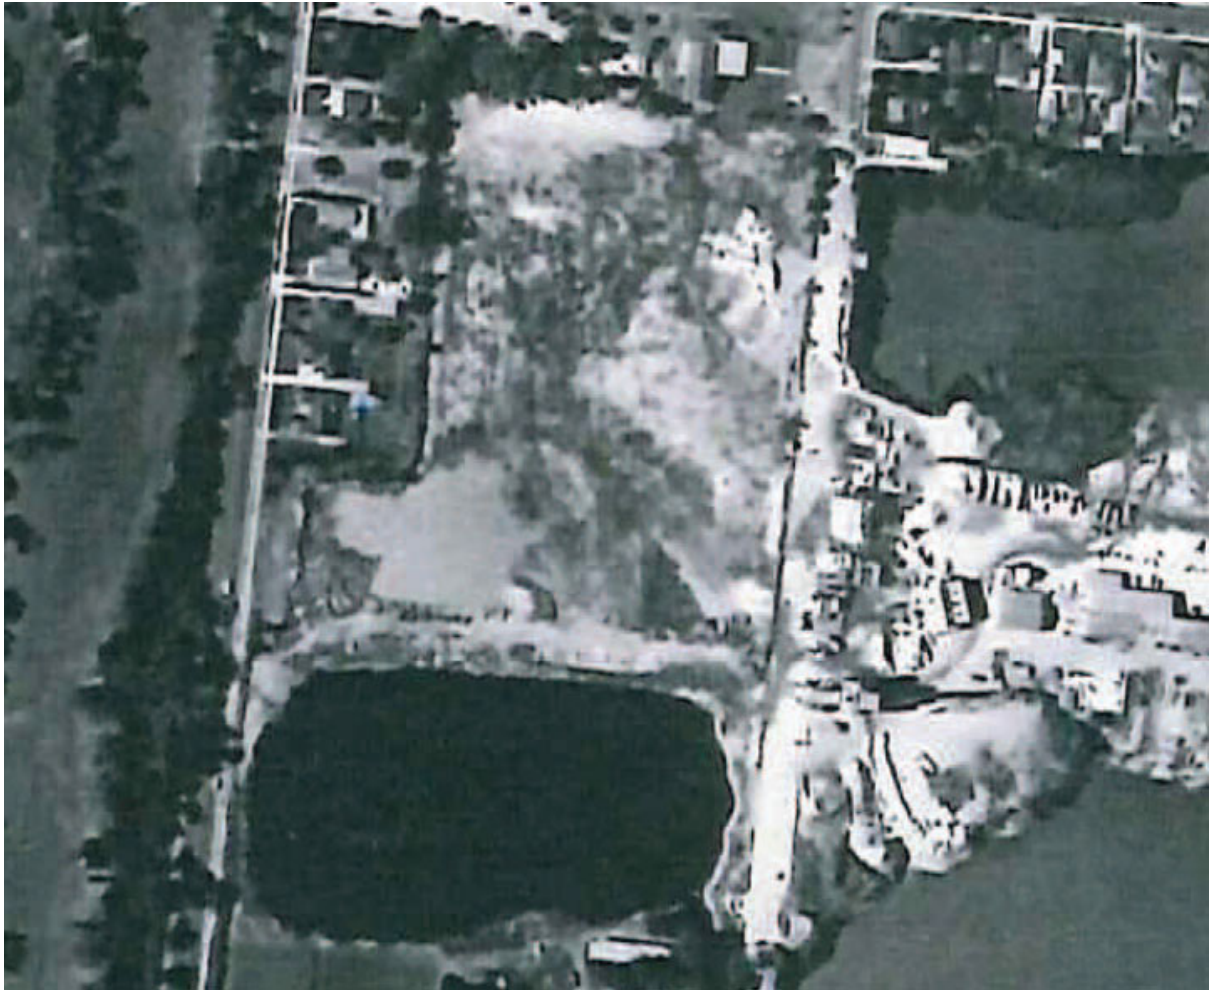
Figure 2 – Aerial photograph from December 1975

The north wall of the Zone 4 pit has some waste materials including cloth and metal items visible on the batter surface. A number of gas bores and groundwater monitoring wells have been excavated since 2004 in the vicinity of the Zone1 / Zone 4 boundary which are shown in Figure 3 also encountered land fill and foundry sand materials to various depths, but often did not penetrate as far as the natural Brighton Group soils underlying the fill materials in the pit wall which indicates that the bund wall between the Zone 1 and Zone 4 pits evident in the 1975 aerial photograph in Figure 2 was

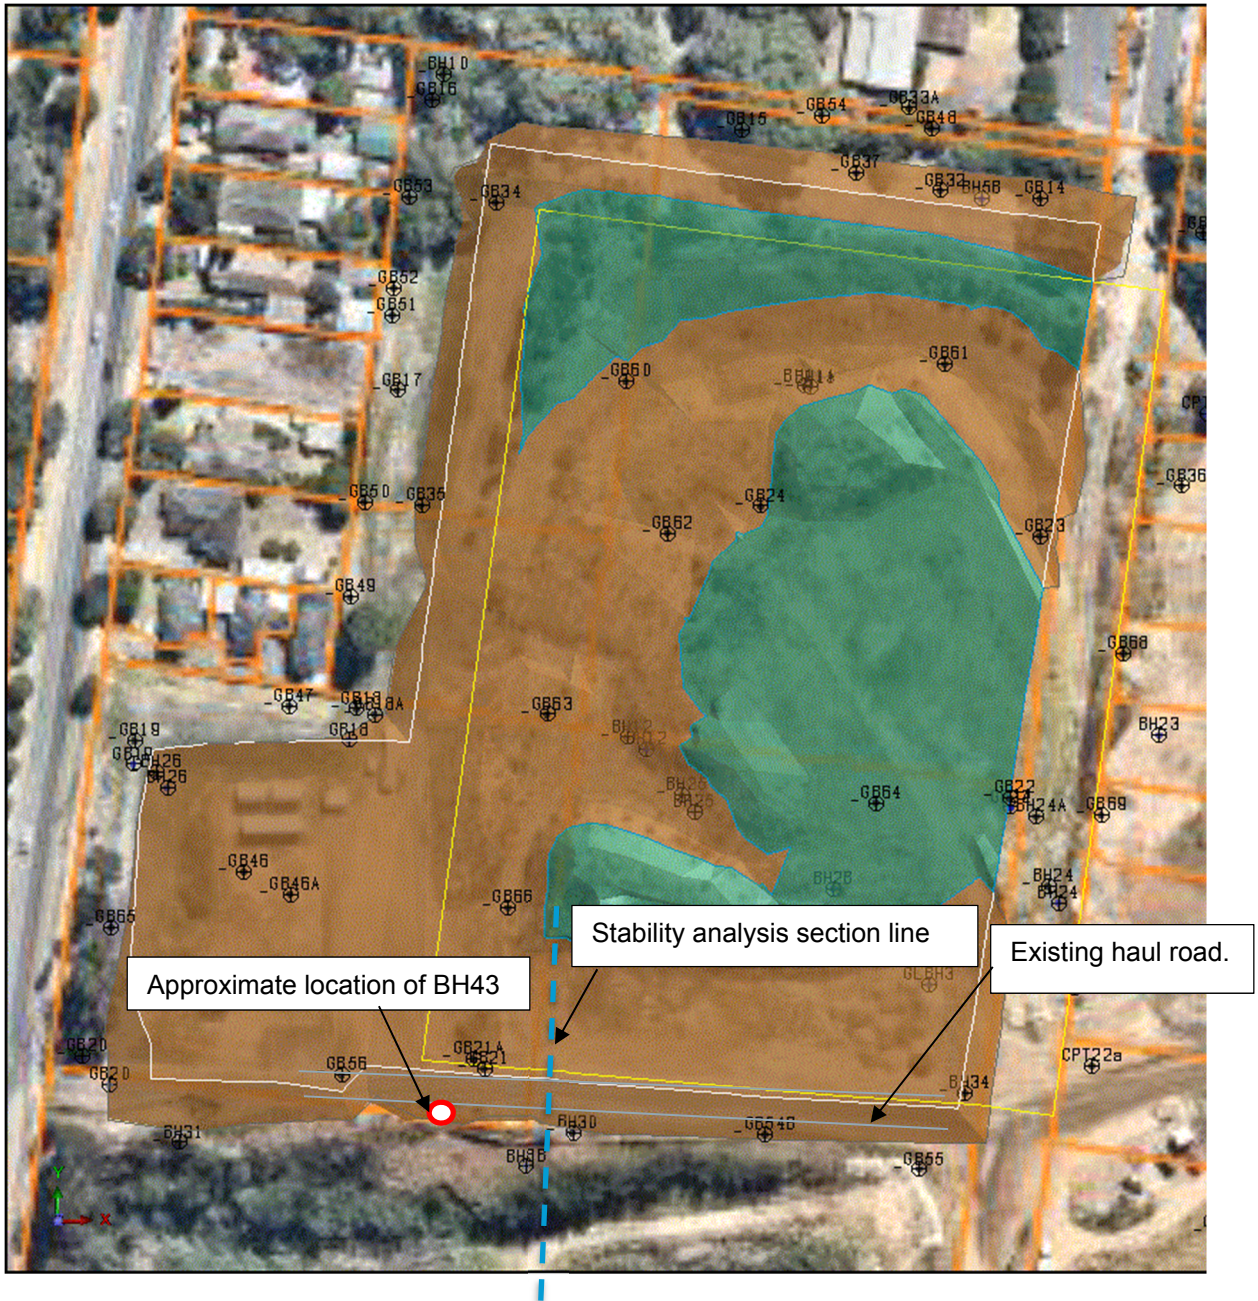
Figure 3 - Zone 1 proposed preload extending to the crest of the Zone 4 north batter

The stability assessment described above indicates the preload may be constructed to the southern side of the existing gravel track with a 3H:1V batter slope with a FOS of 1.3. The edge of the existing track varies between 3m and 5.7m from the crest of the north wall of the pit. We recommend that the track be modified to maintain a 4m exclusion zone in accordance with the backfill design report (GEOTABTF09257AA-AQ-Rev11).

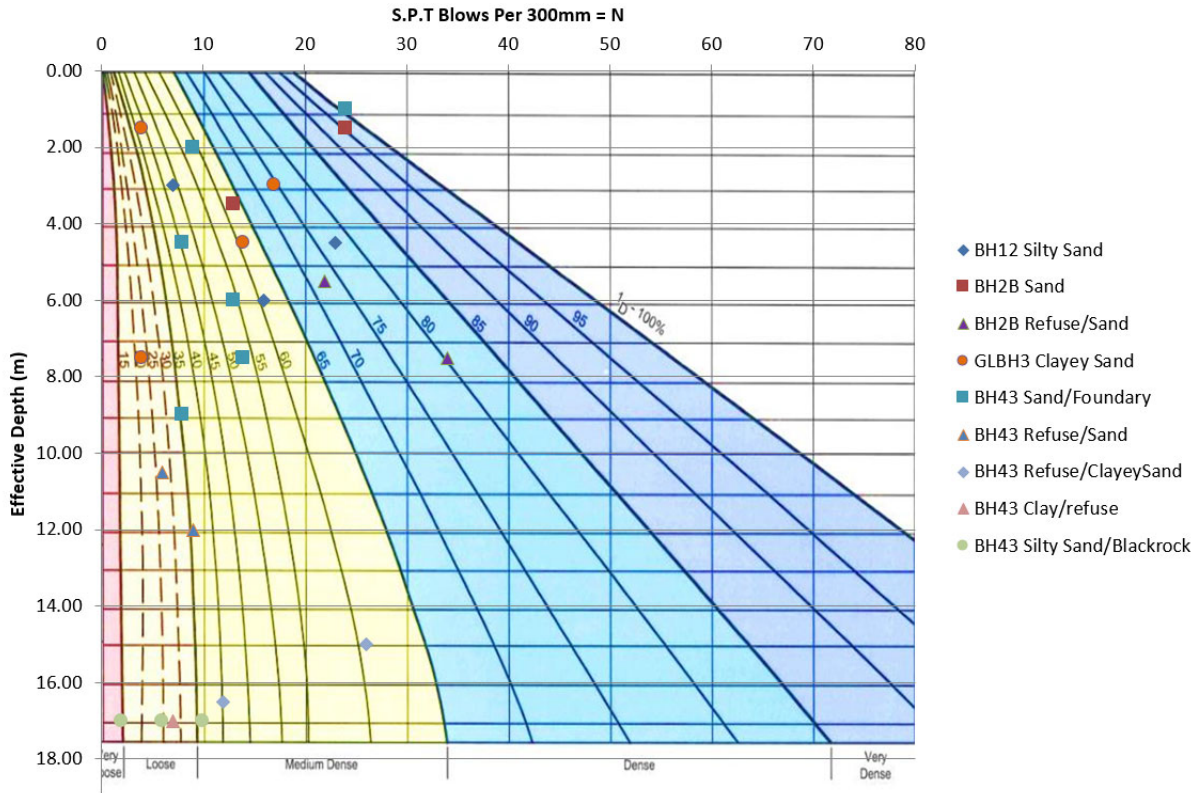
Figure 4 - Standard Penetration Test (SPT) results
