Huntingdale Estate Nominees Pty Ltd

Construction Environmental Management Plan

Huntingdale Estate, 1221 to 1249 Centre Road and 22 Talbot Avenue, Oakleigh South, VIC

01 May 2020

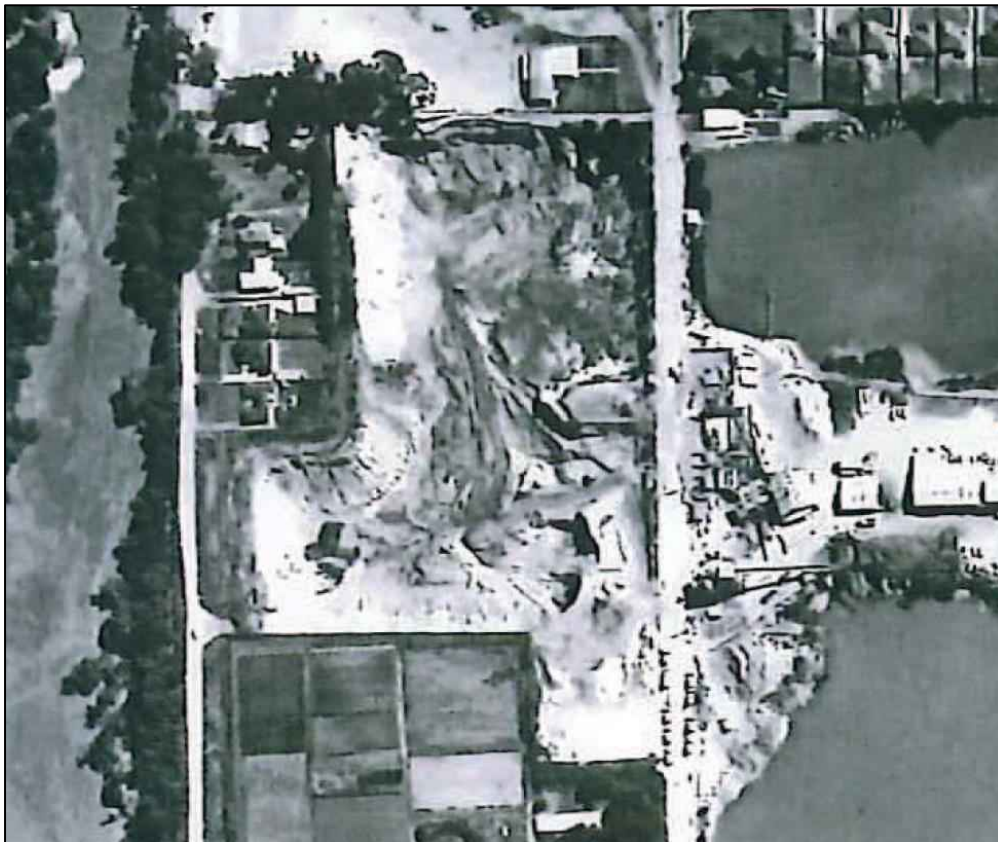
Plate 1 - Aerial photograph of Zone 1 from October 1970

The 1970 aerial photograph shown in Plate 1 was taken during quarrying which shows the footprint of the Zone 1 pit (Zone 1 was filled with refuse in 1972-1975). The offset distance from the crest of the pit batter to the western boundary has been estimated from the aerial photograph to be approximately 10 m – 15 m. The northern boundary appears to have only a narrow crest to boundary off-set.

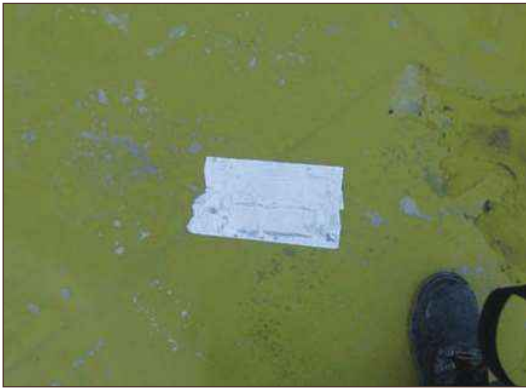
Finished gas membrane on plot 36

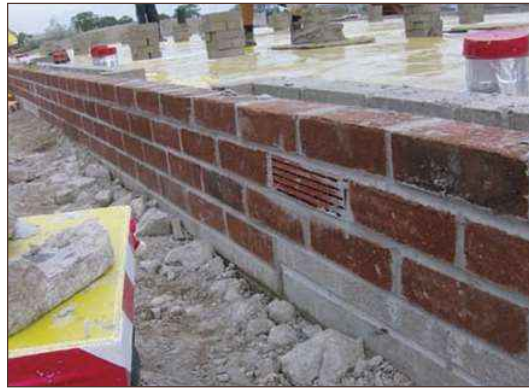
Finished gas membrane on plot 37

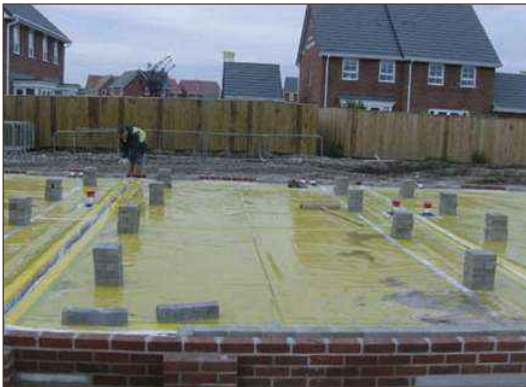
Patch over puncture

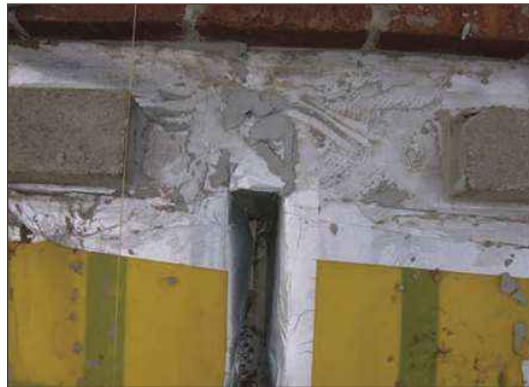
Cavity tray

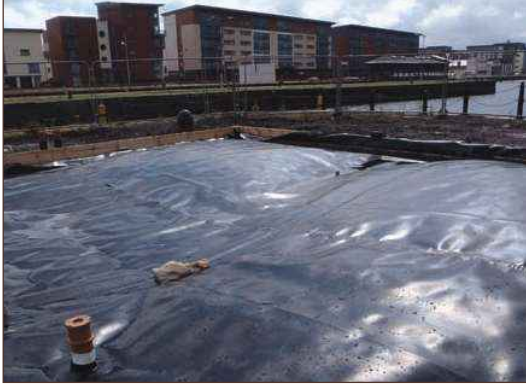
Gas membrane showing air/gas mixture pressurised

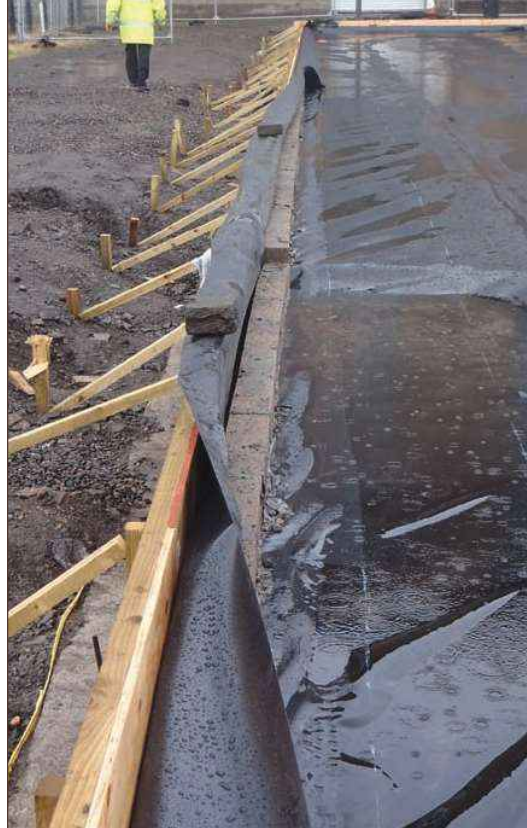
Edge detail showing one course of block work to seal
