**ENVIRONMENTAL AUDIT OF THE NORTHERN PORTION
OF LOT 1 ON PS419739 AT 1213 – 1217 CENTRE ROAD,
OAKLEIGH SOUTH, VICTORIA**

EPA CARMS NO: 41385-2

**ENVIRONMENTAL EARTH SCIENCES VIC
REPORT TO CITY OF MONASH
APRIL 2011**

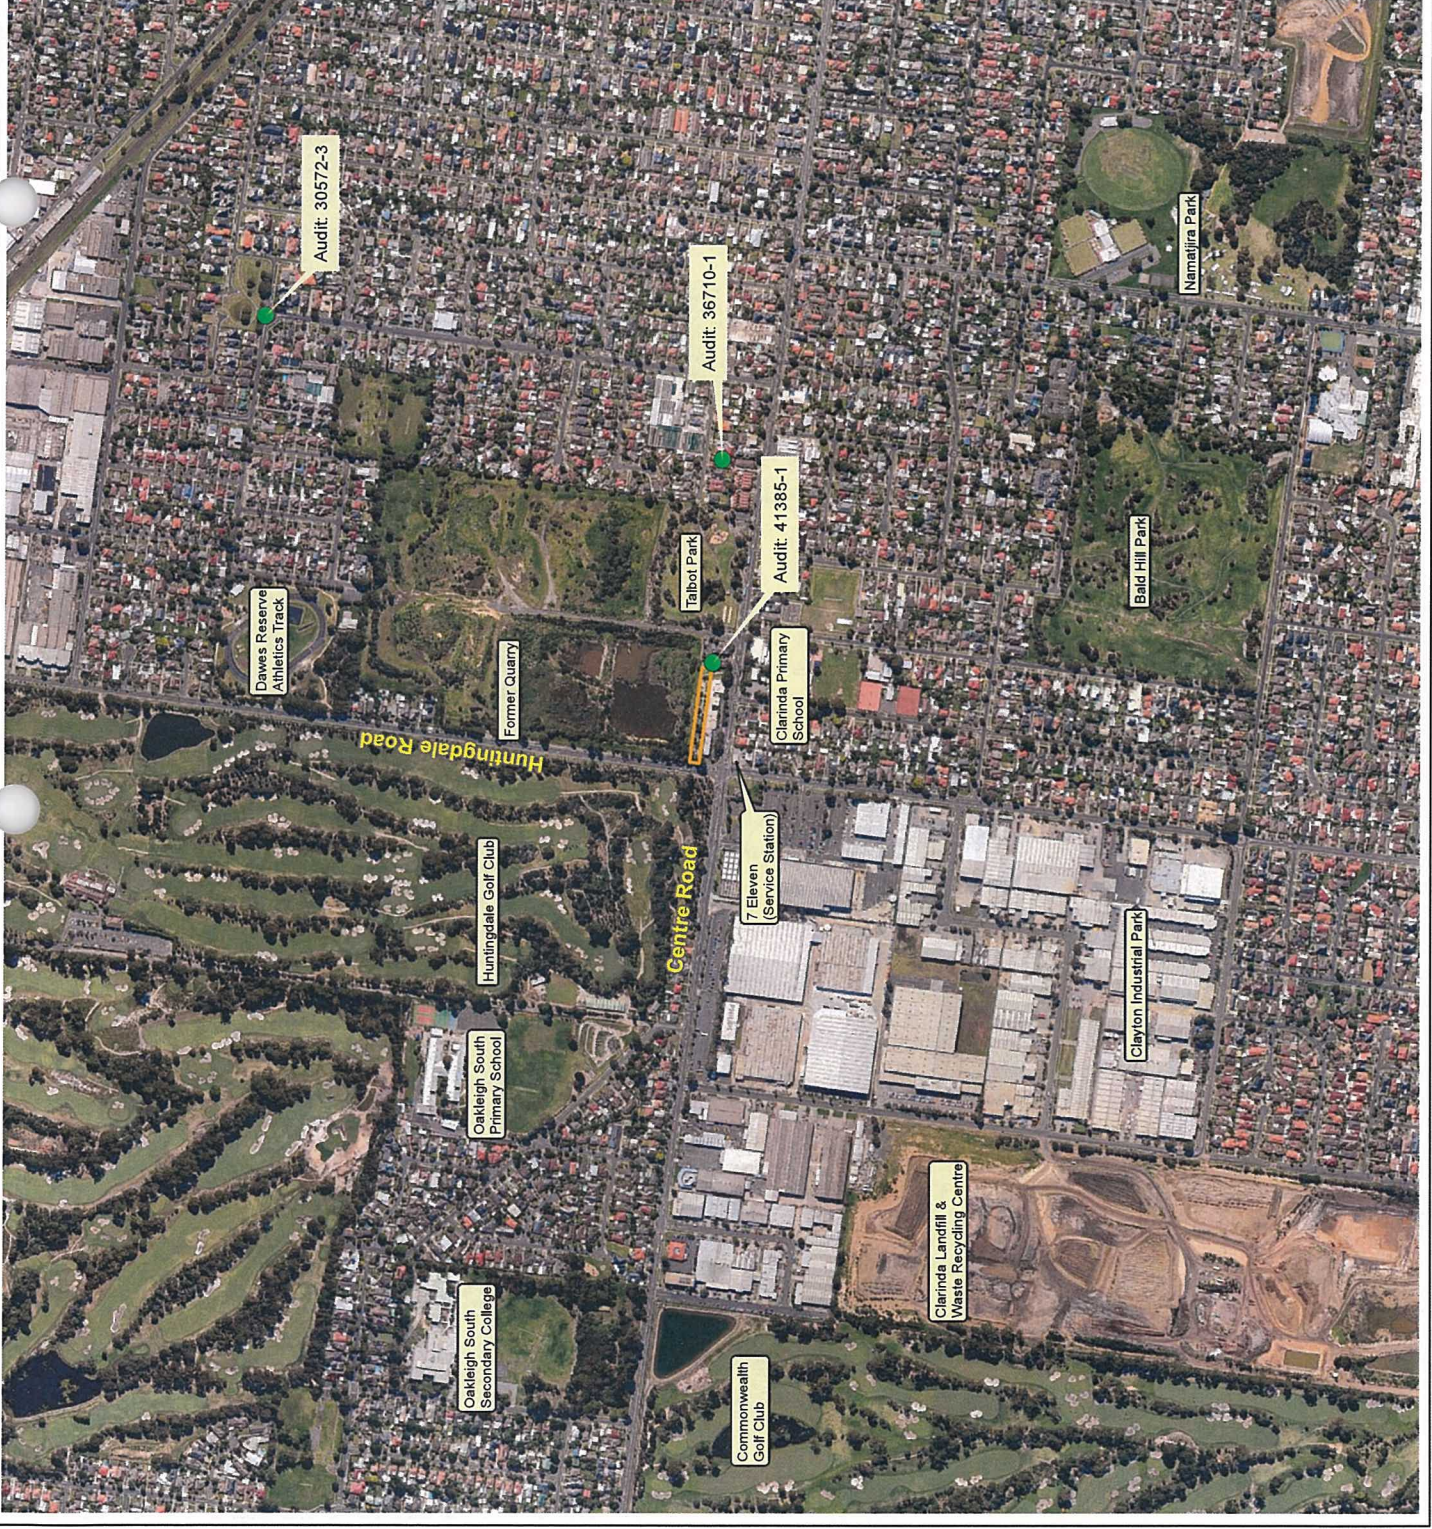
| Proj Man: AS | Date: Apr 2011 | Figure 2 |

- Site Boundary
- Audit Locations

Based on the Auditor's site inspection, the site is situated in an area containing a mixture of land uses. Please refer to Figure 2 for details. The following land uses were observed in the surrounding area:
