Expert Witness Report of Mr Phil Sinclair

Re: Monash Planning Scheme Amendment C129

28 July 2017

Expert Report of Mr Phillip Sinclair
Re: Monash Planning Scheme Amendment C129

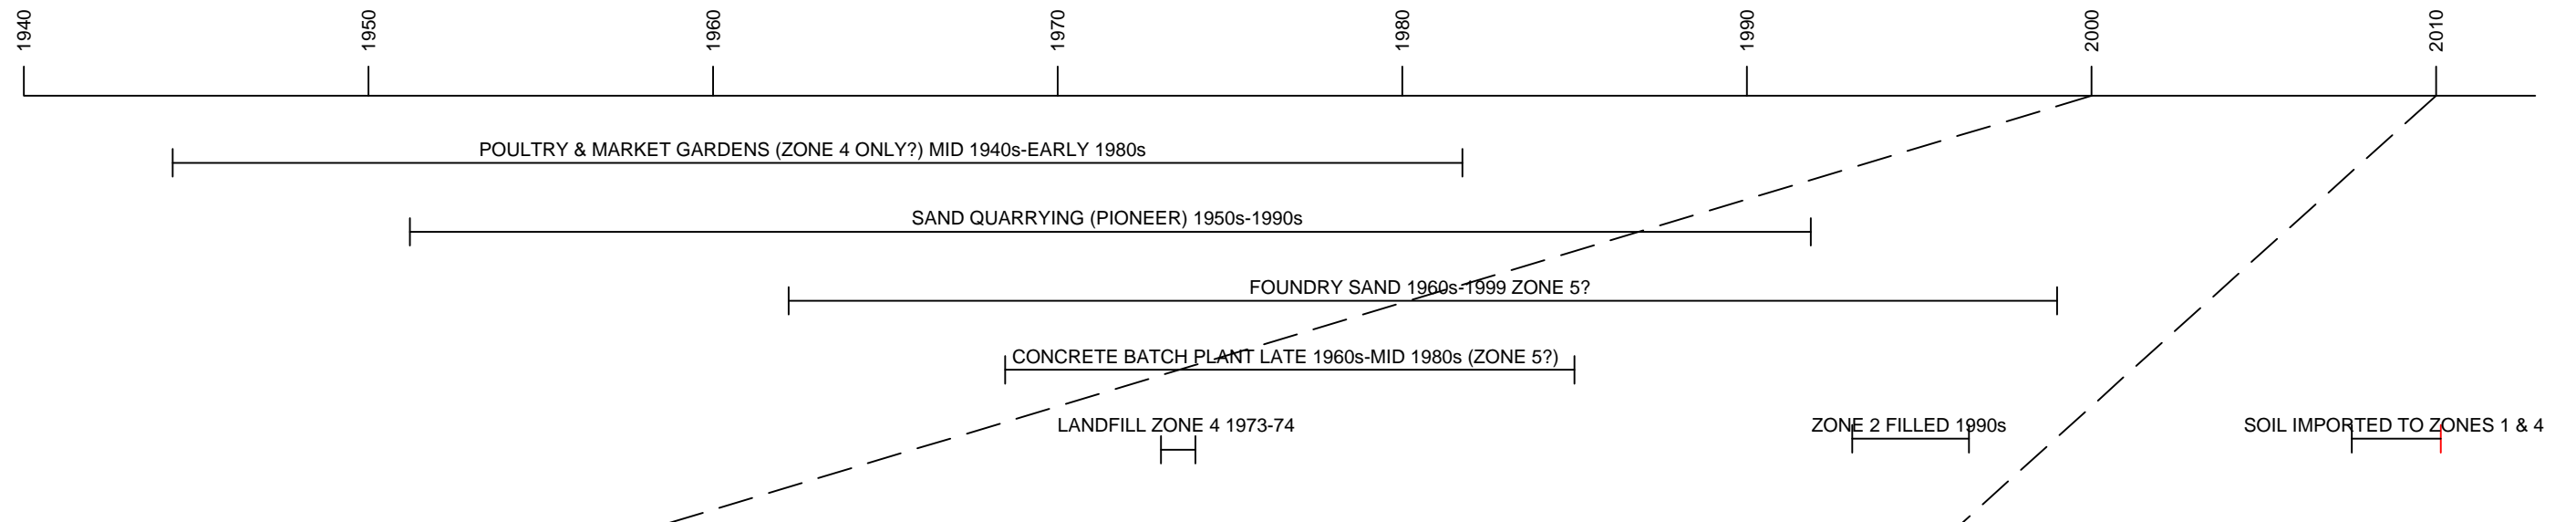
client:	NORTON ROSE FULBRIGHT AUSTRALIA		
project:	EXPERT REPORT OF MR PHIL SINCLAIR MONASH PLANNING SCHEME AMENDMENT C129		
title:	TIMELINE OF SITE HISTORY & SITE INVESTIGATIONS		
project no:	ENAUABTF00751AC-R01	figure no:	FIGURE 3
		rev:	A

SITE USE HISTORY

INVESTIGATION TIMELINE

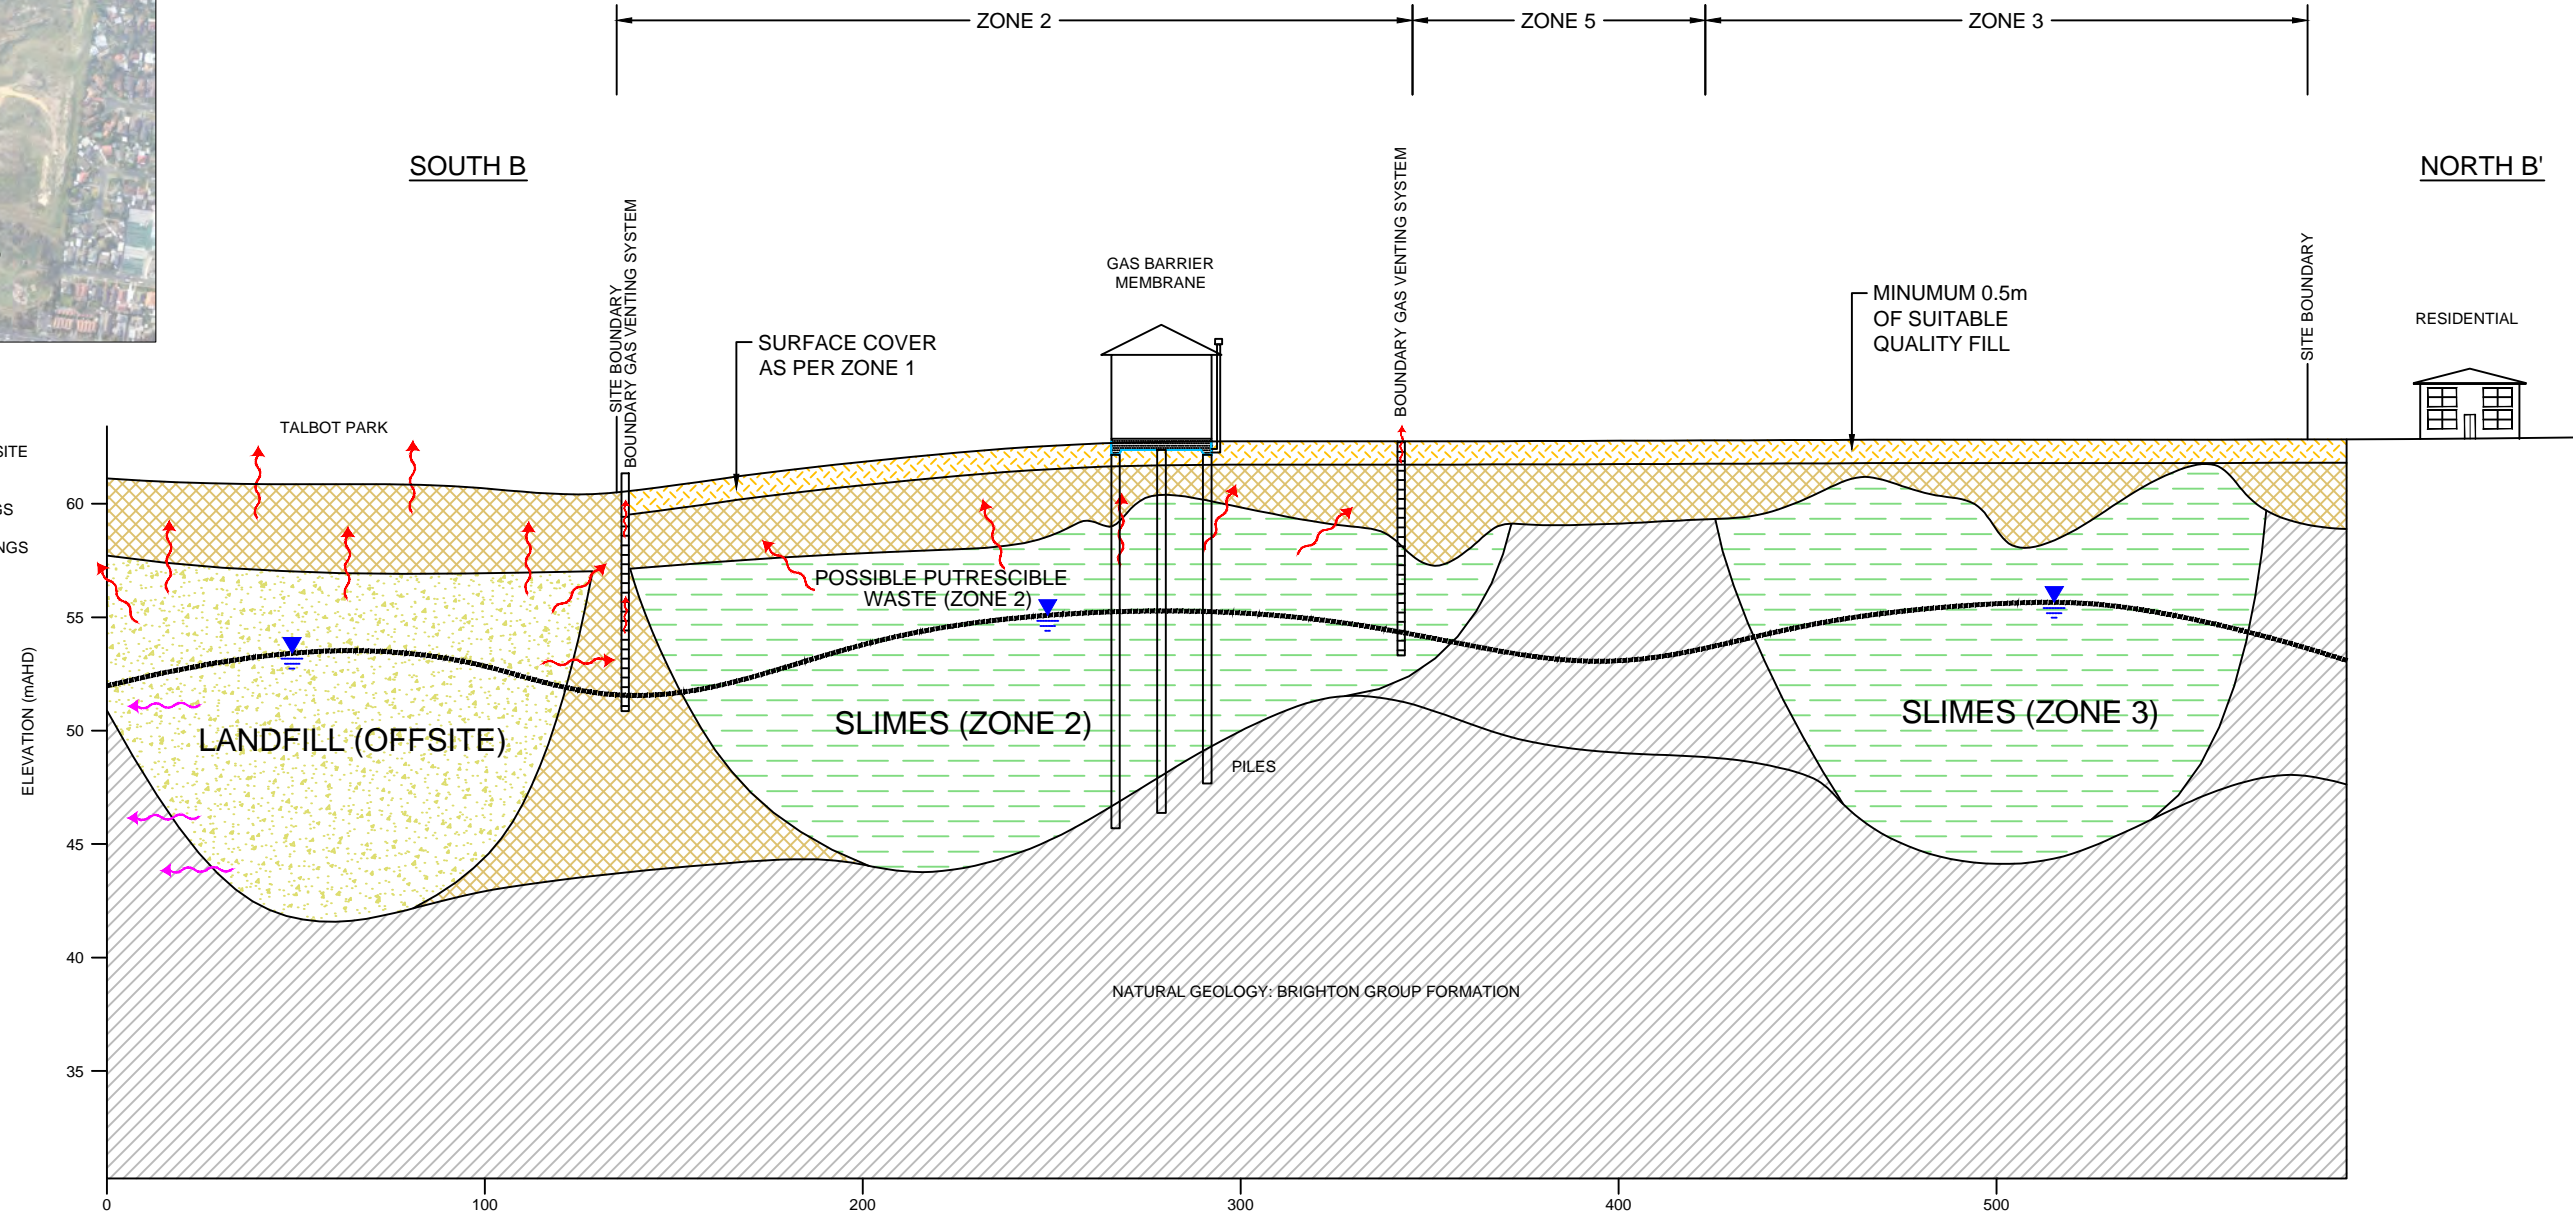
client:	NORTON ROSE FULBRIGHT AUSTRALIA		
project:	EXPERT REPORT OF MR PHIL SINCLAIR MONASH PLANNING SCHEME AMENDMENT C129		
title:	ZONES 2, 3 & 5 CONCEPTUAL DESIGN GAS MITIGATION		
project no:	ENAUABTF00751AC-R01	figure no:	FIGURE 10C
rev:	A

- LANDFILL GAS TREATMENT OPTIONS:**
1. REMOVE LANDFILL WASTE FROM SITE
 2. AREA-WIDE GAS BARRIER AND BOUNDARY VENTING
 3. VOID VENTING BENEATH BUILDINGS WITH BOUNDARY VENTING
 4. GAS MEMBRANE BENEATH BUILDINGS WITH BOUNDARY VENTING

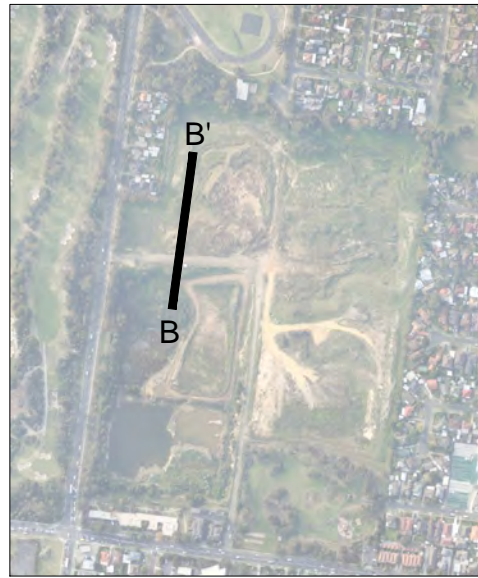
CONCEPT DESIGN FOR
'LOW' GAS HAZARD POTENTIAL

CONCEPT DESIGN FOR
'MODERATE' GAS HAZARD POTENTIAL

CONCEPT DESIGN FOR
'MODERATE TO HIGH' GAS HAZARD POTENTIAL

NOTES:
1. CONCEPT DESIGN FOR MODERATE GAS HAZARD POTENTIAL MAY ALSO BE ADOPTED AS PART OF BOUNDARY PROTECTION MEASURES WHERE GAS HAZARD POTENTIAL IS LOW

DRAINAGE LAYER (REFER TO
 ZONE 4 BACKFILL DESIGN REPORT)
