Talbot Village, Oakleigh South

Domain 4 Batter Stability Assessment Report

Reference: 754-GEOTABTF09257AA-EG

21 September 2021

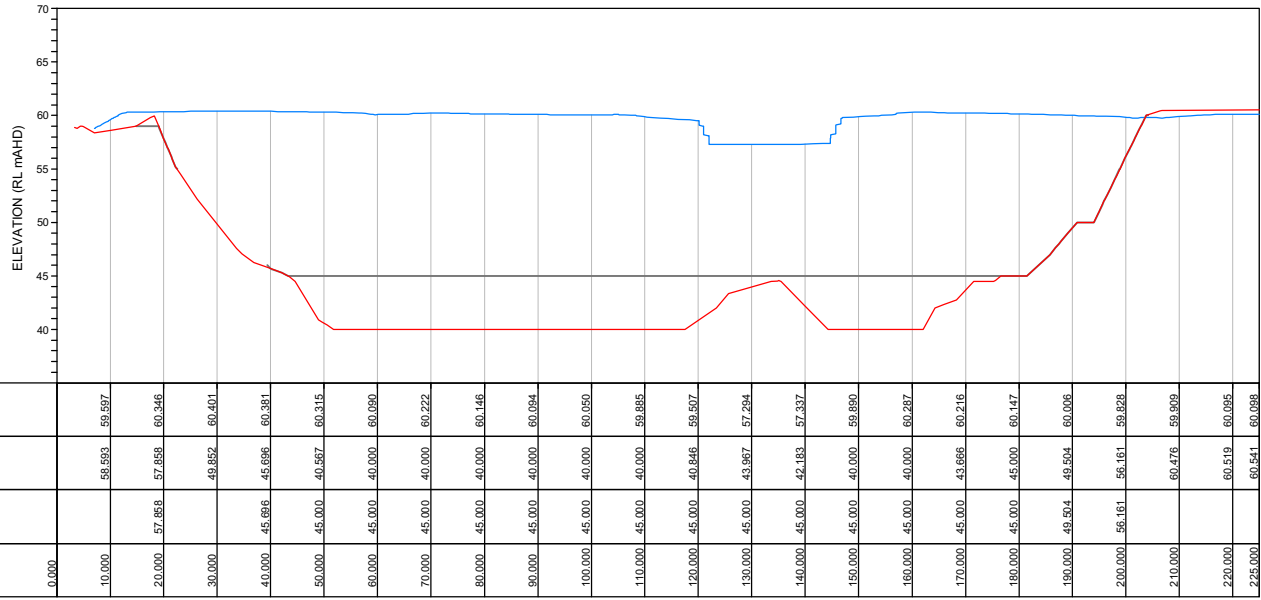
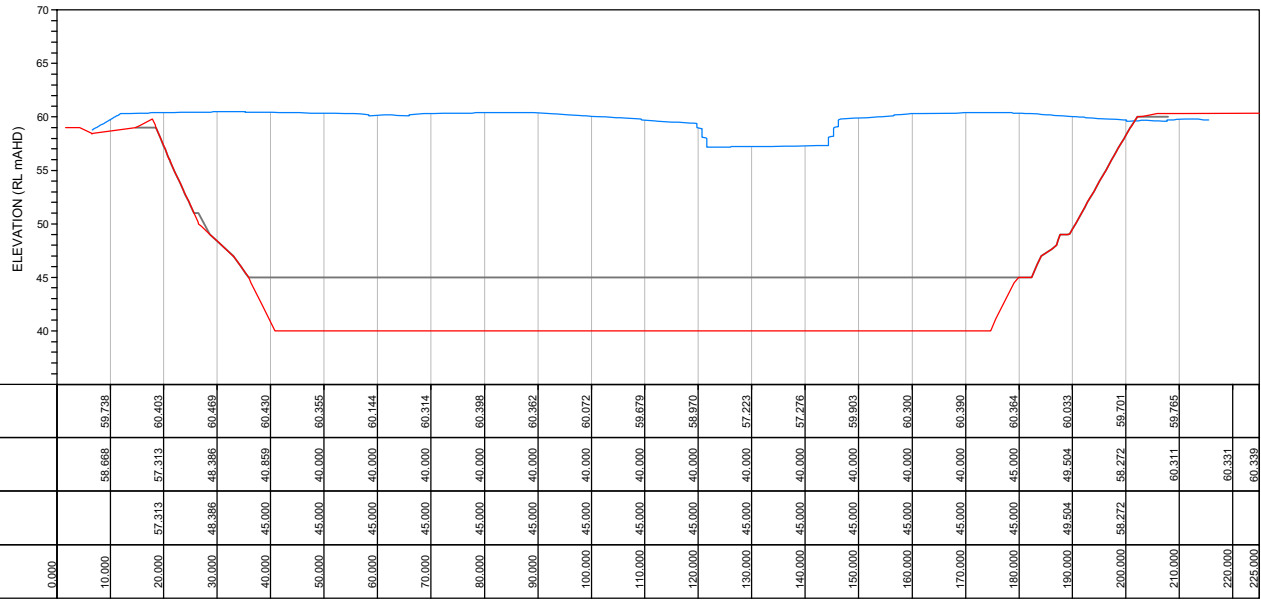
The survey information has been used to generate a series of sections through Domain 4 as shown on Figure 3. Typical quarry pit batters are shown on east west sections G-G' and H-H' in Figure 4 and M-M' and O-O' in Figure 5. These sections show the location of slimes and uncontrolled fill in the northern half of the site. The slimes and uncontrolled fill will be removed and replaced with engineered fill to create an engineered fill platform up to 20m thick to reach the proposed design surface level of approximately RL 60m.

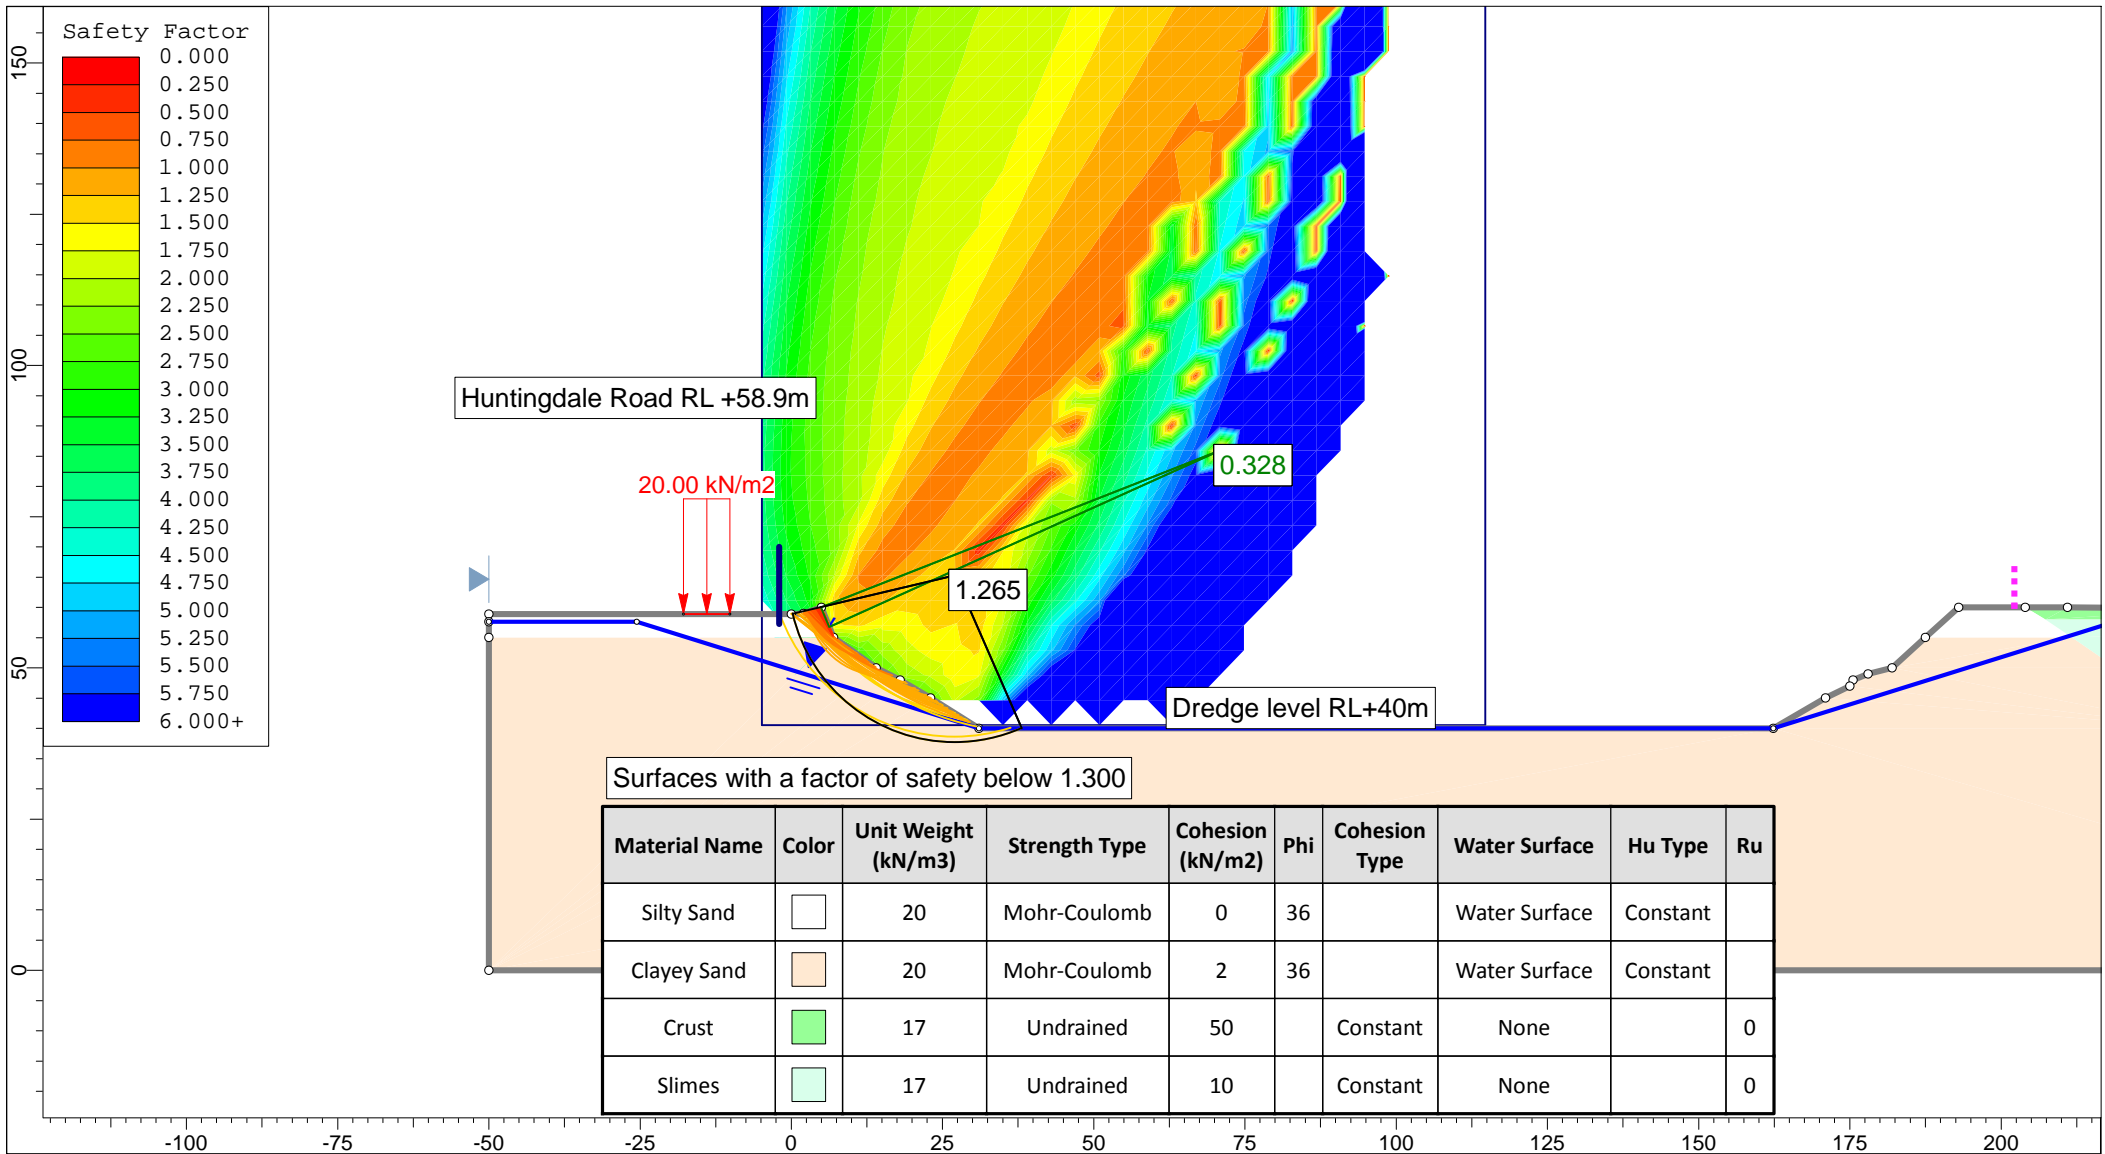
Project				Huntingdale Estate, Oakleigh, Victoria			
	Analysis Description				West batter - Back analysis - Shallow			
	Drawn By		Scale		Company			
	Date		File Name					
		CB		1:1250		Talbot Road Finance Pty Ltd		
		14/01/2015, 2:17:49 PM		WEST Figure A1.slim

The results of the back analysis of the western batters are presented in Figure A1 which are based on an assumed conservative groundwater profile extending rising from the base of the quarry to close to Huntingdale Road level about 25m back from the site boundary. A FOS of 1.06 was obtained for a shallow failure in the upper 10m of the slope using the friction angle of 36° for the sands and a cohesion of 2 kPa for the clayey sands. The result of this analysis gave geotechnical strength parameters which we consider represent conservative values for the materials. These strength parameters are presented in Table 1 together with the results of assessment.

Figures A1 to A3 in Appendix A show the results of an assessment of the western batter using the geotechnical parameters which were derived from the back analysis in Figure A1. A loading of 20kN was included to simulate the potential traffic loading from Huntingdale Road. It is noted that there is an over-steep section at the top of the batter which should be remediated prior to placement of fill within the excavation. Figure A2 shows the FOS for global stability for a failure surface within the site is marginally below 1.3. Figure A3 shows the FOS for a failure surface which would impact Huntingdale Road is 1.41.

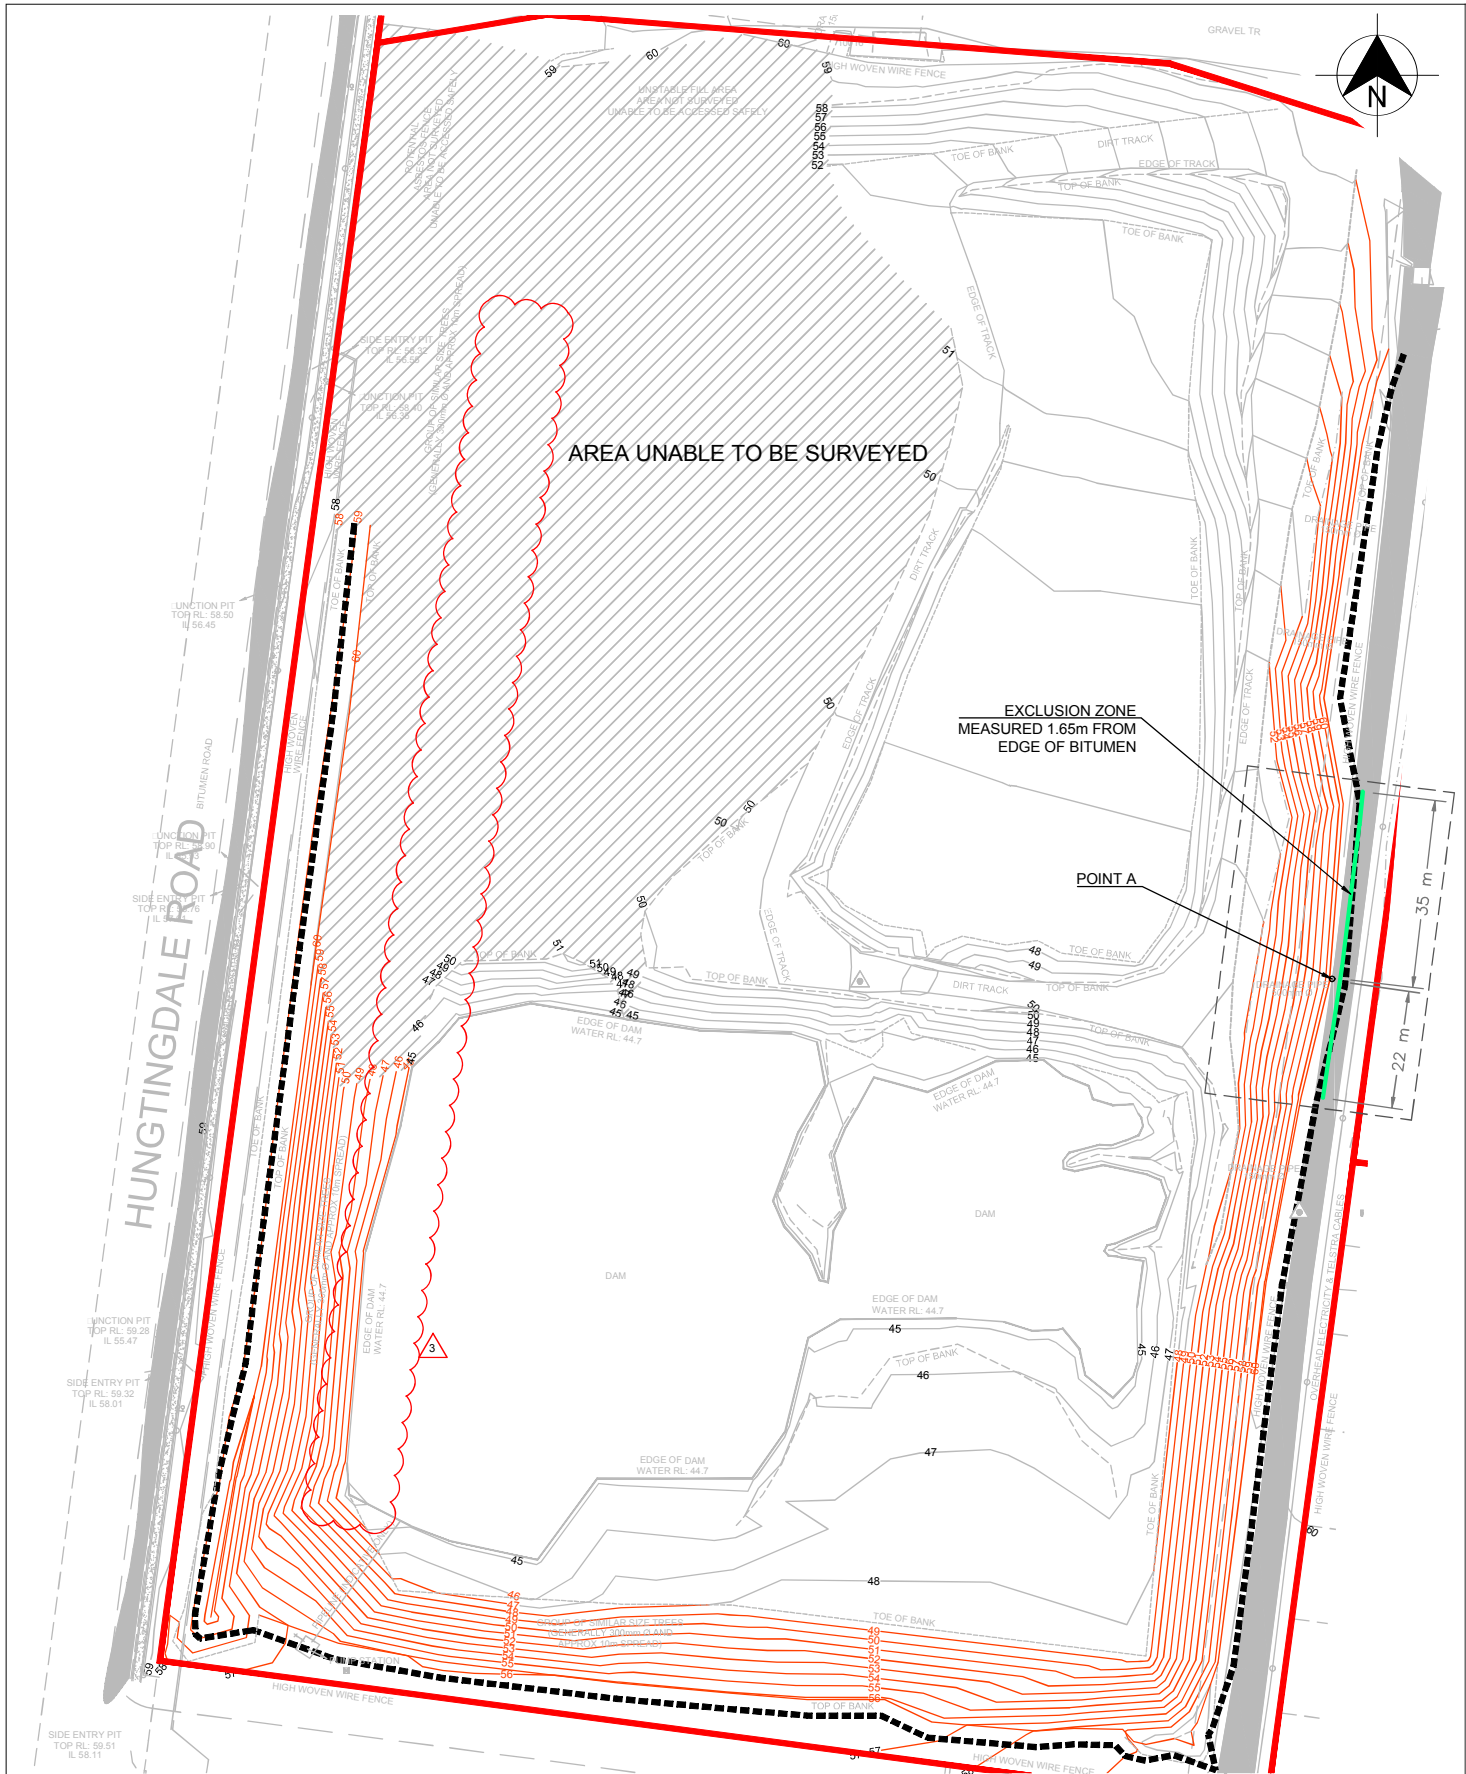
client:	TALBOT ROAD FINANCE PTY LTD
project:	Domain 4 Batter Stability HUNTINGDALE ESTATE, OAKLEIGH SOUTH
title:	EXCLUSION ZONE AT EASTERN BATTER
project no:	GEOTABTF09257AA
figure no:	B6

- An exclusion zone of minimum 4m from the crest of the batter should be maintained throughout the construction of the fill platform in Domain 4. It is noted that this is based on the assessed section of the eastern batter which is the steepest. A reduced exclusion zone may be considered for other parts of the site but specific assessment would be required. A plan showing the exclusion zone is presented in Figure B6 in Appendix B.

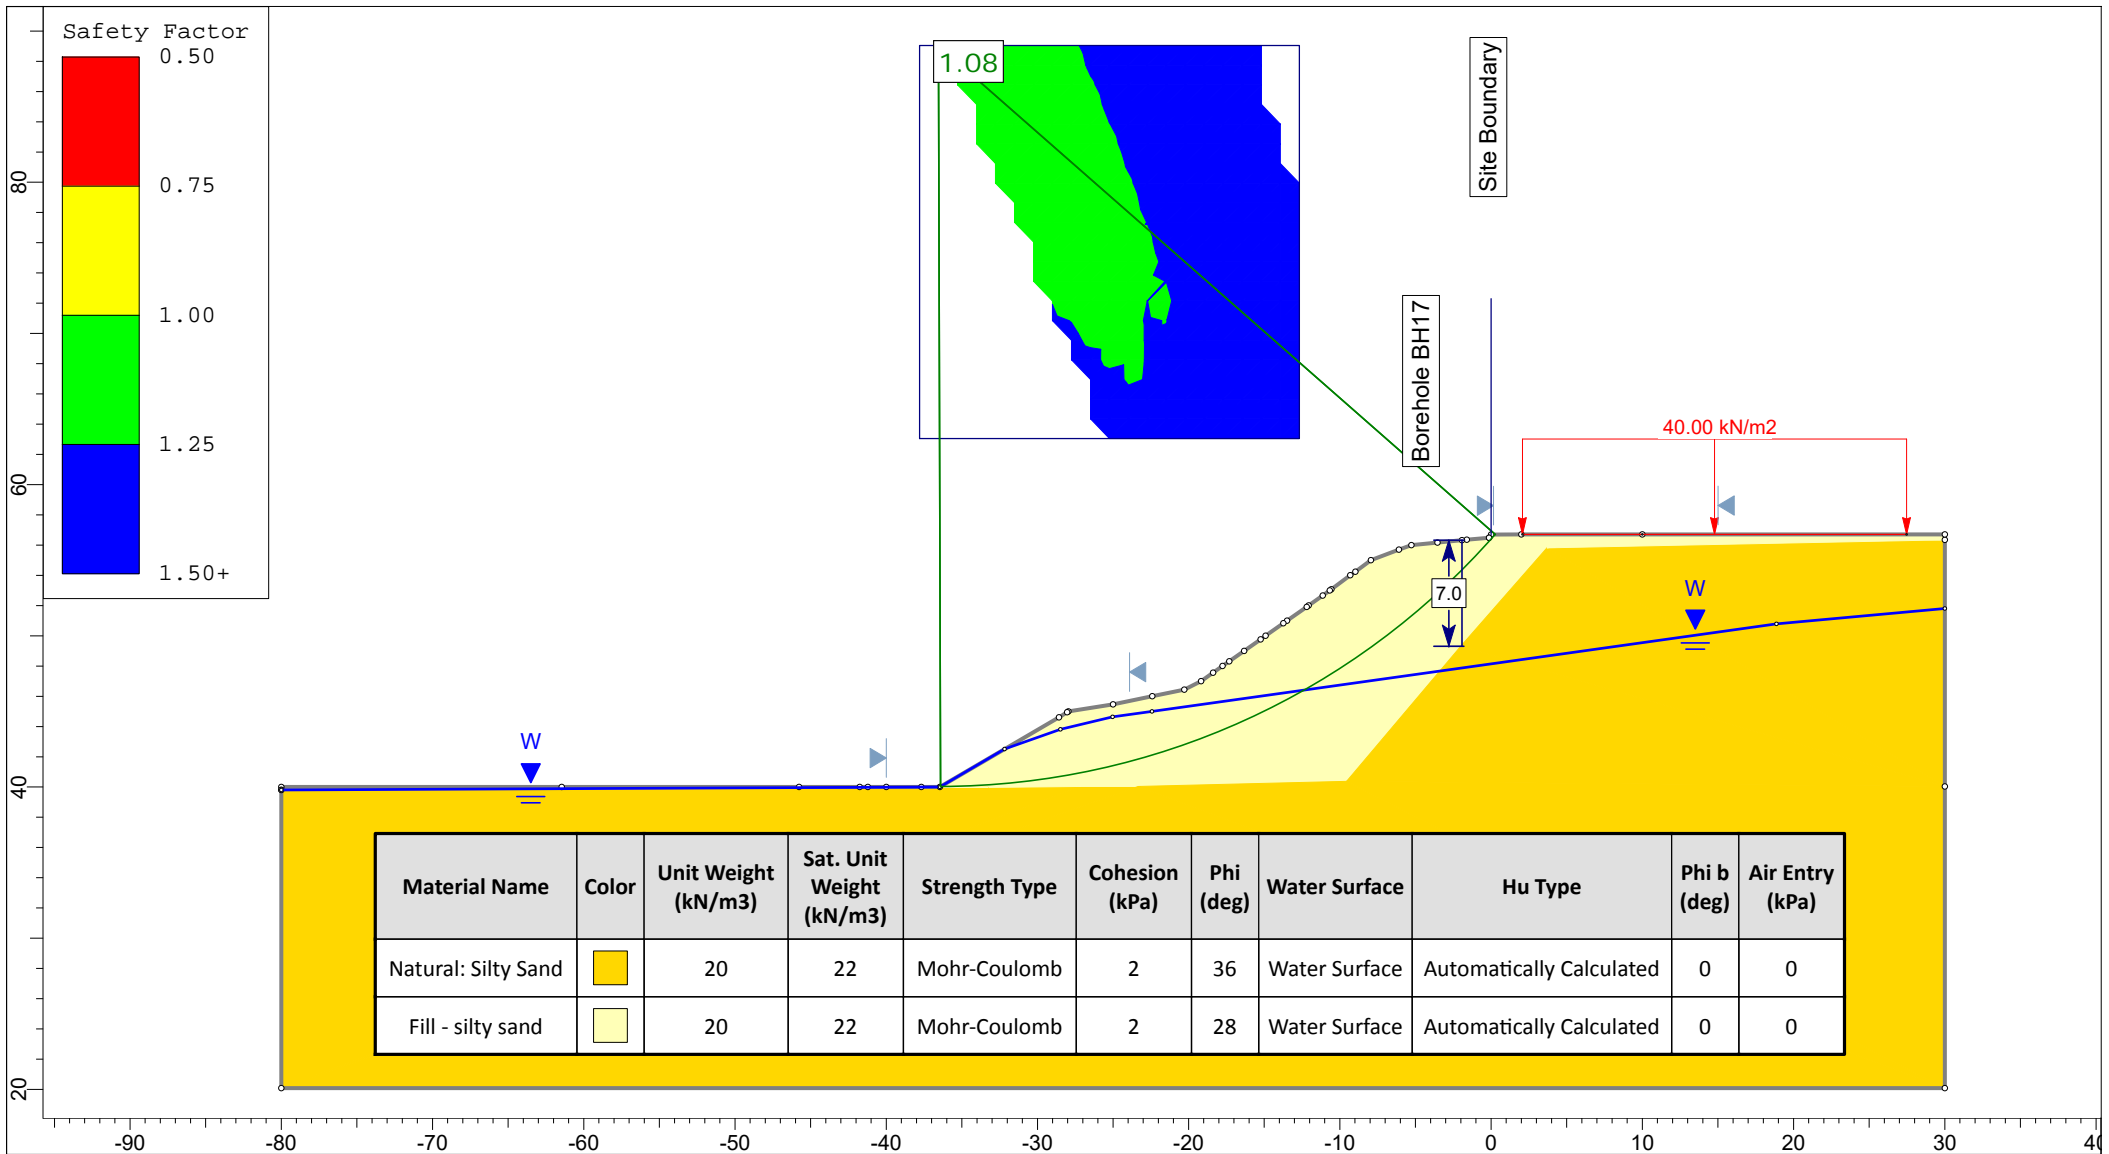
<i>Project</i>		Huntingdale Estate, Oakleigh	
<i>Analysis Description</i>		Domain 4! - Stability of south batter - estimated existing pond water level	
<i>Drawn By</i>	MF	<i>Scale</i>	1:500
<i>Date</i>	11/09/2017	<i>Company</i>	Talbot Road Finance Pty Ltd
		<i>File Name</i>	SOUTH Figure C2.slim

Figure C2 considers a complete slope failure at the site boundary with the fill placed along the southern boundary and the water level at RL45m. The results show a FOS of 1.17 where the failure slip extends near to the southern boundary.

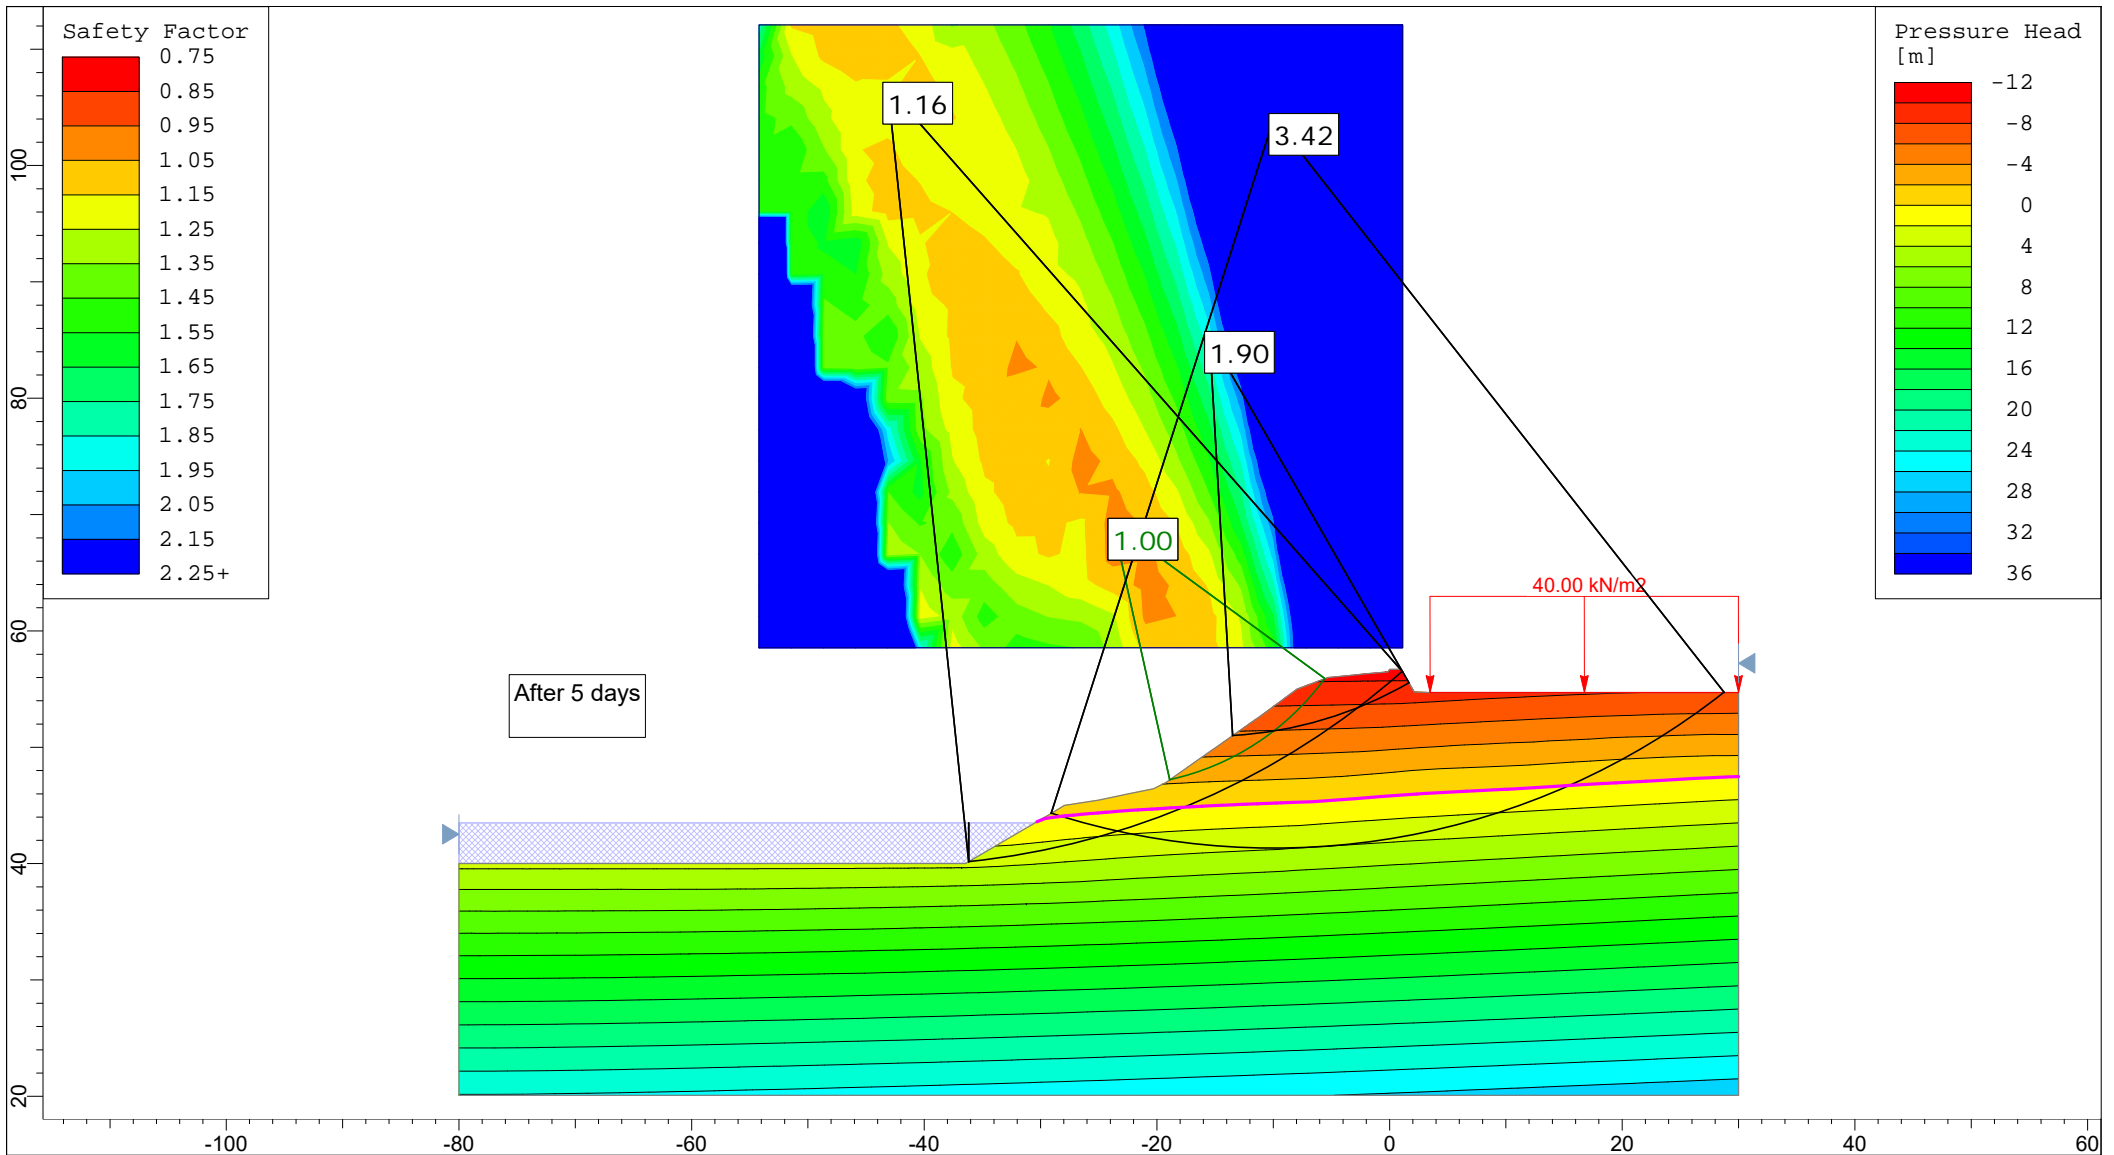
Figure C8b presents the results after 5 days for a drawdown of 0.1m per day. This results in a FOS of 1.16. The FOS after 30 days and 60 days are 1.18 and 1.21 respectively (Figures C8c and C8d). The results indicate that the FOS changes by a few percent (generally less than 2%) during the drawdown process. In all cases the FOS is more than the back-analysed shallow slope failure.
