# **Landfill Gas Risk Assessment**

**52 Golf Road, Oakleigh South,  
Victoria**

**Golf Road Project Development  
February 2021**

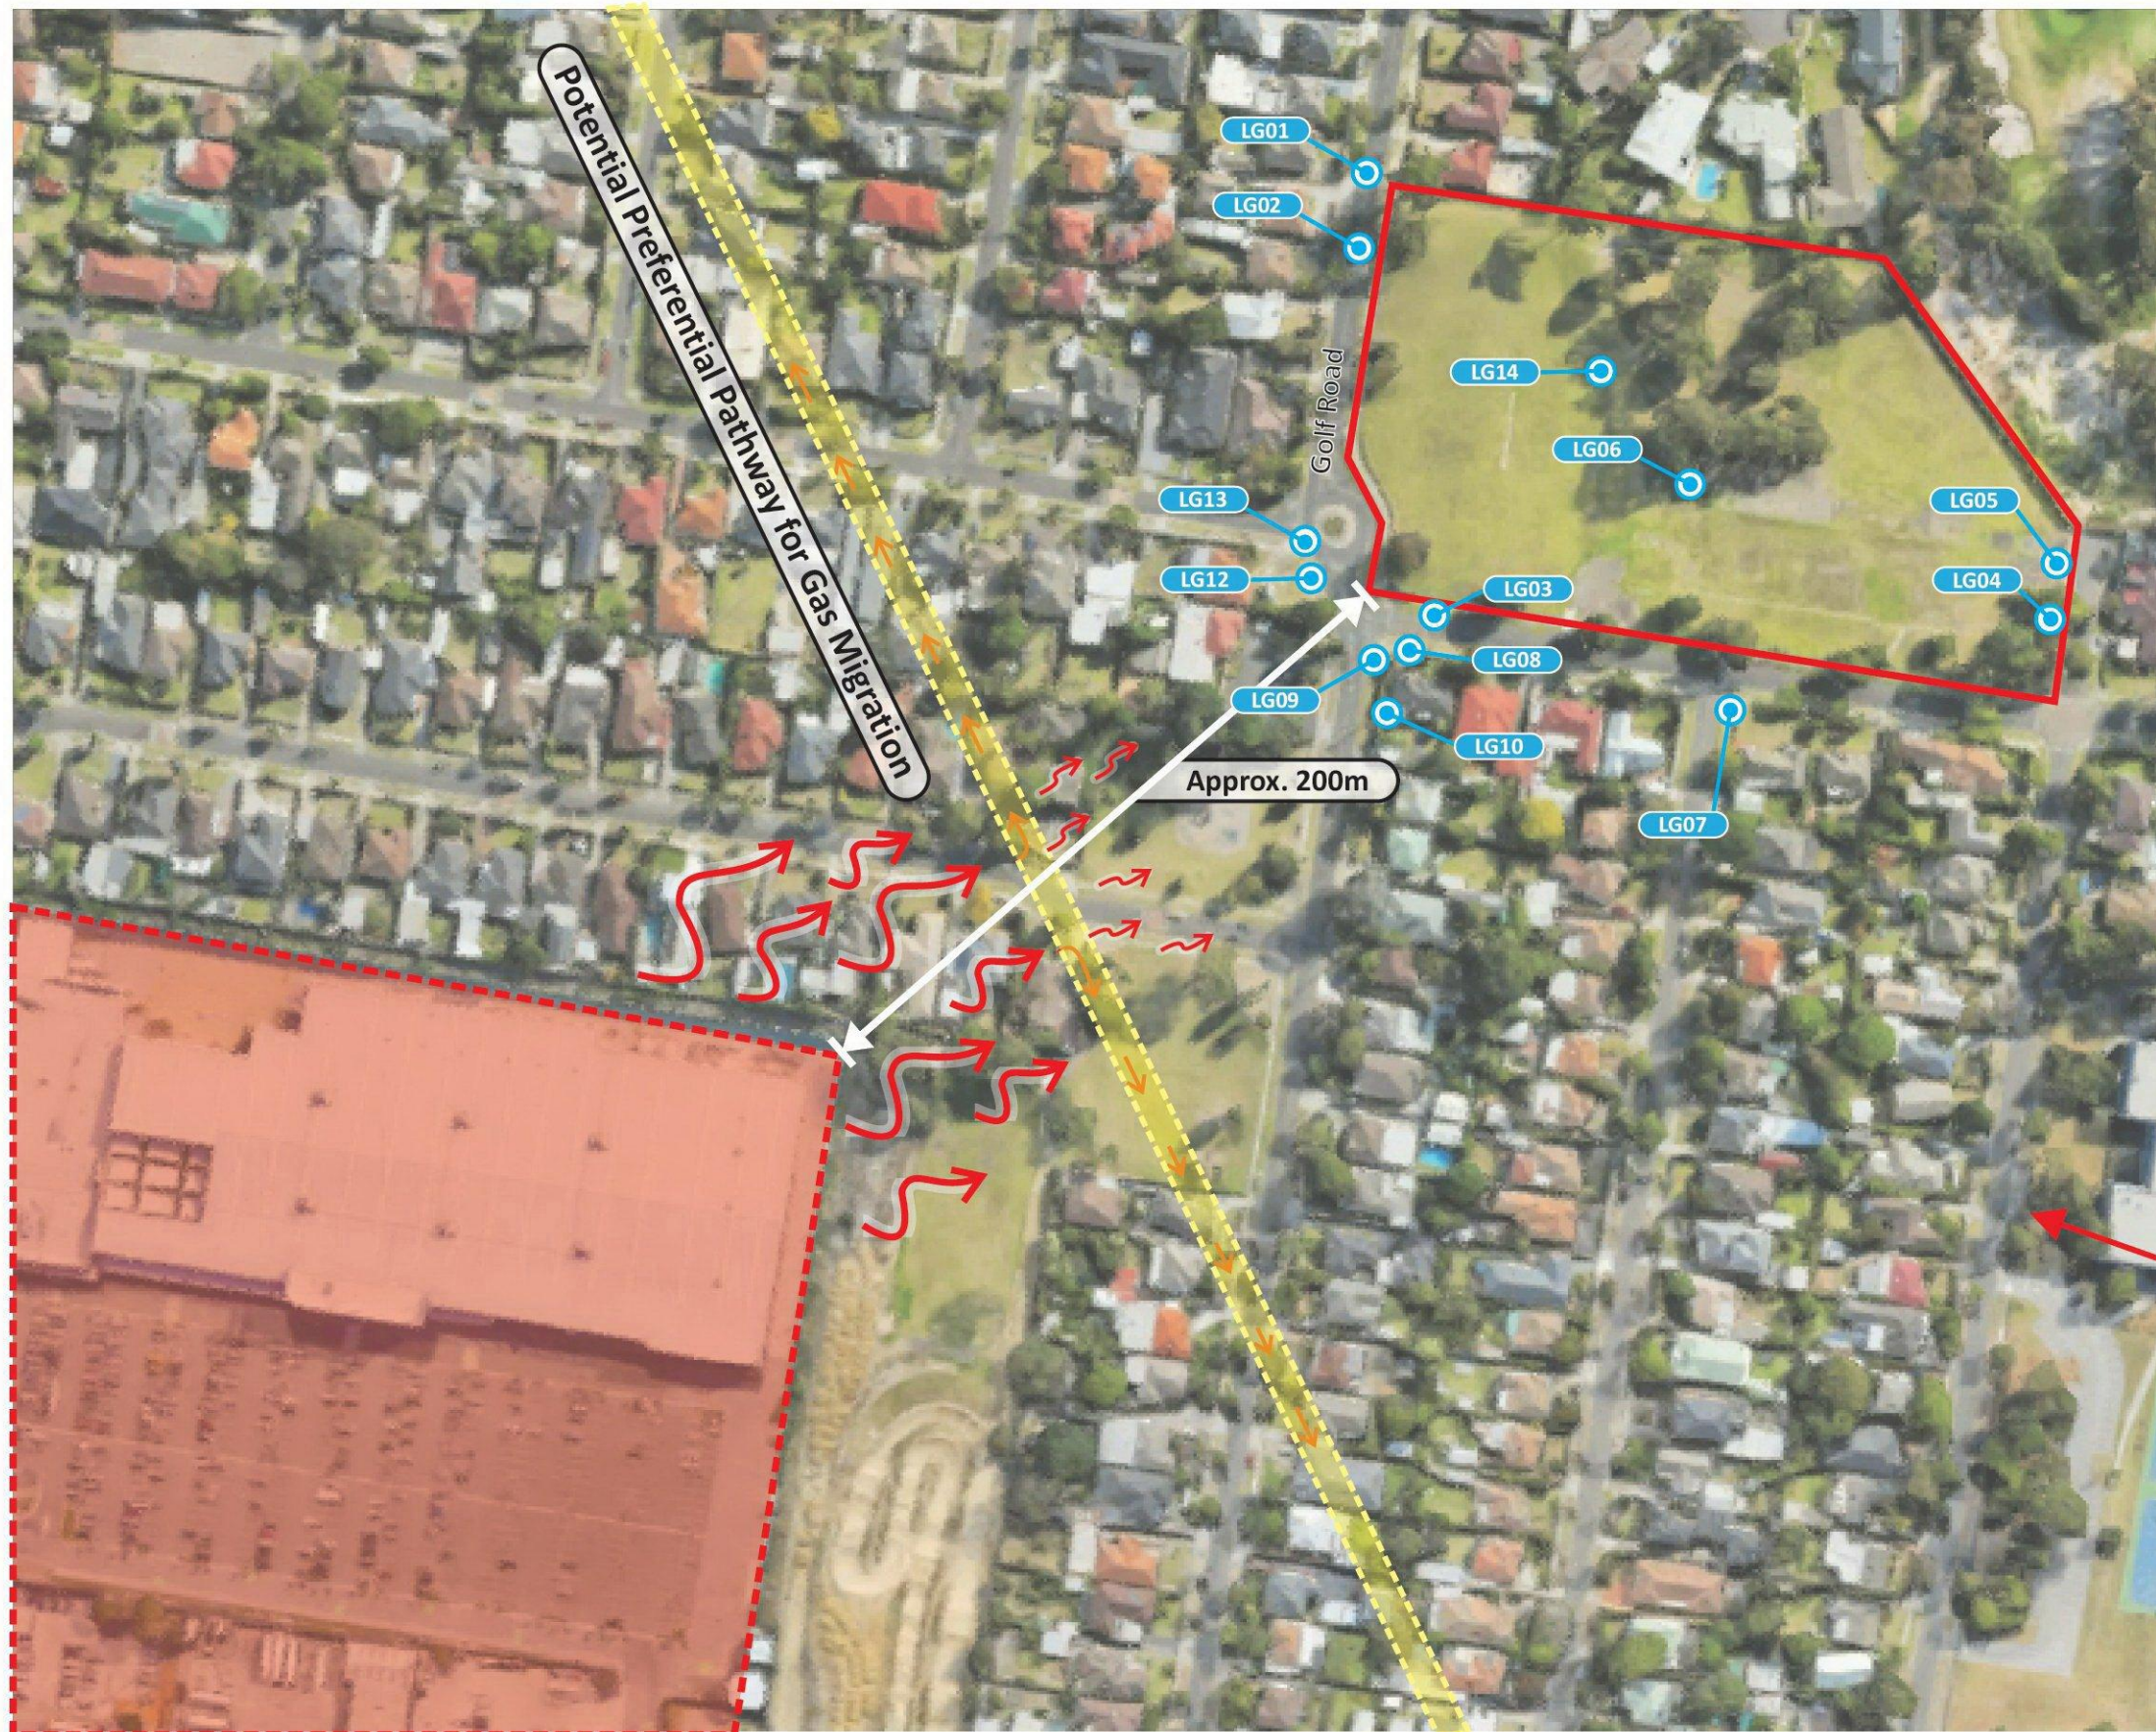
File Name: 37497 LGRA Figure 1			Version: 1
Drawn By: NTA	Checked By: GXM	Date: 23/02/2021	Figure number: 1

# 52 Golf Road, Oakleigh South Conceptual Site Model and Sampling Plan

Not to scale - All locations are approximate

- The Site
- Former Quarry
- Sewer main
- ~ Potential Soil Vapour Migration
- LG Sample location

The monitoring locations are illustrated in the **CSM** attached to this report.

Gas measurements were taken to assess for the presence of landfill related gases on and surrounding the Site. Prior to monitoring of subsurface services, a background reading in ambient air was recorded. A total of fourteen (14) measurements were collected. Specific locations have been illustrated within the **CSM** attached to this report.

Based on the findings of the desktop review, a CSM was developed for the Site (refer to the attached **CSM**).

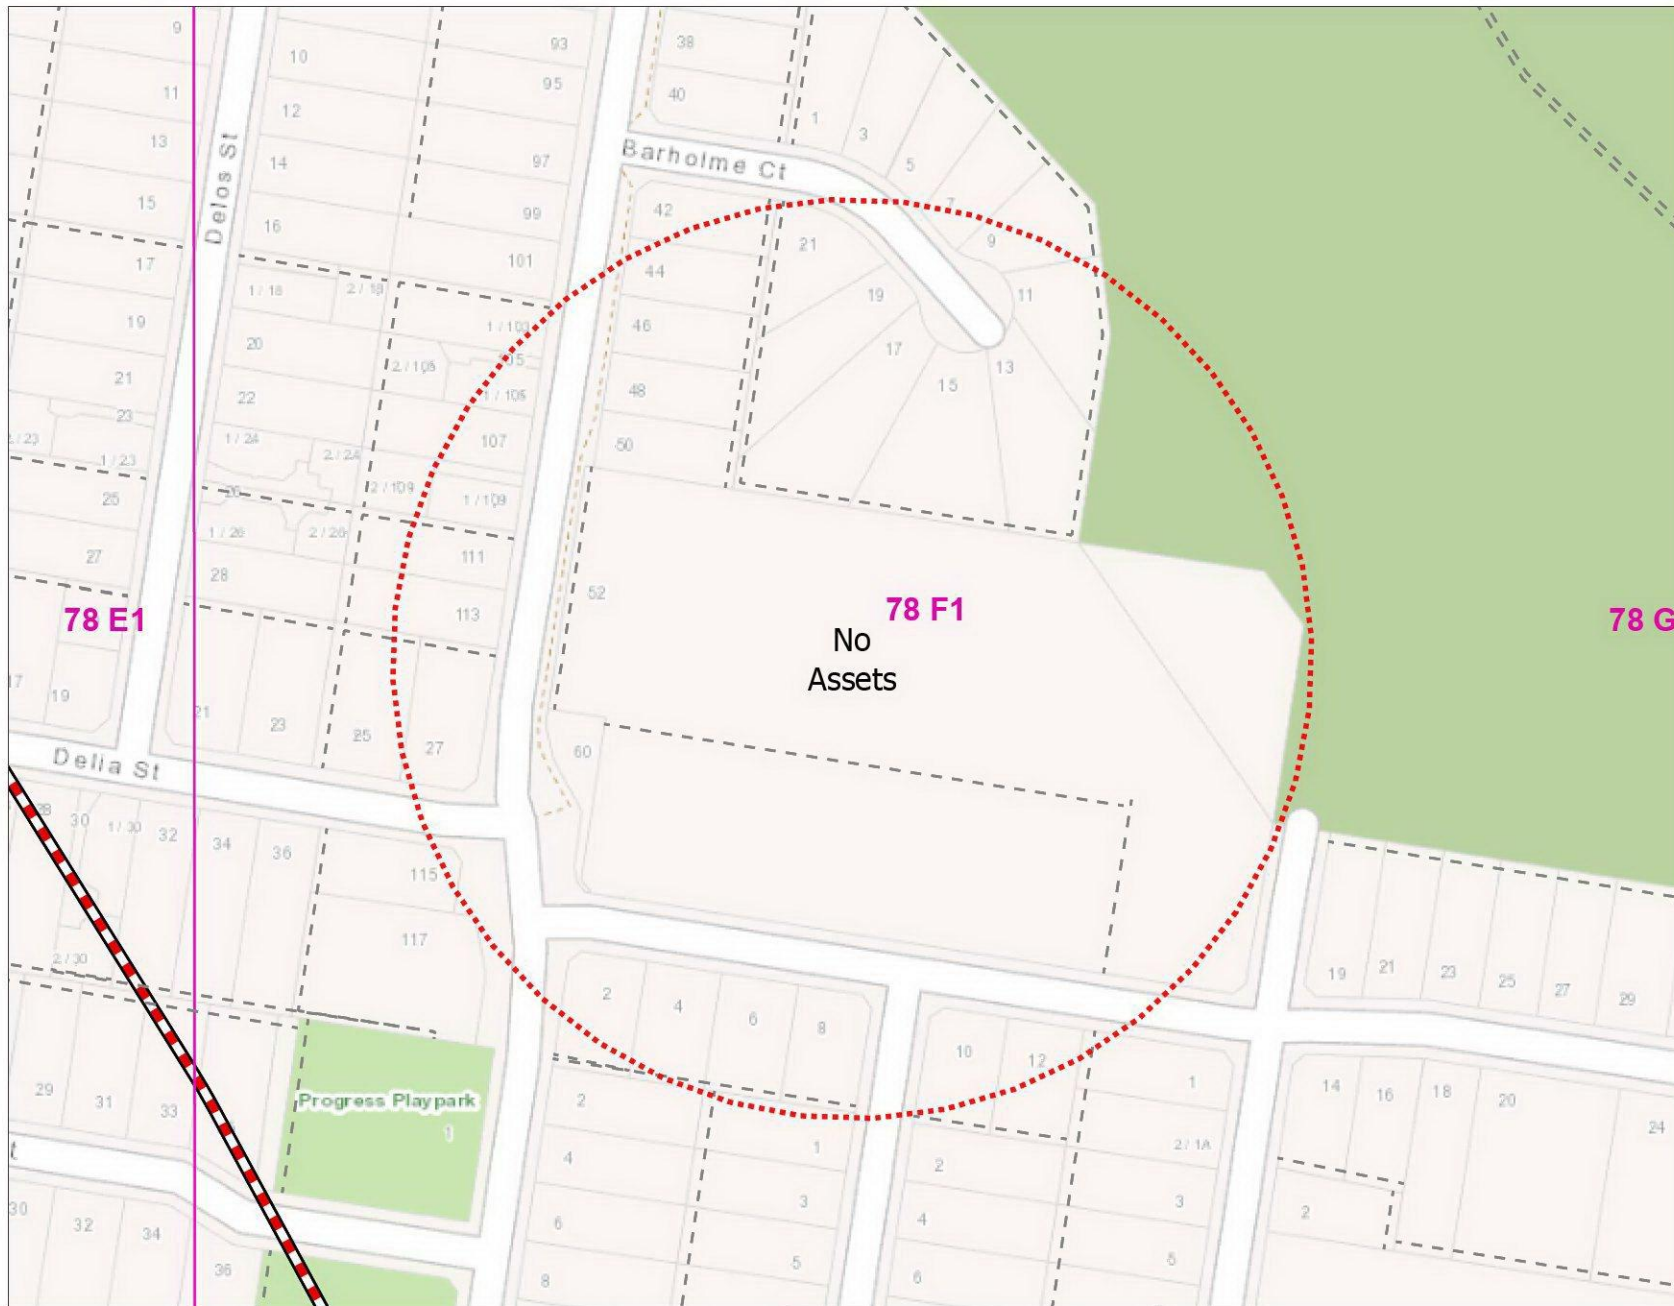
# Appendix A: DBYD Plans

A review of the plans indicated that the South Eastern Trunk Sewer is present running in a north-western to south-eastern direction in between the Site and the former quarry.

Review of the Locality Plan and Longitudinal Section provided by Melbourne Water indicated that the sewer pipeline located between the Site and the former landfill was approximately 3.5 m diameter, with the invert located approximately 3 m below surface.

<b>Preferential Pathways</b> Based on DBYD plans obtained for the Site (refer to <b>Appendix A</b> ), a trunk sewer is present between the former quarry and the Site. The sewer is approximately 3.5 m diameter and located approximately 3 m below surface (refer to attached <b>CSM</b> ). The trunk sewer does not connect the landfill and the Site, but may present a preferential pathway for lateral migration of landfill gas from the landfill.
	<b>Buffer distance</b> The distance to the Site from the Cavanagh Sands Quarry is approximately 200 m, which is the buffer distance recommended for solid inert landfills.  The distance to the Site from the Carrol Road Landfill is approximately 800 m, which is greater than the recommended buffer distance.
